The following is a numerical list of all active Service Letters.

Model 114 Service Letter Index (Cont)

SERVICE LETTER NO. SL-114-1A

CABIN NOISE REDUCTION

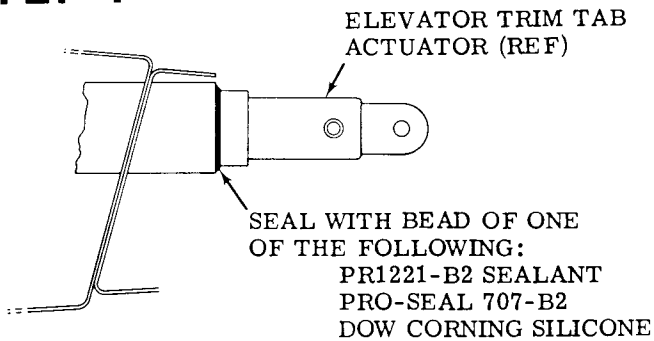
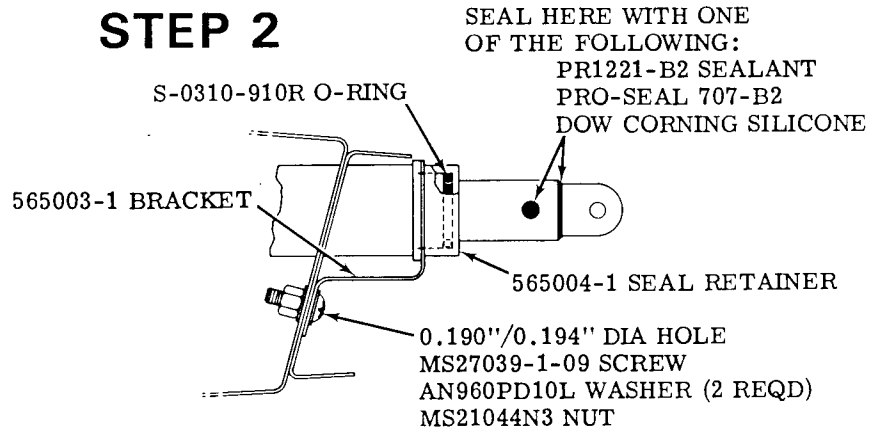
MODELS AFFECTED: MODEL 114, SERIAL NO'S. 14000 THRU 14058.
REASON FOR PUBLICATION: PREVENT MOISTURE FROM ENTERING ELEVATOR TRIM TAB ACTUATOR.
COMPLIANCE: DURING NEXT 100-HOUR INSPECTION OR ANNUAL INSPECTION.

4. Add a bead of PR1221-B2 sealant, or Pro-Seal 707-B2, or Dow Corning Silicone around elevator trim tab actuator as shown in Figure 1.
5. Install S-0310-910R O-ring, 565004-1 seal retainer and 565003-1 bracket on elevator trim tab actuator, drill a 0.192 (± 0.002) inch diameter hole through bracket and elevator spar and install MS27039-1-09 screw, AN960PD10L washer (2 places) and MS21044N3 nut (see Figure 1.).
6. Cover clevis joint and both ends of roll pin with either PR1221-B2 sealant, Pro-Seal 707-B2 or Dow Corning Silicone (see Figure 1.).

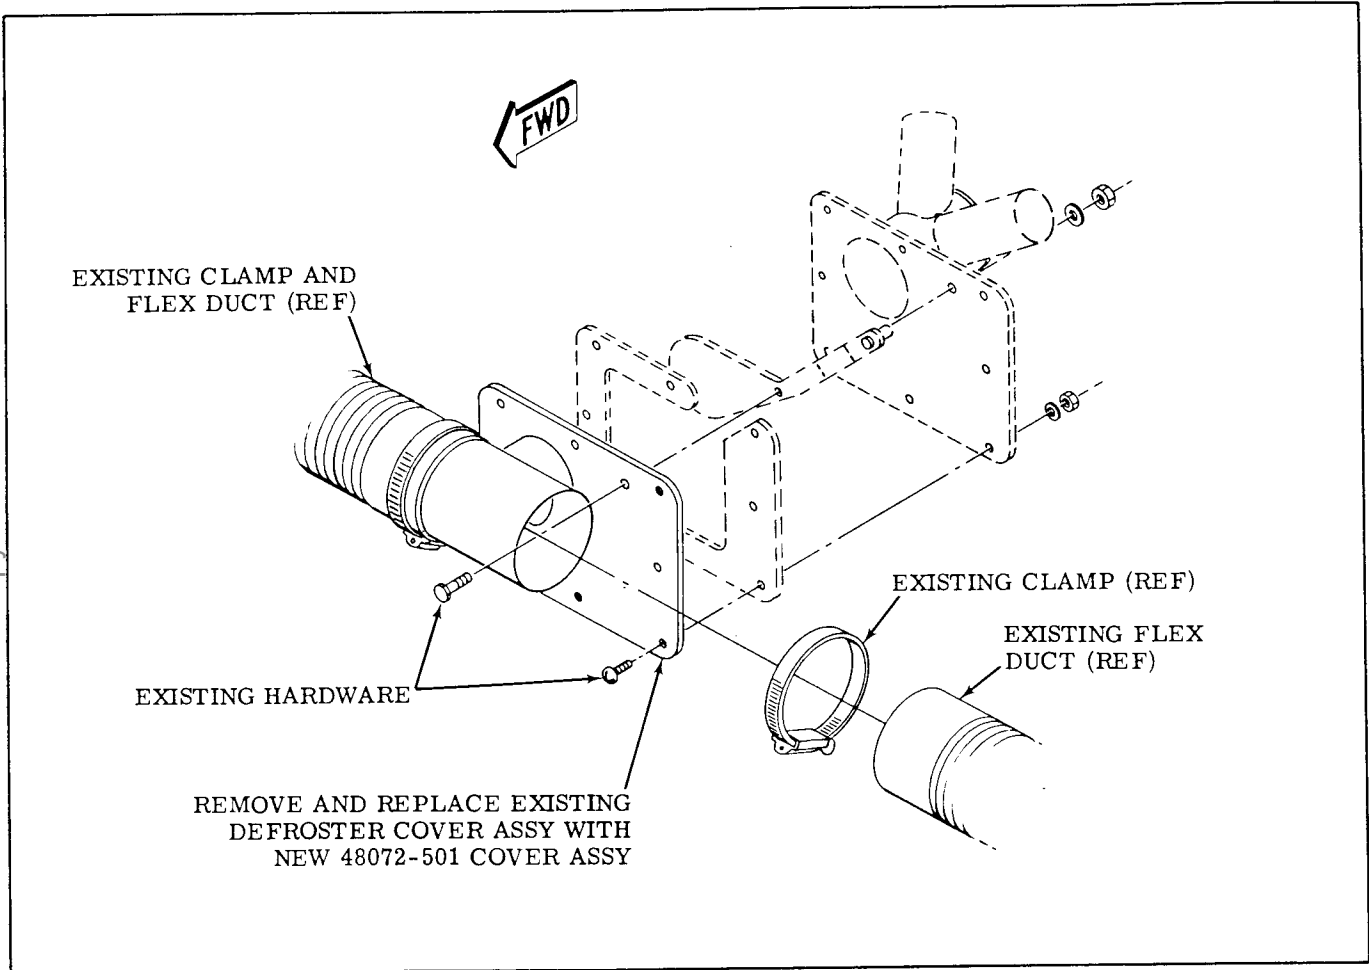
Figure 1.

MODELS AFFECTED: MODEL 114, SERIAL NO'S 14001 THRU 14016.
REASON FOR PUBLICATION: DEFROSTER VALVE COVER ASSEMBLY MAY HAVE A DEFECTIVE WELD. THIS SERVICE LETTER IS BEING ISSUED TO CORRECT THIS SITUATION.
COMPLIANCE: WITHIN NEXT 25-HOURS TIME IN SERVICE.

1. Remove upper engine cowling.
2. Disconnect flex ducts from defroster valve cover.
3. Remove and discard existing defroster valve cover assembly (see Figure 1.).
4. Install 48072-501 defroster valve cover assembly using existing hardware and seal around outer perimeter of cover assembly with Coast Pro-Seal 700, MIL-S-38249, Type I (see Figure 1.).
5. Reconnect existing flex ducts to new defroster valve cover assembly using existing clamps.
6. Reinstall upper engine cowling.

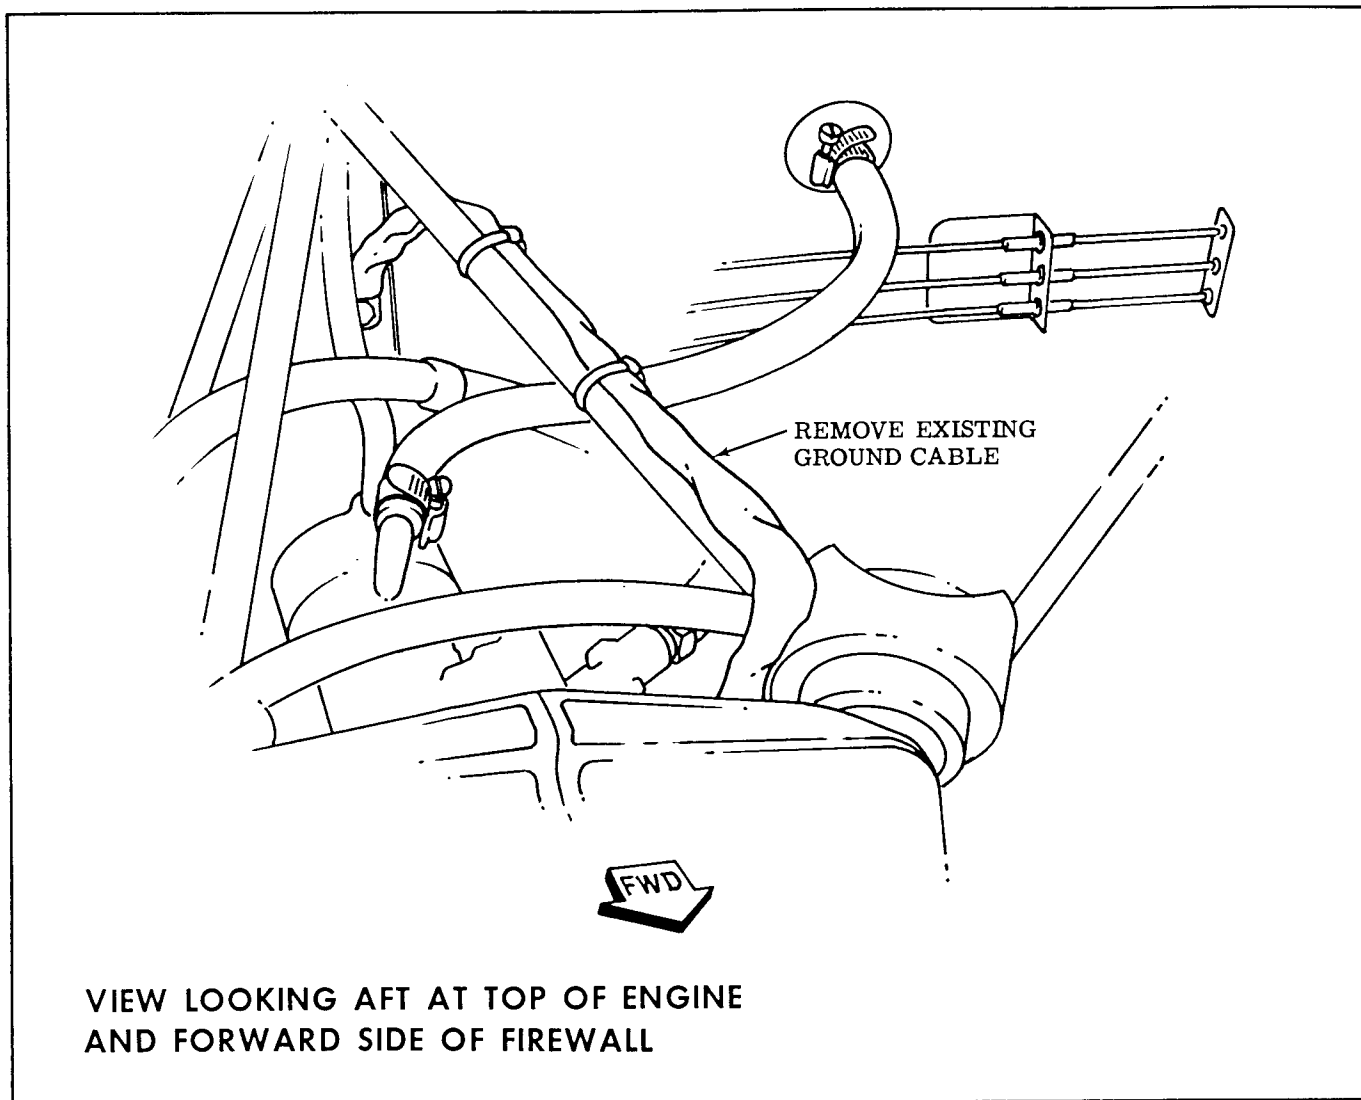
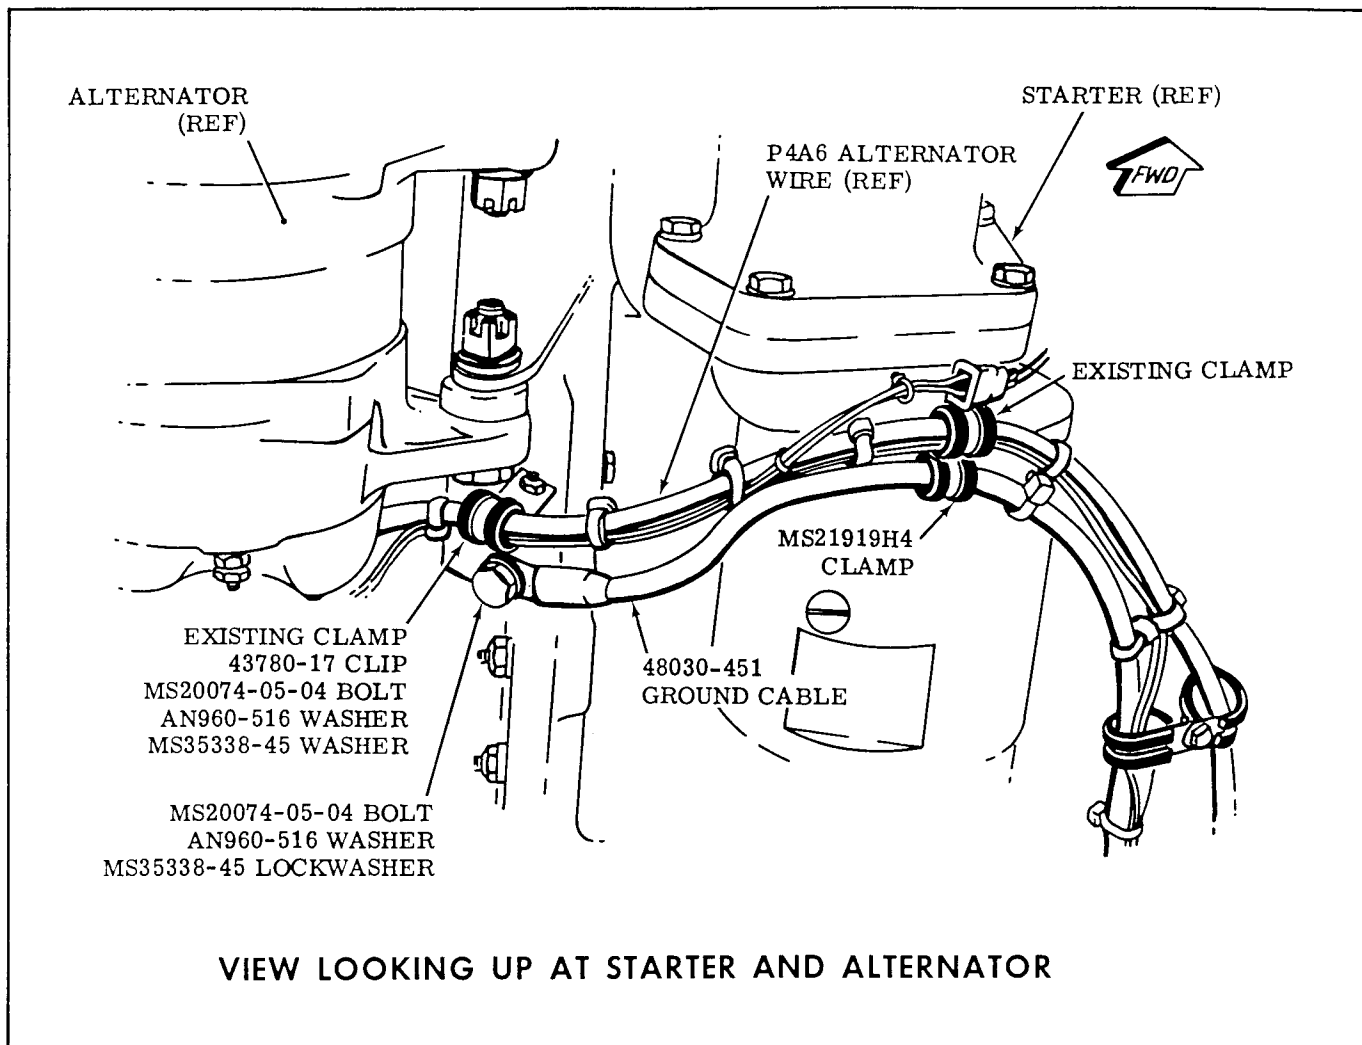
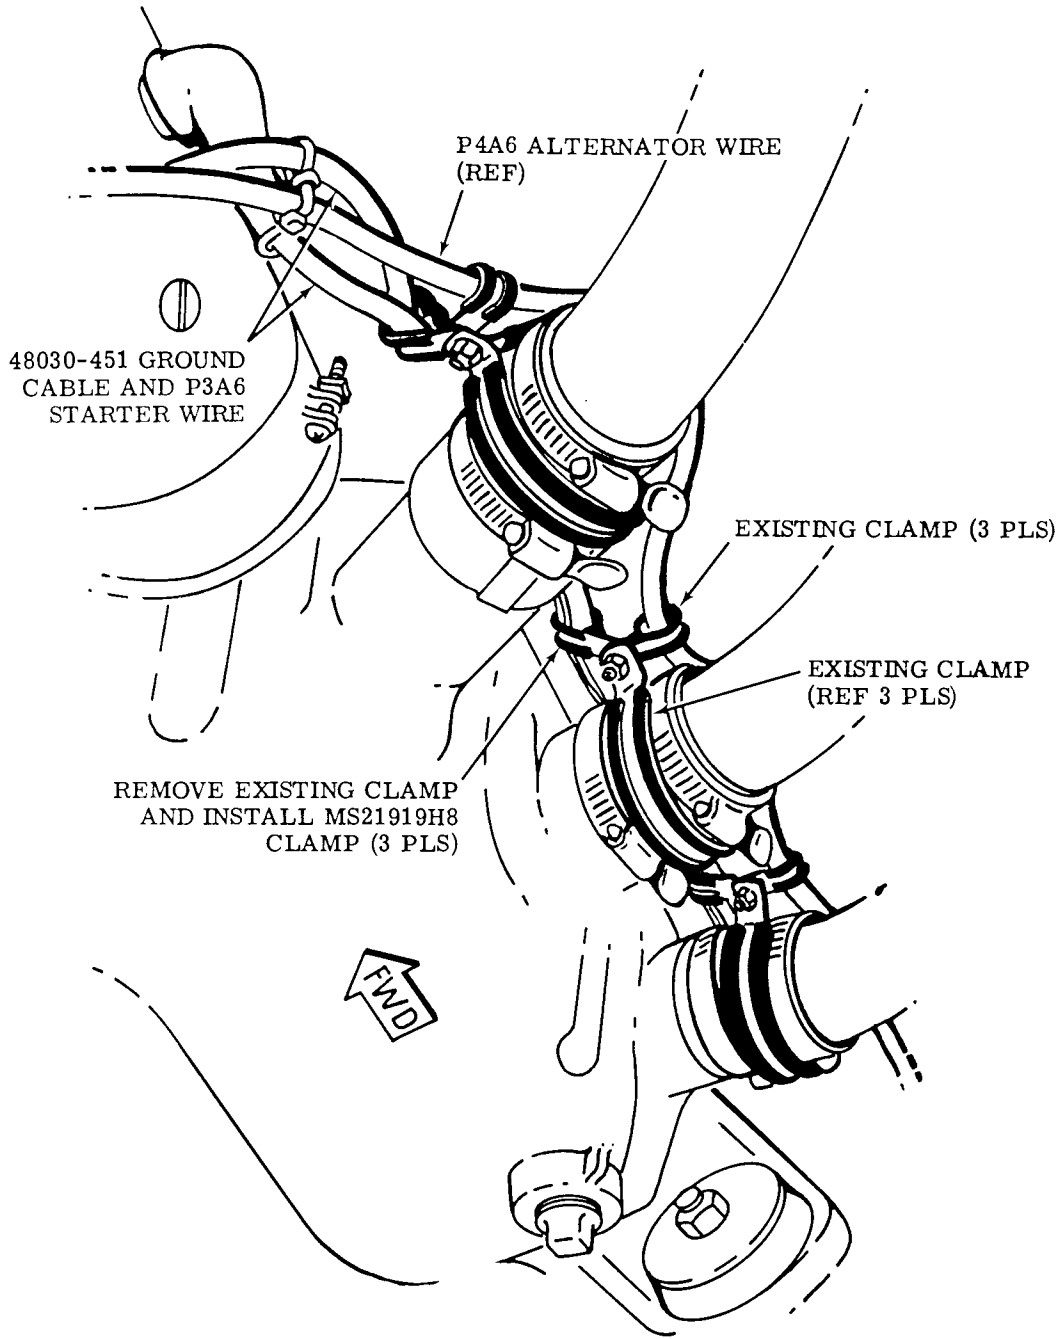
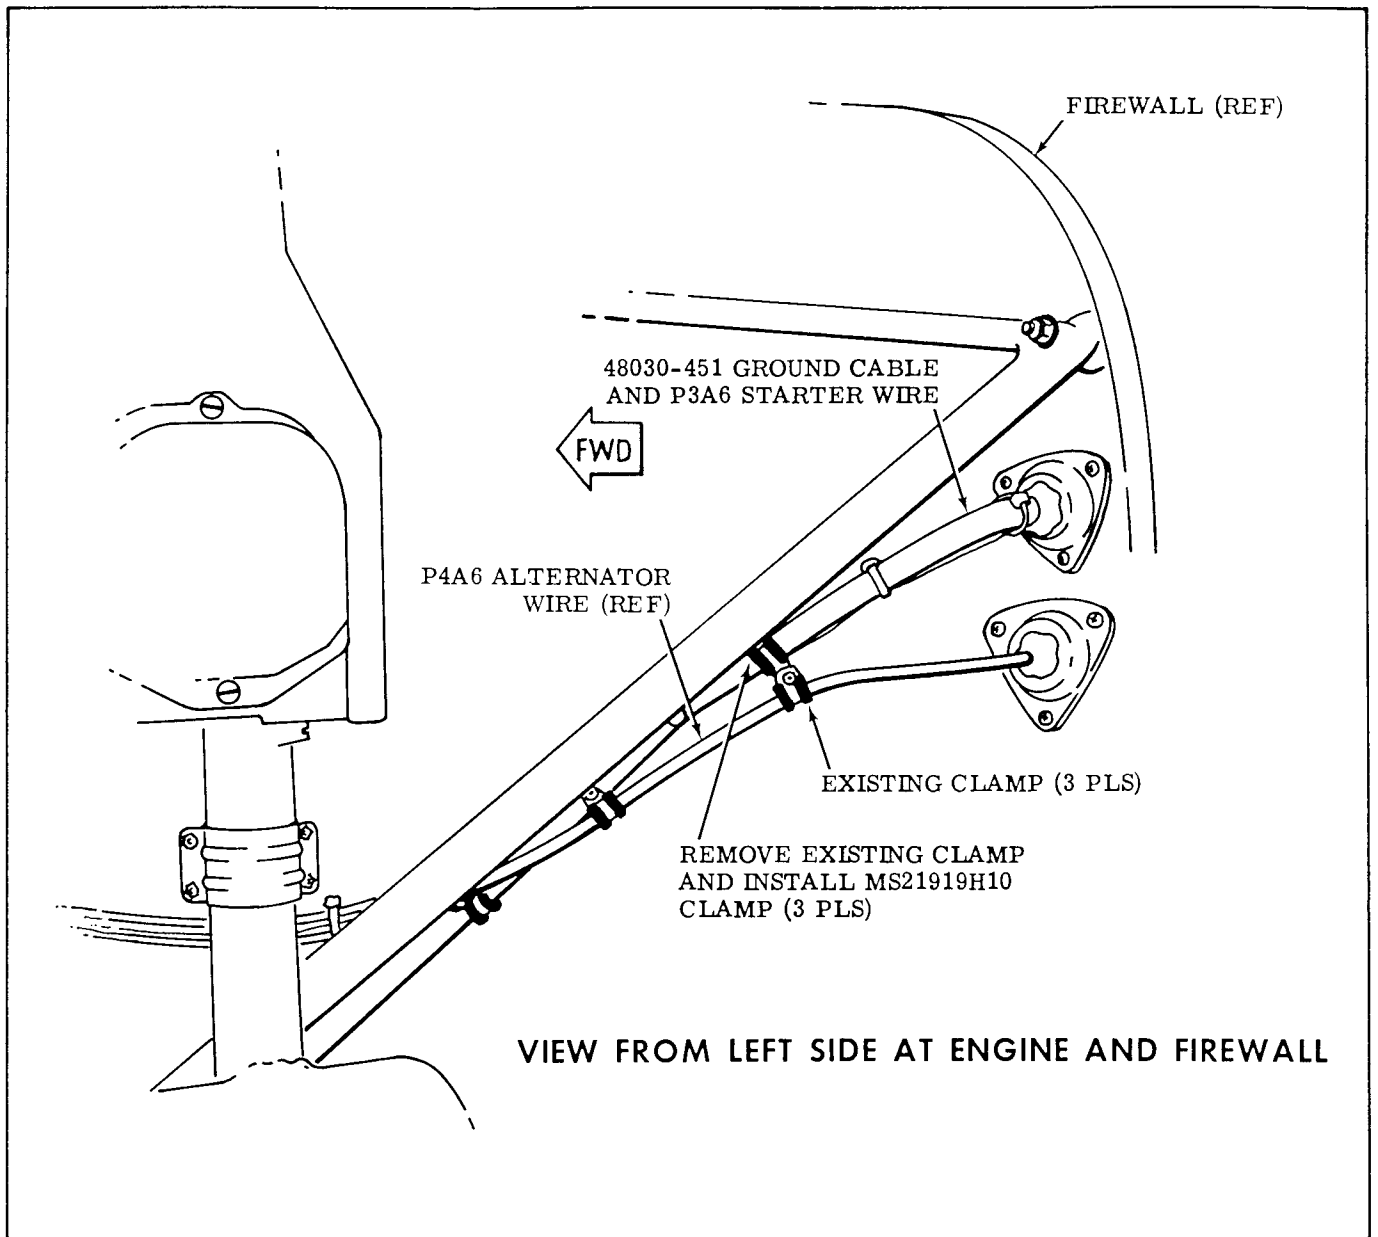
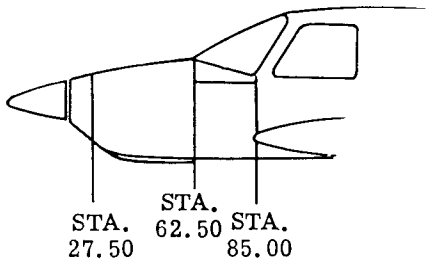
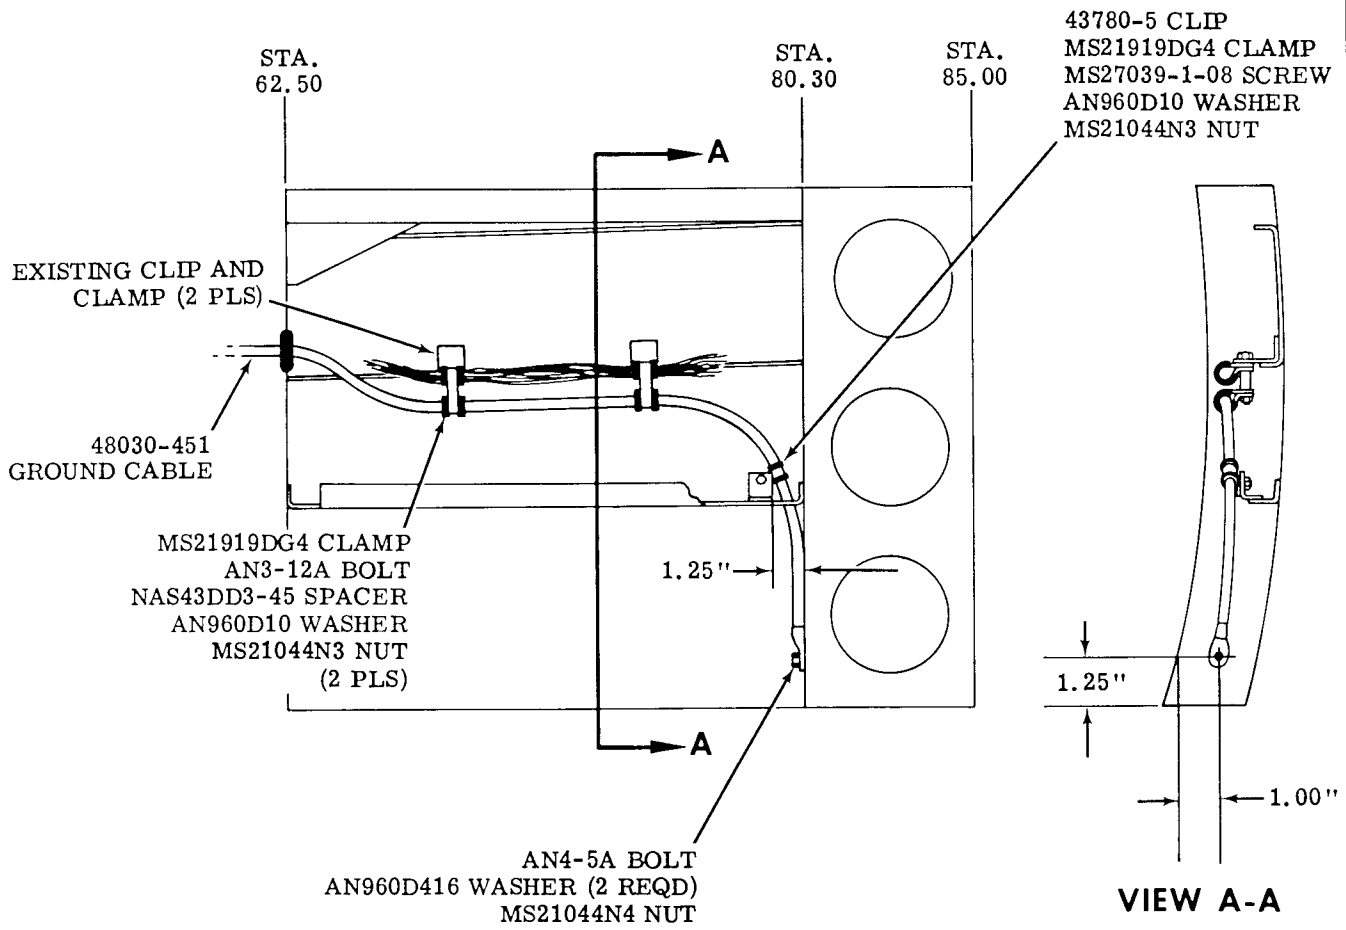
REASON FOR PUBLICATION: TO PREVENT MAGNETIC COMPASS INTERFERENCE DUE TO IMPROPER/INSUFFICIENT BONDING OF ENGINE TO AIRFRAME GROUND. THIS HAS BEEN NOTED ON CERTAIN AIRCRAFT BY BEING UNABLE TO ACHIEVE PROPER COMPASS HEADINGS.

1. Assure that airplane master switch is in the OFF position.
2. Remove upper engine cowling.
3. Remove lower engine cowling as outlined in the Airplane Maintenance Manual, Section IV.
4. Remove left door scuff plate and door jamb moulding as necessary to facilitate removal of left forward interior side panel.
5. Remove left forward interior side panel.
6. Remove and discard existing engine ground strap (see Figure 1.).
7. Install 43780-17 clip on engine with MS20074-05-04 bolt, AN960-516 washer and MS35338-45 lockwasher (see Figure 2.).

8. Install 48030-451 ground cable on engine with MS20074-05-04 bolt, AN960-516 washer and MS35338-45 lockwasher and route ground cable aft to firewall with existing P3A6 starter wire, but maintain separation with alternator wire P4A6 in the engine area (see Figures 2., 3. and 4.).
9. Locate, drill and install 43780-5 clip with MS20470AD3 rivet (see Figure 5.).
10. Route 48030-451 ground cable through engine firewall and attach to fuselage frame, at Sta. 80.30, with AN4-5A bolt, AN960D416 washer (2 places) and MS21044N4 nut (see Figure 5.).

11. Install MS21919DG4 clamp (3 places) between fuselage Sta. 62.50 and Sta. 80.30 to support ground cable (see Figure 5.).
12. Remove existing clamps in engine compartment and install new MS21919H clamps as shown in Figures 2., 3. and 4.
13. Seal around wires routed through firewall grommet with Proseal 700, MIL-S-38249, Type 1 (or equivalent).

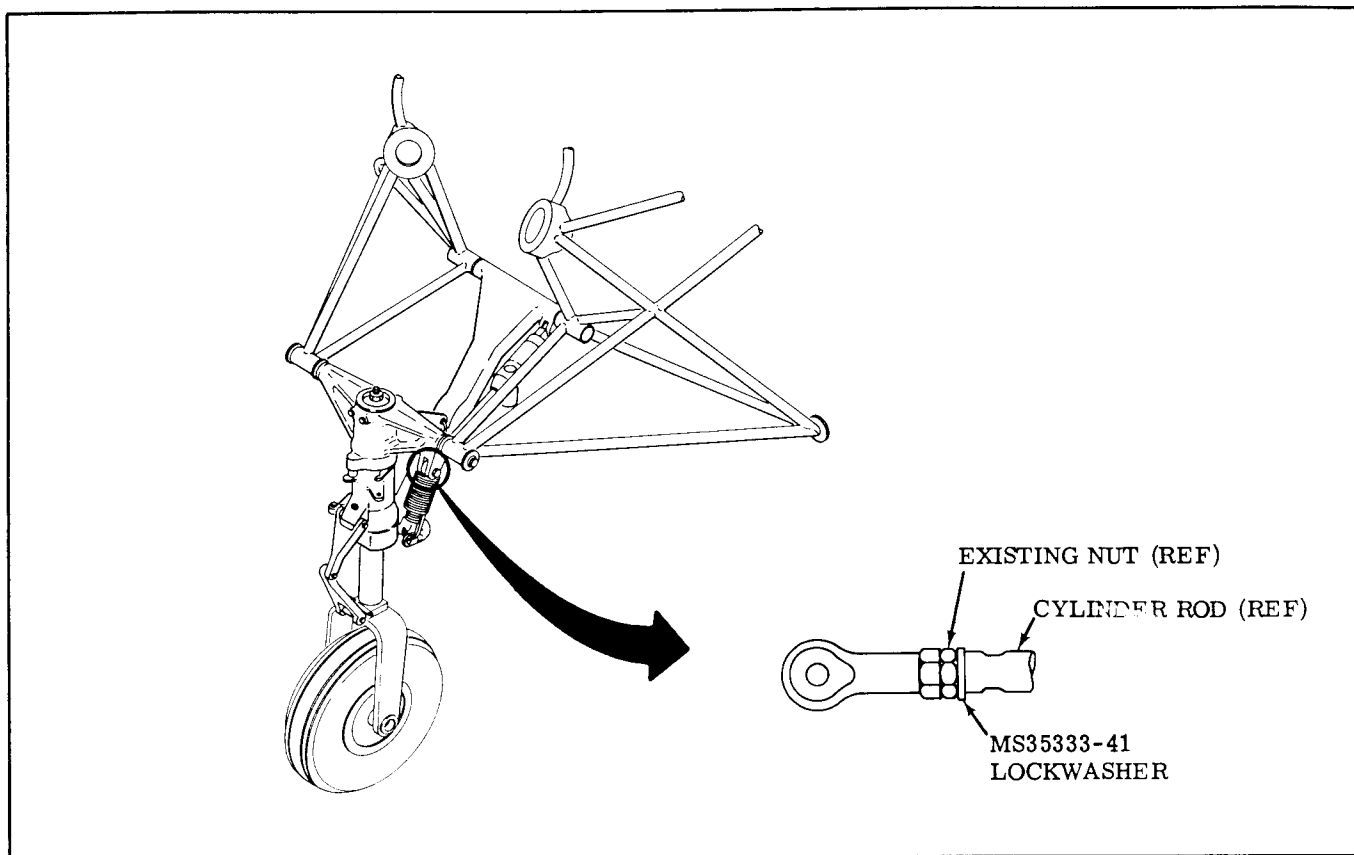
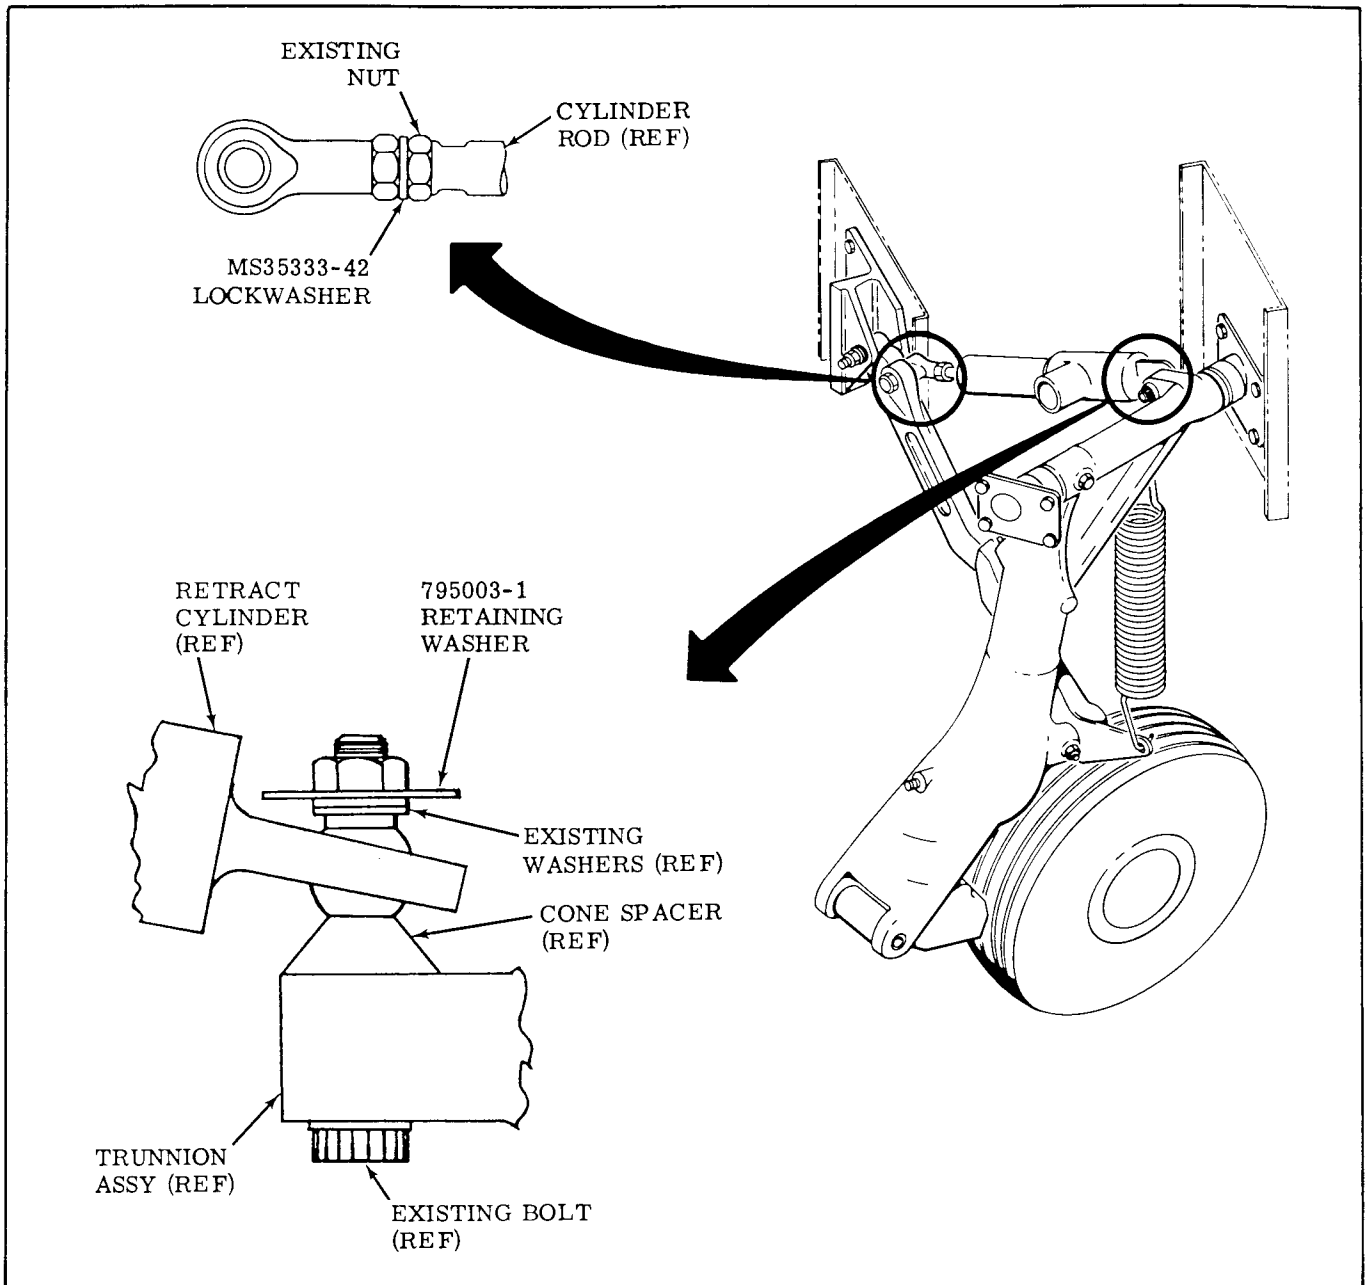
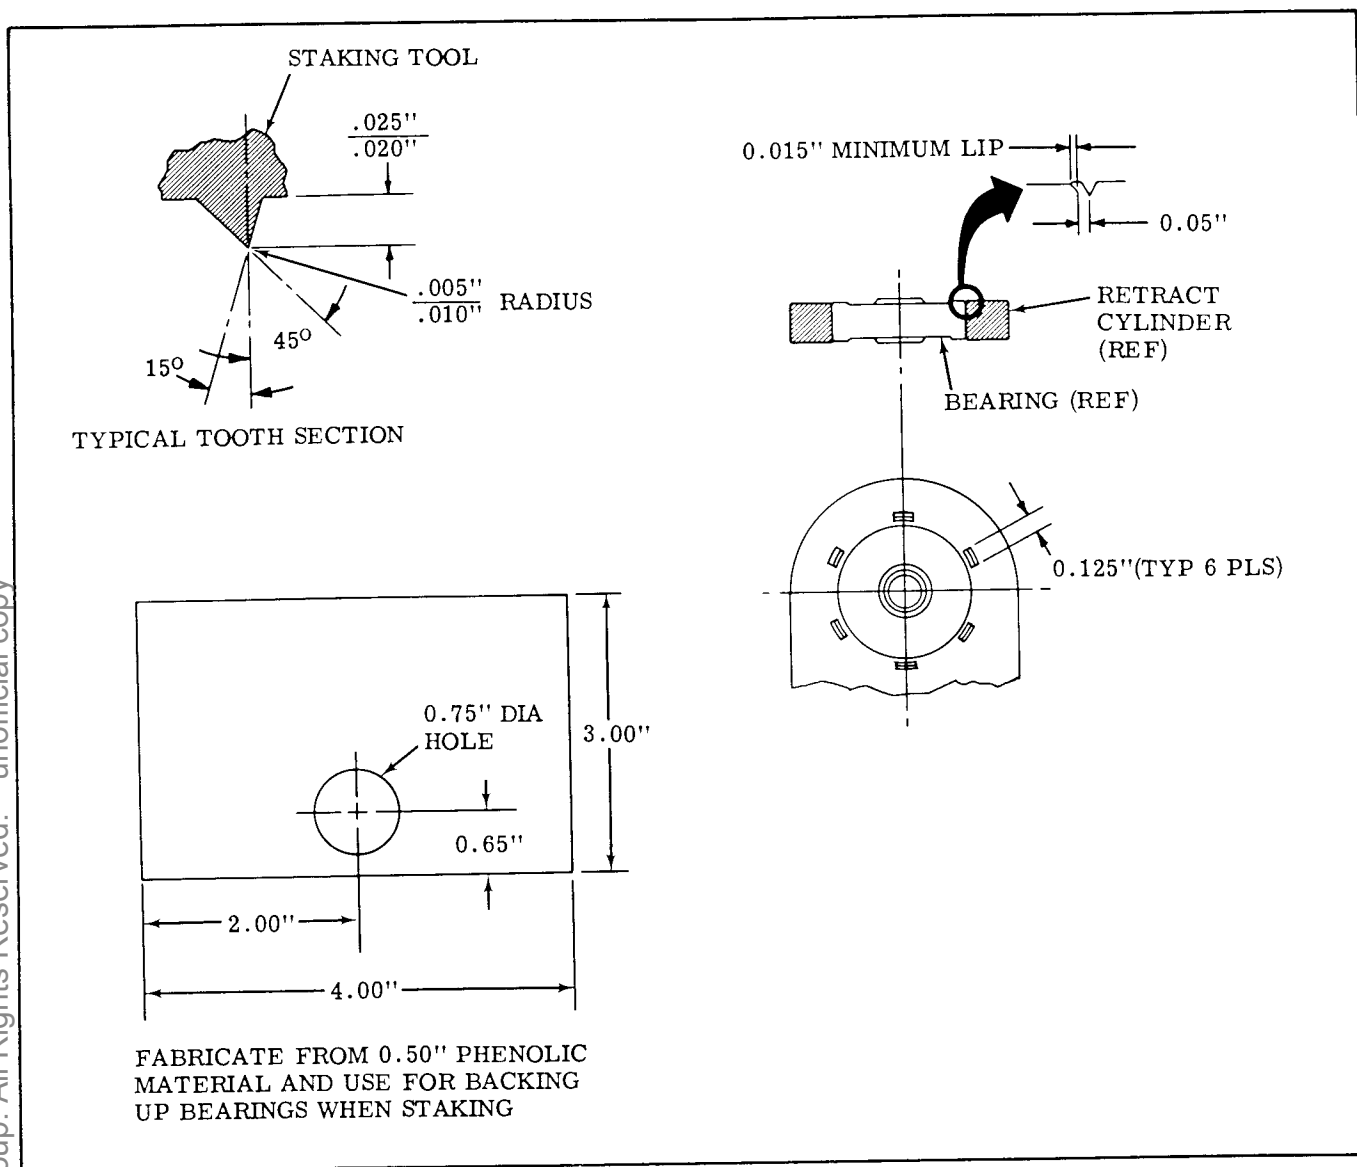
REASON FOR PUBLICATION: THE RETAINER IS TO PREVENT LOSS OF ATTACHMENT OF THE MAIN LANDING GEAR RETRACT CYLINDER IF BEARING BECOMES LOOSE IN CYLINDER END. THE LOCKWASHER IS TO PREVENT ROTATING OF ROD END NUT ON NOSE LANDING GEAR AND MAIN LANDING GEAR RETRACT CYLINDERS.

1. Jack airplane as outlined in the Airplane Maintenance Manual, Section II.
2. Disconnect nose landing gear retract cylinder at landing gear trunnion.
3. Loosen rod end nut and remove rod end.
4. Install MS35333-41 lockwasher and existing rod end on nose landing gear retract cylinder and run nut and rod end all the way down on threads of retract cylinder (see Figure 1.).
5. Check drag brace assembly at knuckle area to assure that drag brace is resting on stop.

8. Collapse nose landing gear as necessary to gain access to rod end nut and torque nut 60 to 85 inch-pounds against cylinder rod and lockwasher while holding cylinder rod securely.
9. Remove bolts attaching the inboard end of the left and right main landing gear retract cylinder to the side brace assemblies.
10. Loosen rod end nut and remove rod end.
11. Install MS35333-42 lockwasher and existing rod end on left and right main landing gear retract cylinder (see Figure 2.).

- b. Inspect cylinder end plug bearings to assure that the bearings are properly staked as shown in Figure 3.

Fabricate a block from 1/2-inch phenolic material for backing up bearing when staking (see Figure 3.).

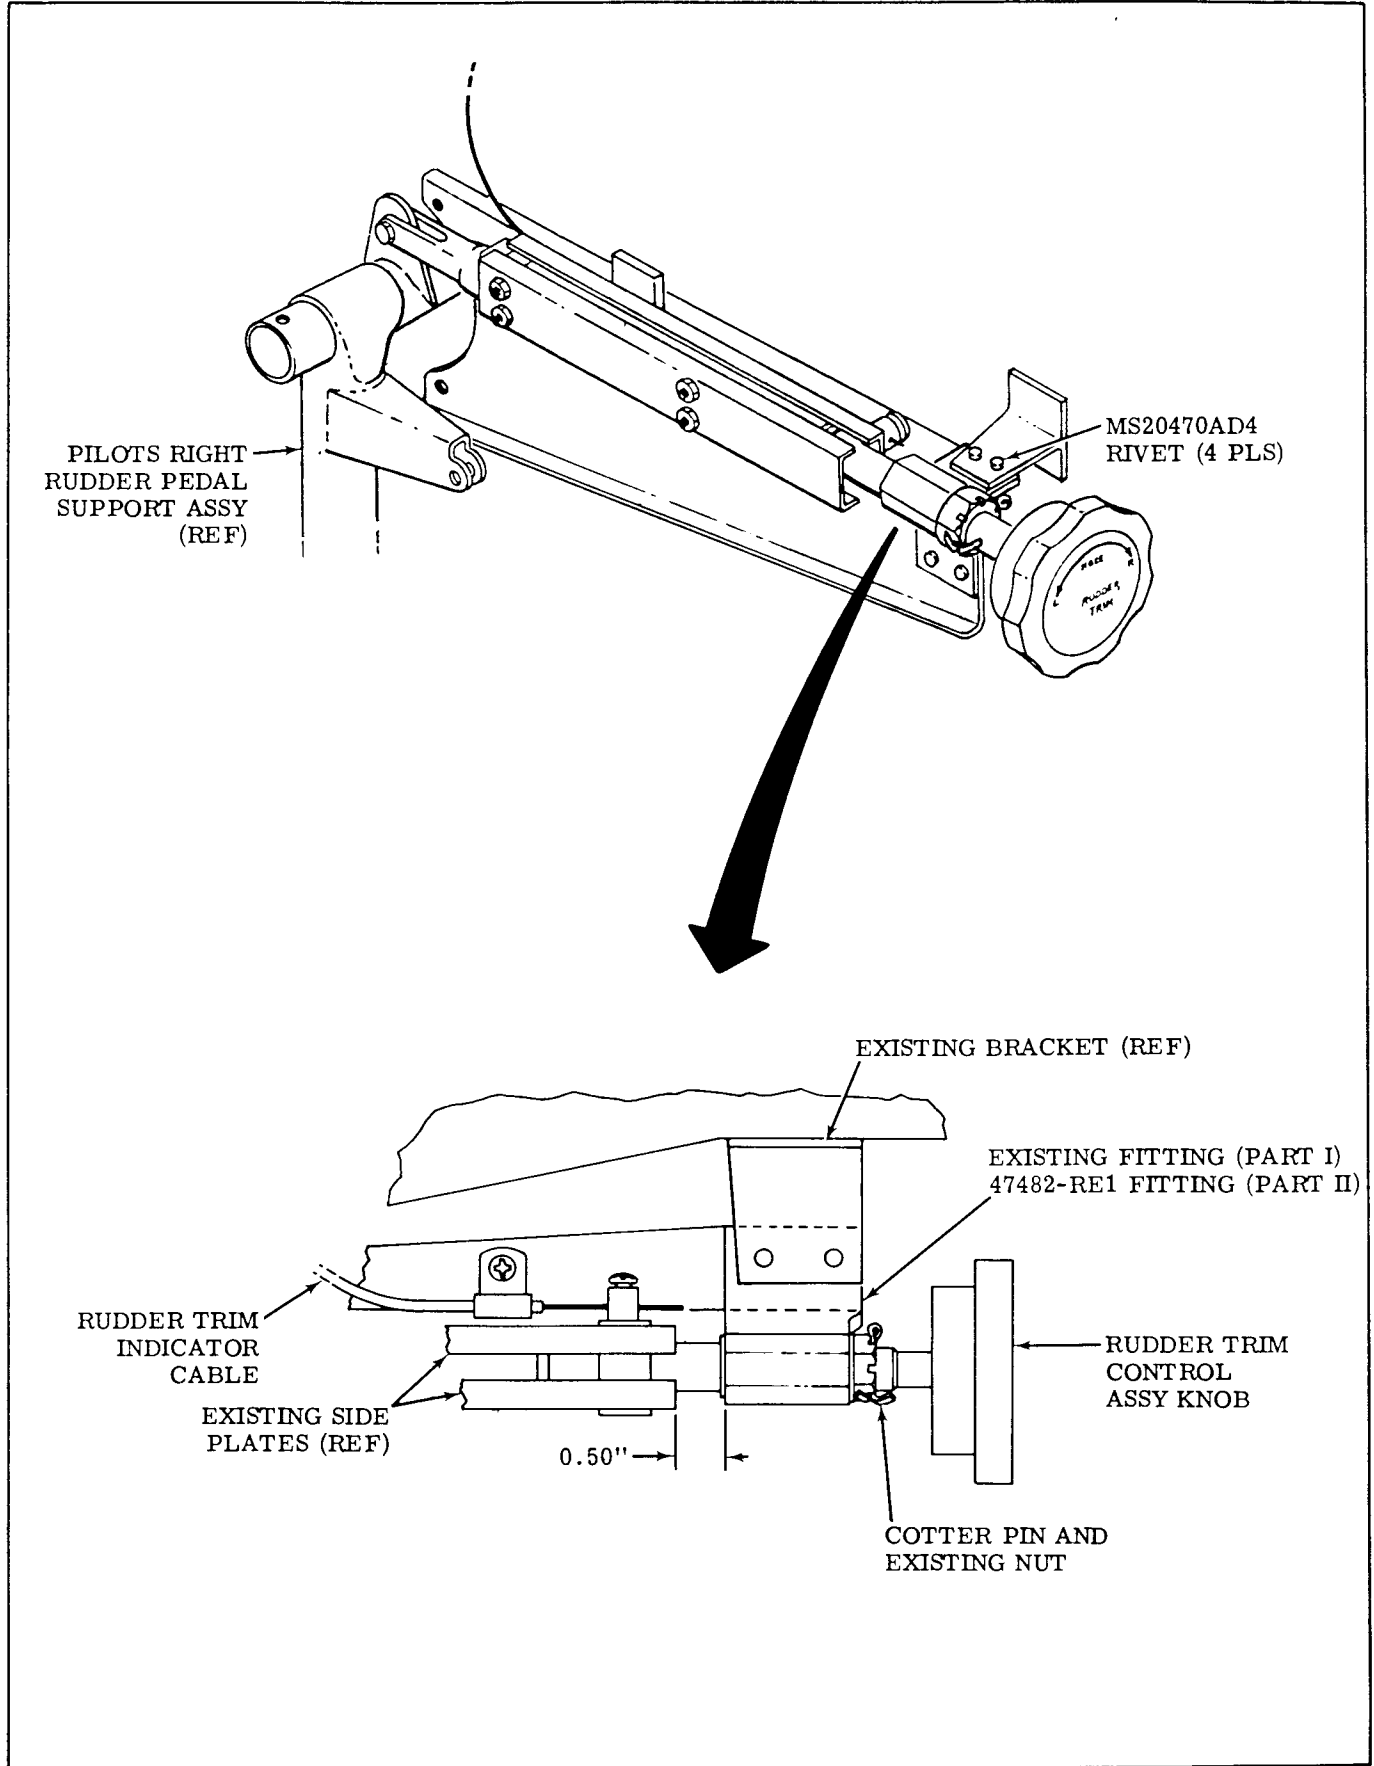
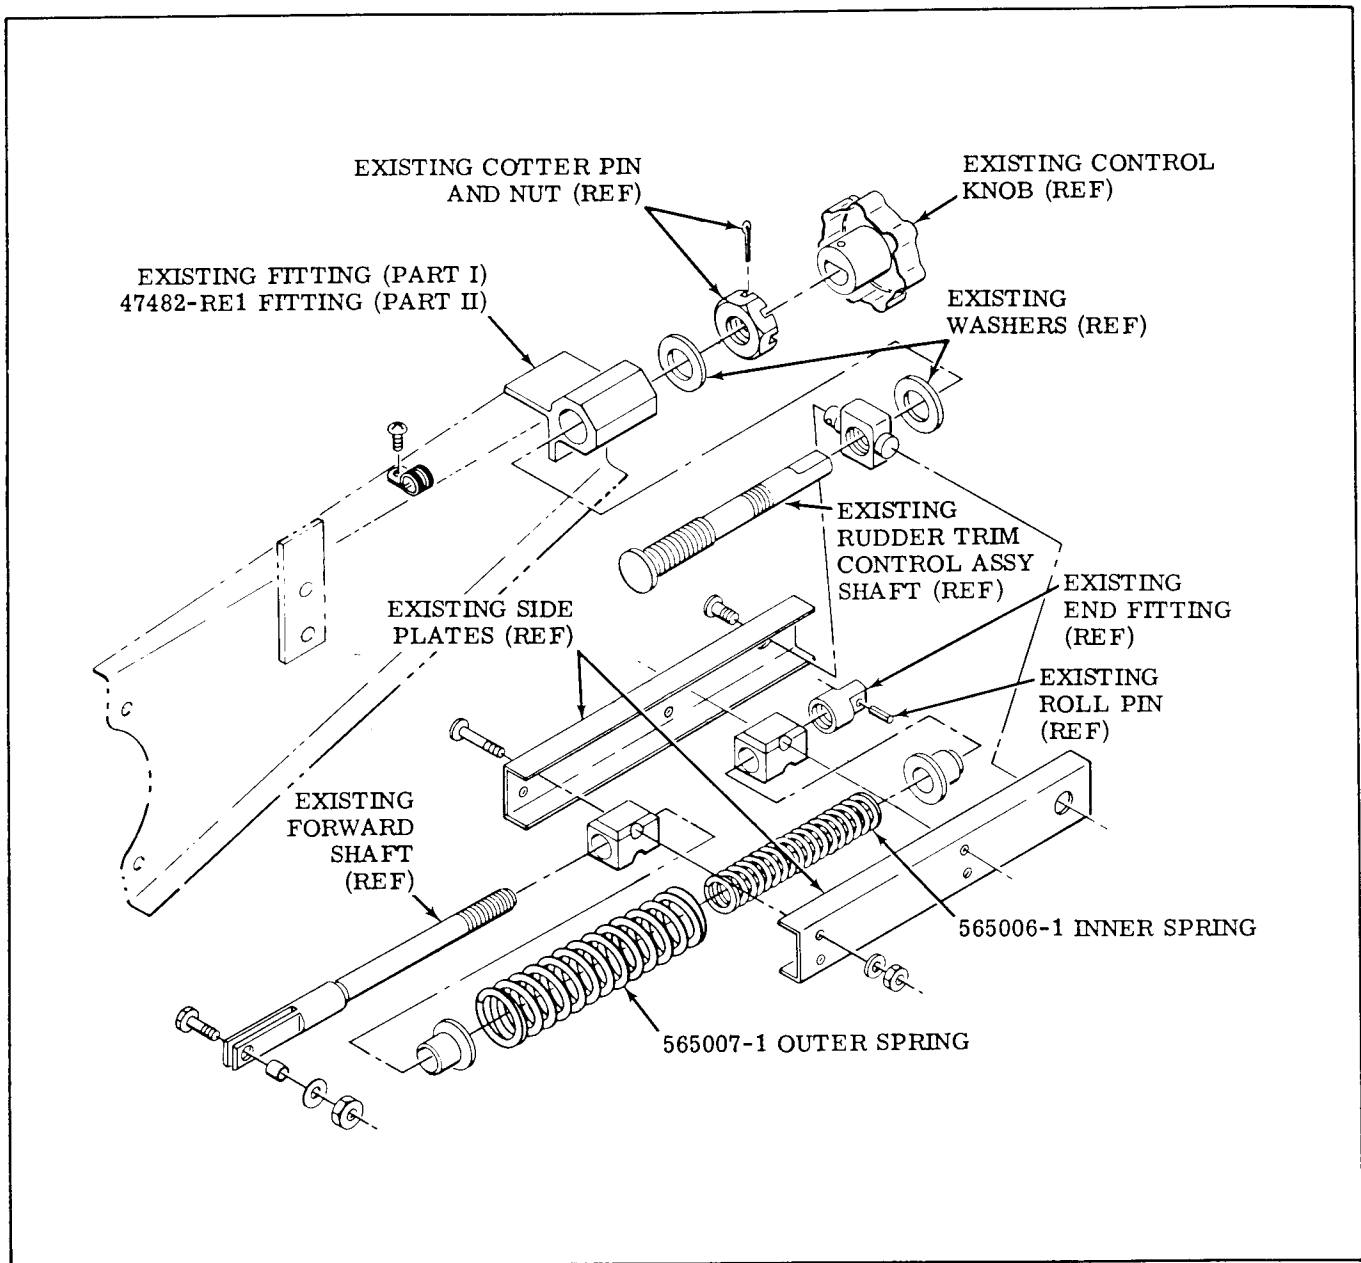
REASON FOR PUBLICATION: TO IMPROVE RUDDER TRIM AND PREVENT THE POSSIBLE BOTTOMING OF RUDDER TRIM SPRING AT EXTREME TRIM CONDITION.

3. Check for 0.50 (\pm 0.03) inch dimension between rudder trim control assembly fitting and side plate (see Figure 1.).
4. If dimension between rudder trim control assembly fitting and side plate exceeds 0.53-inch, remove straight edge from pilot's rudder pedals and proceed to Part II.
5. If dimension between rudder trim control assembly fitting and side plate is 0.50 (\pm 0.03) inch, remove straight edge from pilot's rudder pedals.
6. Remove rudder trim control assembly knob and nut, loosened in step 1., from shaft.
7. Disconnect forward shaft of rudder trim control assembly from top of pilot's right rudder pedal support assembly.
8. Disconnect rudder trim indicator cable from rudder trim control assembly and remove rudder trim control assembly from airplane.
9. Disassemble rudder trim control assembly and discard existing springs.

5. Install new 565006-1 inner spring and 565007-1 outer spring and reassemble rudder trim control assembly (see Figure 2.).
6. Remove and discard existing fitting from rudder trim control assembly bracket (see Figure 2.).
