The following is a numerical list of all active Service Letters.

Model 114 Service Letter Index (Cont)

SERVICE LETTER NO. SL-114-1A

CABIN NOISE REDUCTION

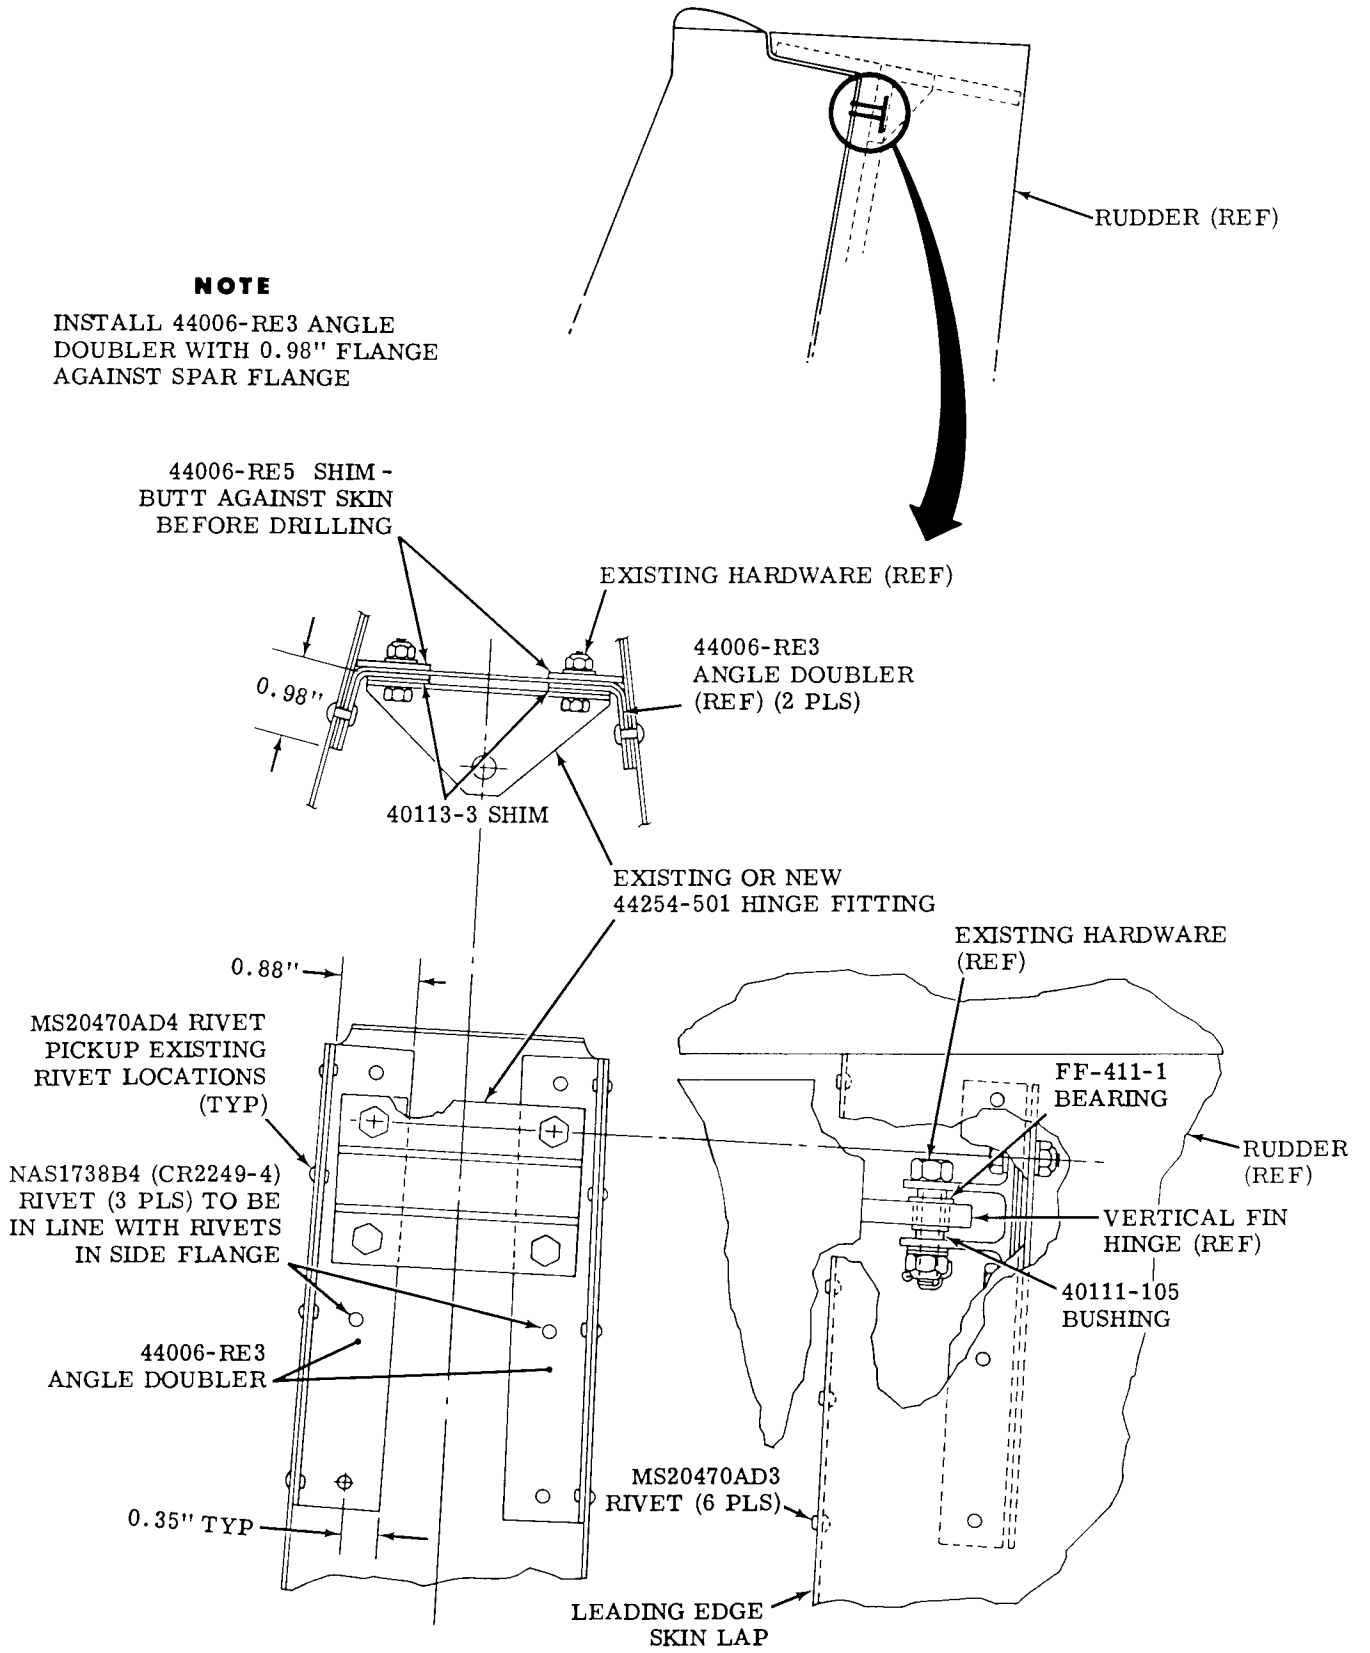
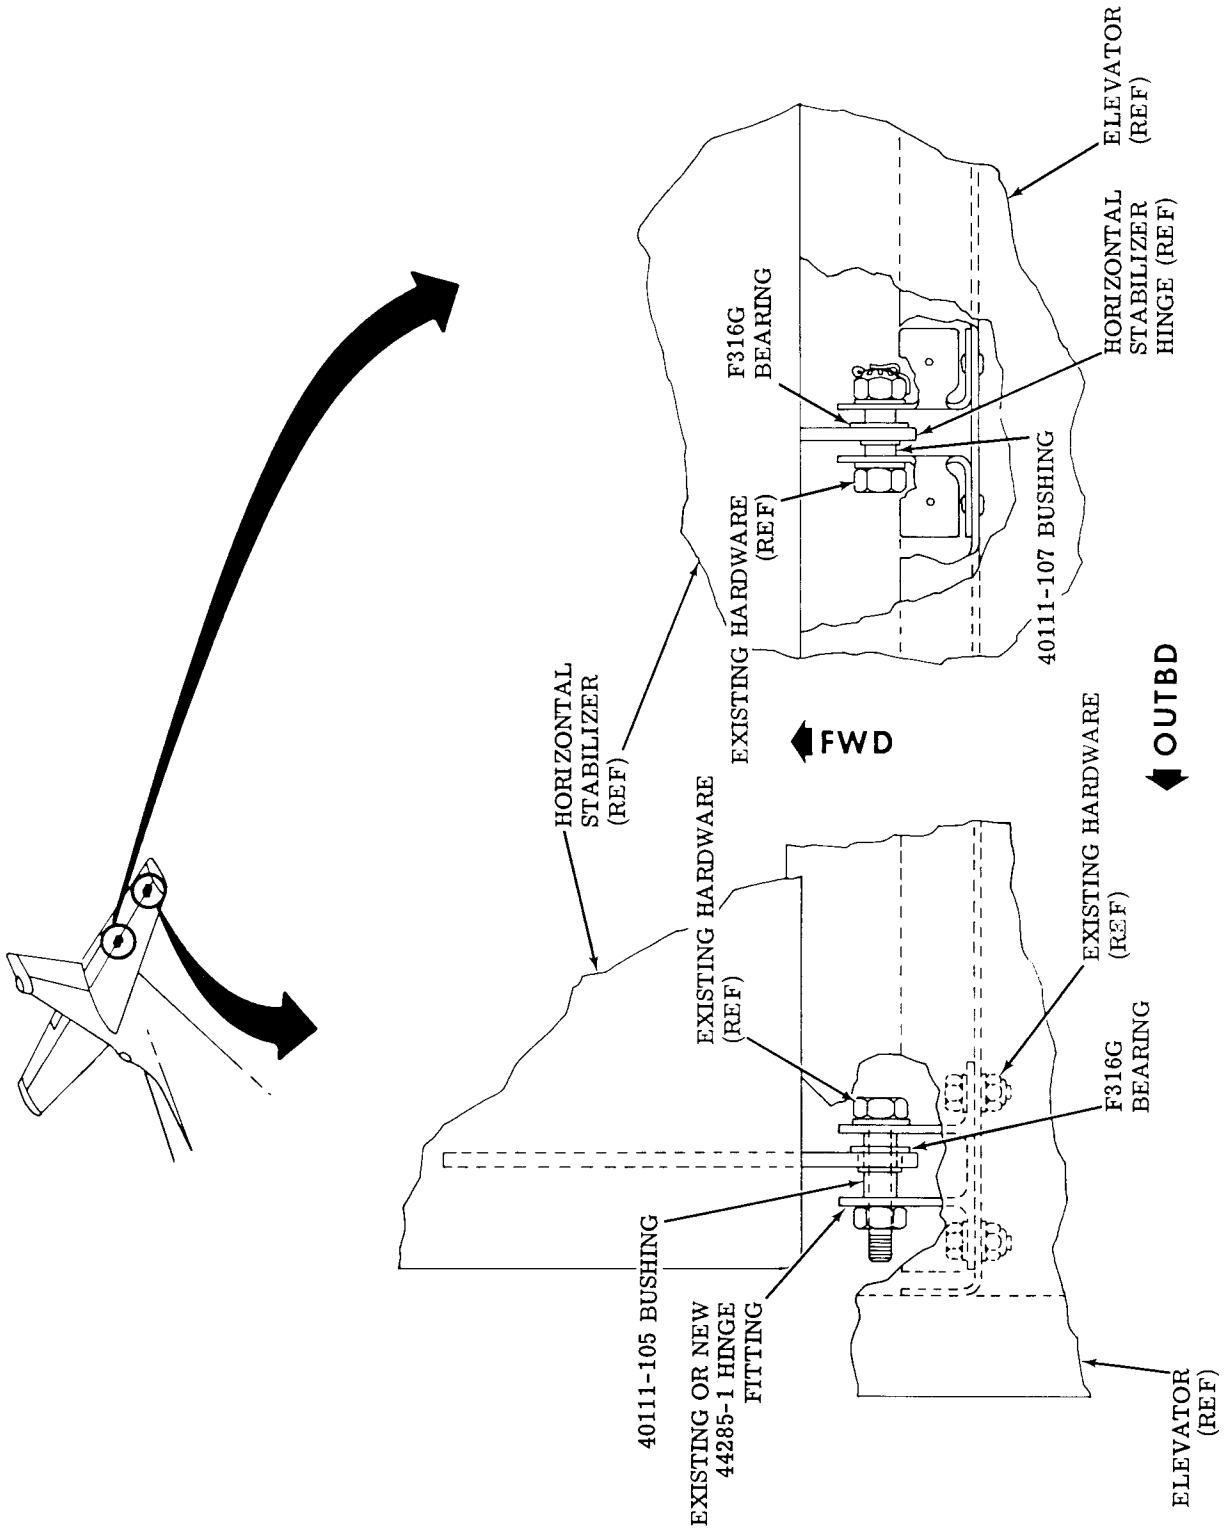
REASON FOR PUBLICATION: POSSIBLE ELONGATION OF HOLES IN HINGE FITTINGS AND CRACKS IN RUDDER SPAR.

6. Dye penetrant inspect the bend radius of rudder spar, in area of upper hinge fitting, for cracks.
7. If no cracks are found in bend radius of rudder, in area of upper hinge fitting, proceed to step 9.

8. If cracks are found in bend radius of rudder spar, in area of upper hinge fitting, proceed as follows:
 - a. Remove upper four (4) rivets, attaching skin to spar, from left and right side of rudder assembly (total of eight (8) rivets).

- b. Remove upper six (6) rivets from rudder assembly leading edge skin lap.
 - c. Stop drill all cracks with a No.40 (0.098) diameter drill.
 - d. Locate, drill and install 44006-RE3 angle doubler (2 places) on rudder assembly (see Figure 1.).

NOTE
INSTALL 44006-RE3 ANGLE DOUBLER WITH 0.98" FLANGE AGAINST SPAR FLANGE

Replace center hinges if holes are elongated.
