General Aviation Division
Rockwell International

SERVICE INFORMATION NO. SI-102

SUBJECT: FAA AIRWORTHINESS DIRECTIVE 74-24-13.

SUBJECT: FLOW DIVIDERS FOR BENDIX FUEL INJECTION SYSTEMS, INSPECTION AND MODIFICATION OF

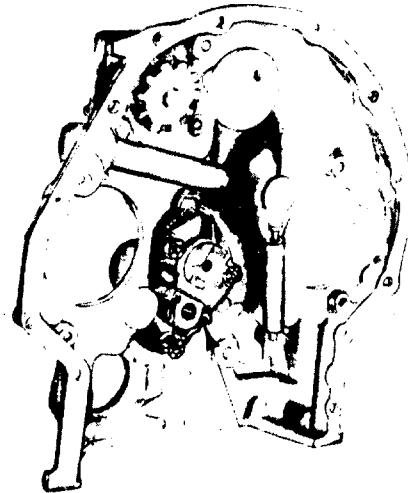
Figure 1. Interior View of Accessory Housing Showing Location of Cotter Pin in Oil Pump Idler Shaft

This modification consists of replacing the oil pump drive shaft and drive impeller to eliminate the Woodruff key drive which has proven to be the cause of excessive wear in the keyway of the hardened drive impeller. Therefore, it is recommended that all of the applicable engines listed above, as well as any others that may have been modified in accordance with Service Instruction No. 1272, use the following procedure for parts replacement.

IF IDLER SHAFT IS SECURED
WITH A COTTER PIN AT THIS LOCA-
TION MODIFICATION IS NOT REQUIRED

3. Reassemble the oil pump using the new drive shaft and drive impeller supplied with the kits shown in the following "Parts Data" section. See figure 2. Be sure all of the parts are lubricated thoroughly during assembly. After assembly, turn the drive

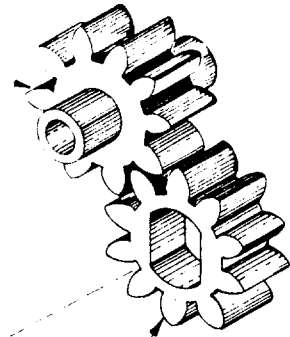
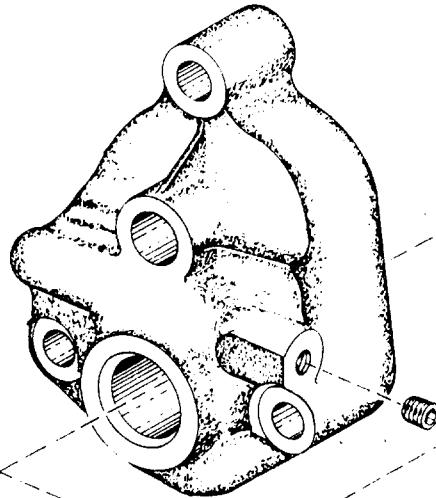
4 AND 6 CYLINDER ENGINES
DRIVING IMPELLER P/N LW-14038
REPLACES
DRIVING IMPELLER P/N'S LW-12897
AND P/N 77313 WHICH HAVE KEYWAY.

6 CYLINDER ENGINES
P/N 74641 DRIVE SHAFT
REPLACES
DRIVE SHAFT WITH KEYWAY
P/N 78619

4 CYLINDER ENGINES
P/N 61174 DRIVE SHAFT
REPLACES
DRIVE SHAFT WITH KEYWAY
P/N 75288

4 CYLINDER ENGINES WITH
DUAL MAGNETO INSTALLATIONS
P/N LW-14040 OIL PUMP DRIVE
GEAR, REPLACES P/N'S LW-10316
OR LW-12916

USE EITHER
78532 DRIVEN IMPELLER & SHAFT ASSEMBLY (IRON)
OR
LW-13775 DRIVEN IMPELLER & SHAFT ASSEMBLY (ALUMINUM)

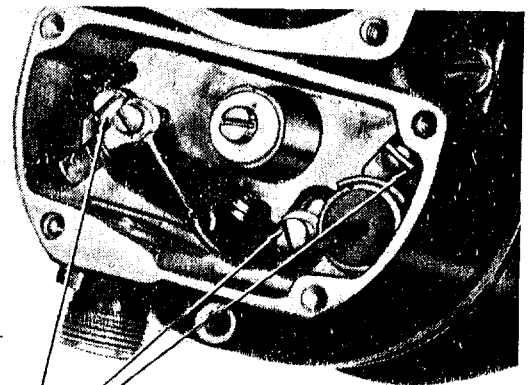
Typical S-20 Series Magneto
Figure 1

The captive lockwasher on some screws 10-35936-7 is breaking or cracking after the screw is tightened. This breakage is due to hydrogen embrittlement of a certain group of parts. For all practical purposes the lockwasher will perform normally until the screw is loosened or removed.

Whenever a 10-35936-7 screw is loosened or removed for any reason, carefully inspect lockwasher for breakage or cracking (as evidenced by loss of normal offset).

If the lockwasher is missing, broken or cracked, replace the screw with a new 10-35936-7 screw with captive lockwasher and tighten to 20-25 lb.-in. of torque.

**SCREW 10-35936-7
(Torque to 20-25 lb.-in.)**

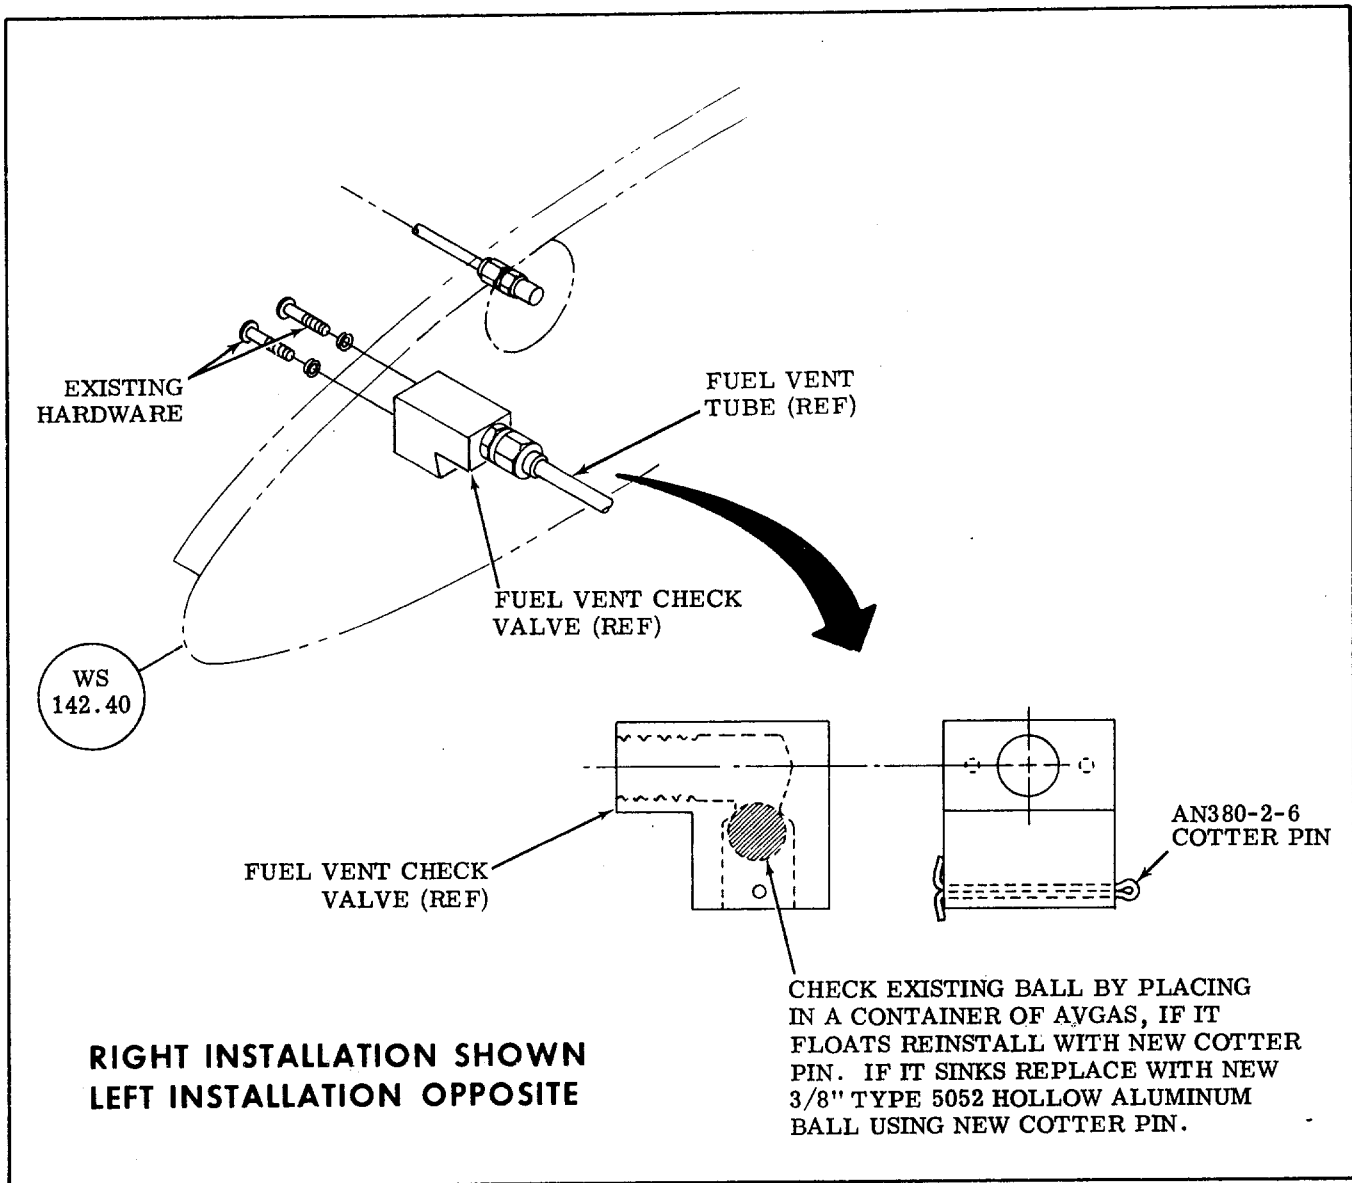
Figure 1.

Fuel leakage may be observed at lower fuselage fuel vent outlet particularly when the tanks are full.

11. If check valve balls do not float, discard existing balls and install new 3/8-inch balls using new AN380-2-6 cotter pins (see Figure 1.).
12. Reinstall existing fuel vent check valves in airplane using existing hardware.
13. Reconnect left and right fuel vent tube assemblies to fuel vent check valves.
14. Thoroughly clean all surfaces, to which sealing compound is to be applied, around fuel vent check valve and valve attaching screws with Methyl Ethyl Ketone (MEK) using clean paper towels or small paint brush and wipe clean.

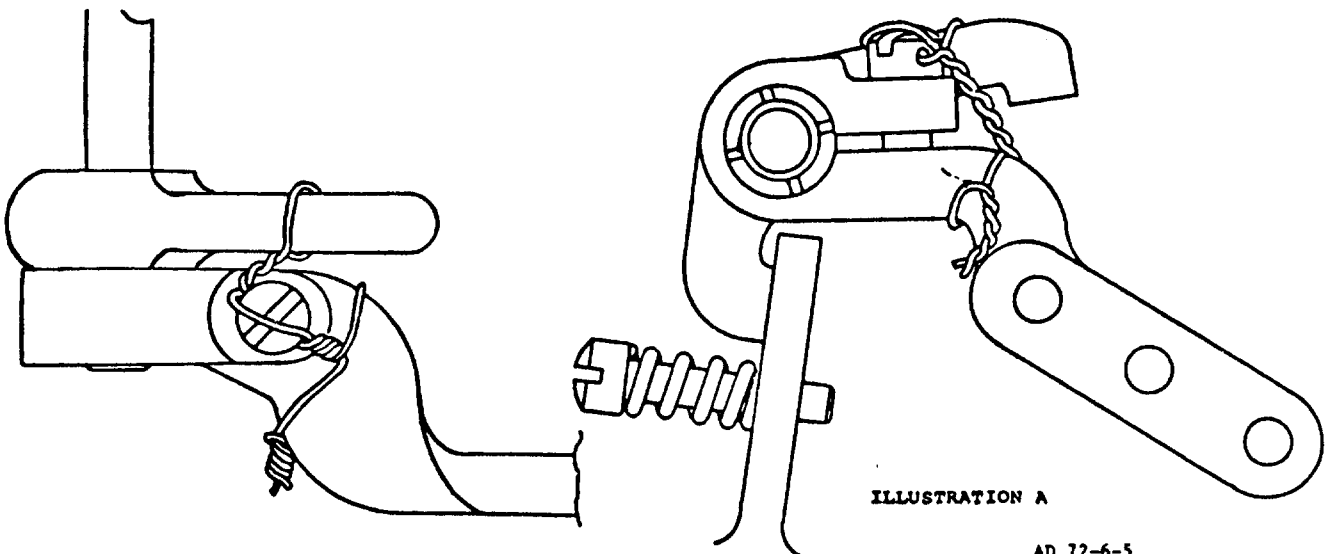
(2) Inspect the throttle arm on Marvel Schebler MA-3, MA-3A, MA-3PA, MA3-SPA, and MA-4SPA carburetors to determine whether it has a spotfaced or milled flat for the head of the clamping screw. Replace any arm having a milled flat with one having a spotfaced flat. If not already installed, install a Marvel Schebler P/N A15-493 clamping screw (No. 10-24 x 5/8 slotted drilled fillister head) in the throttle arm. Torque the clamping screw to 20-28 in.-lb. and inspect the slot in the end of the arm for clearance. If the slot has closed so that no clearance remains, replace the arm and retorque to the above specifications. After the specified torque is established safety wire the throttle arm and clamping screw to the throttle stop as shown in Illustration A.

(1) Inspect the throttle arm to verify that it is bottomed against the shoulder on the throttle stop and positioned so that full throttle travel is obtained, and if not, loosen clamping screw and reposition arm and/or re-rig control system in accordance with airplane manufacturers' maintenance instructions to obtain these conditions.

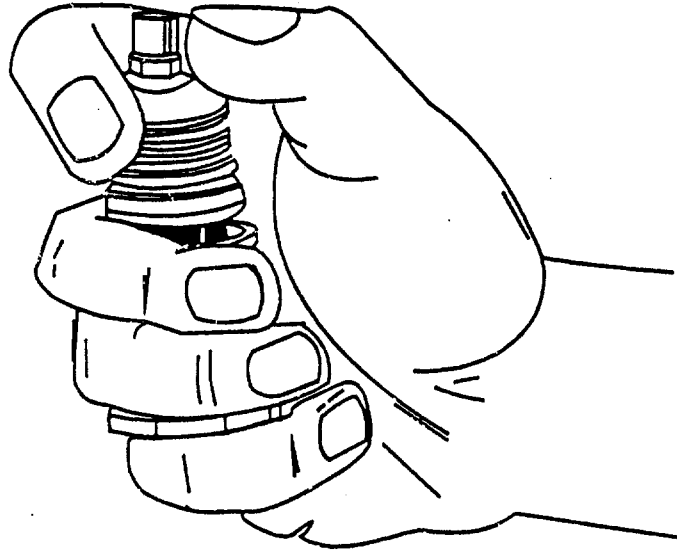
Figure 1.

A physical inspection of the crimp nut is required to ensure it is seated and solid on the shaft. Separate the seat and retaining nut by holding the valve assembly in one hand and compressing the valve spring with the forefinger and thumb. (See Figure 1.) With the seat and nut separated, grasp the crimp nut with the other hand and attempt to move it. The crimp nut must not move. If the thermostatic bypass valve assembly does not meet this inspection, it must be replaced immediately.
