SERVICE LETTER NO. SL-1

EFFECTIVITY: Rockwell Commander 112 S/N 3 through 79

SUBJECT: Rudder Assembly

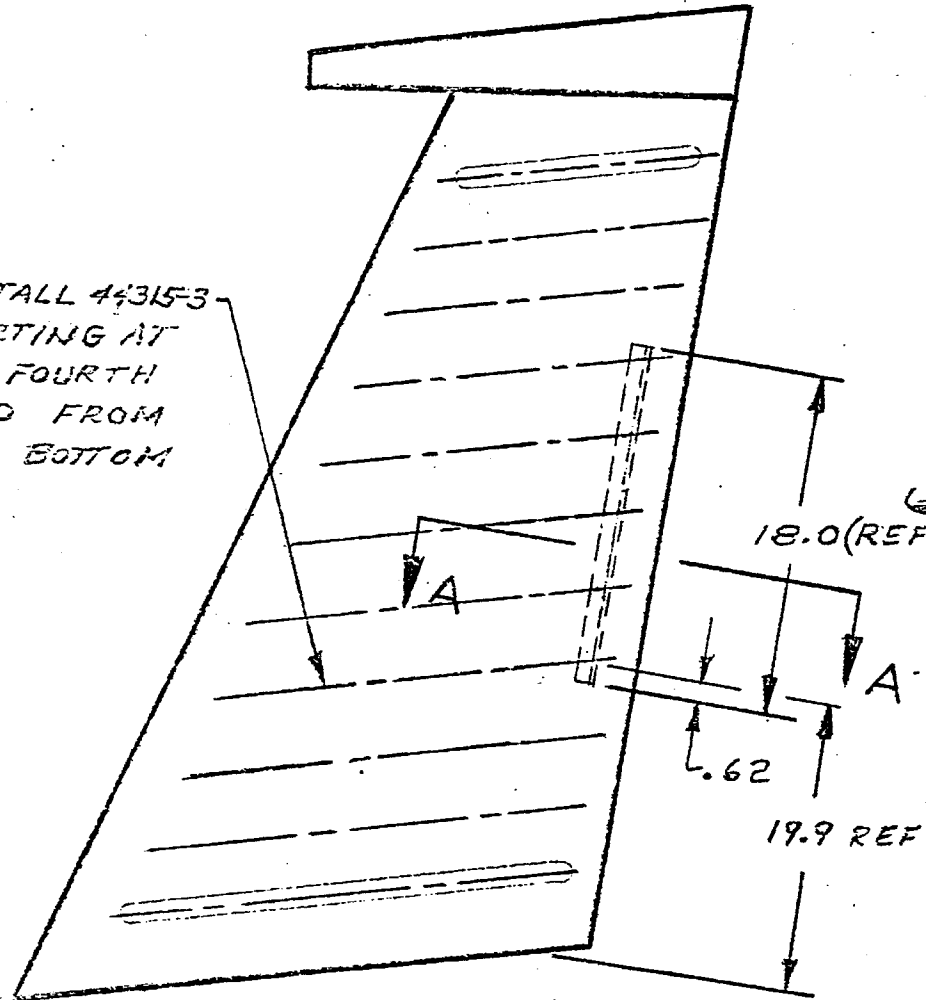
PURPOSE: Service investigation has revealed that the skin on the aft portion of the rudder assembly may need to be stiffened in order to prevent cracks from forming on the skin.

INSTALL 44315-3
STARTING AT
THE FOURTH
BEAD FROM
THE BOTTOM

1. Inspect exterior of rudder. If cracks are found, replace the rudder assembly with a new rudder assembly (P/N 44006-1).

2. Remove rudder.
3. Drill top and bottom rivet holes on both sides of rudder.
4. Mark rivet center line on channel then mark locating line for one of the rivets.
5. Insert channel through lightening hole on the leading edge of rudder and position channel so that center line for one end rivet is visible through rivet hole. Drill and cleco.

6. Position channel so that rivet line is centered in the remaining hole. Drill and cleco.
7. Drill remaining holes through rudder skin and channel, then rivet.
8. Paint rivet heads with minimum amount of touch up paint.
9. Check balance of rudder and rebalance if necessary.
10. Replace rudder adding AN960-416L washer under head of lower hinge bolt.
11. Make the following entry in the Airframe Logbook:

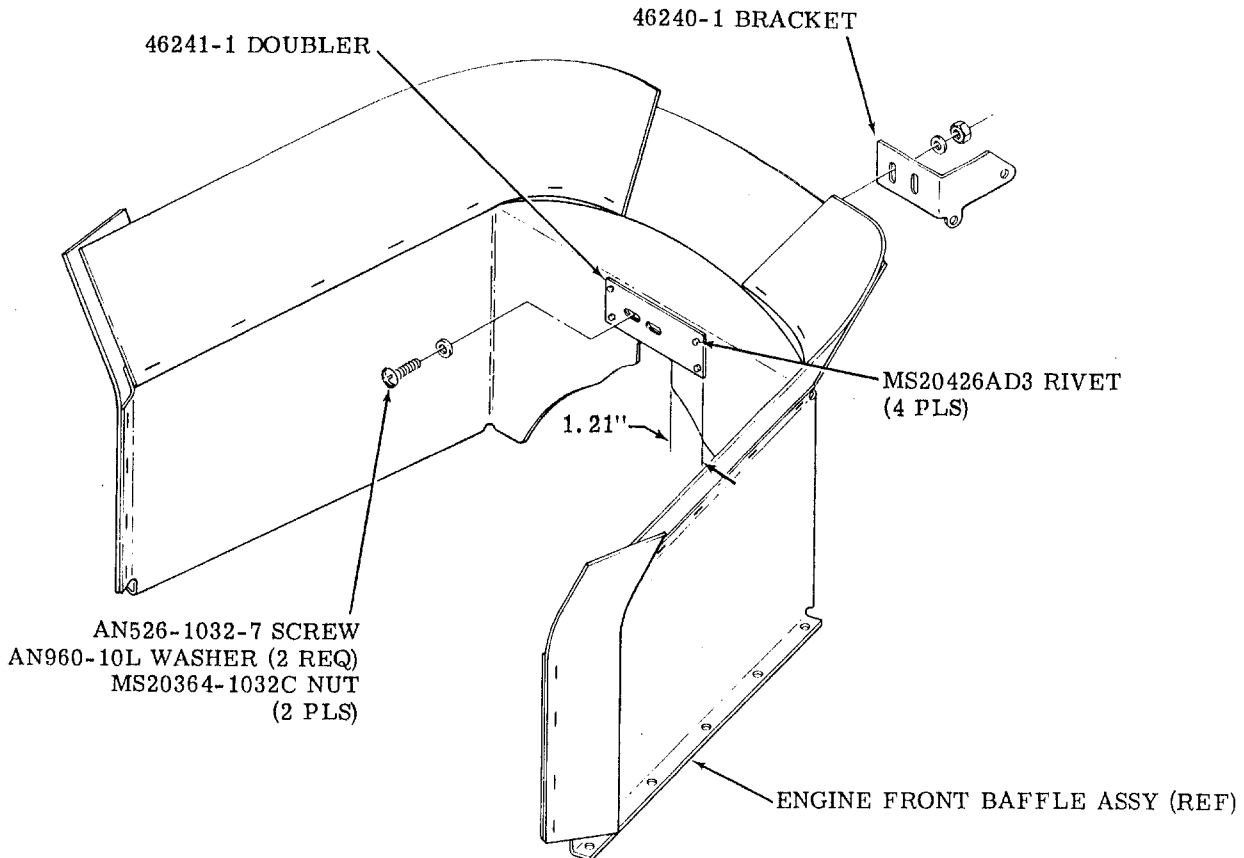
Figure 1.

PURPOSE: To prevent engine front baffle assembly from cracking.

- a. Remove top engine cowling assembly.
- b. Remove and discard existing bracket from center of engine front baffle assembly (see Figure 1.).
- c. Stop drill any cracks in engine front baffle assembly using a No. 40 drill.
- d. Locate, drill and install 46241-1 doubler on engine front baffle assembly (see Figure 1.).
- e. Cut slots in engine front baffle assembly to match slots in 46241-1 doubler (see Figure 1.).
- f. Install 46240-1 bracket on engine case using existing hardware (see Figure 1.).
- g. Attach reworked engine front baffle assembly to 46240-1 bracket (see Figure 1.).
- h. Reinstall top engine cowling assembly.
- i. Proceed to AIRCRAFT RECORDS.

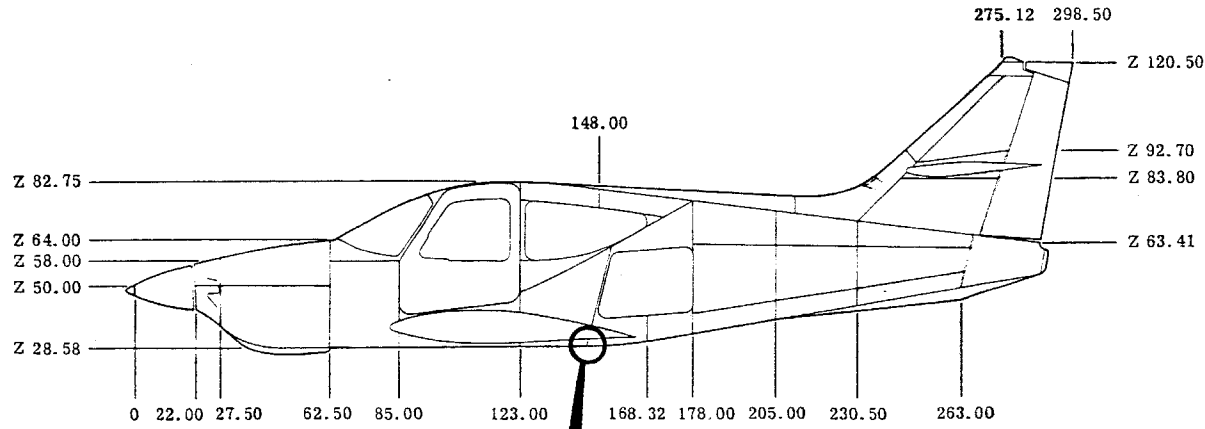
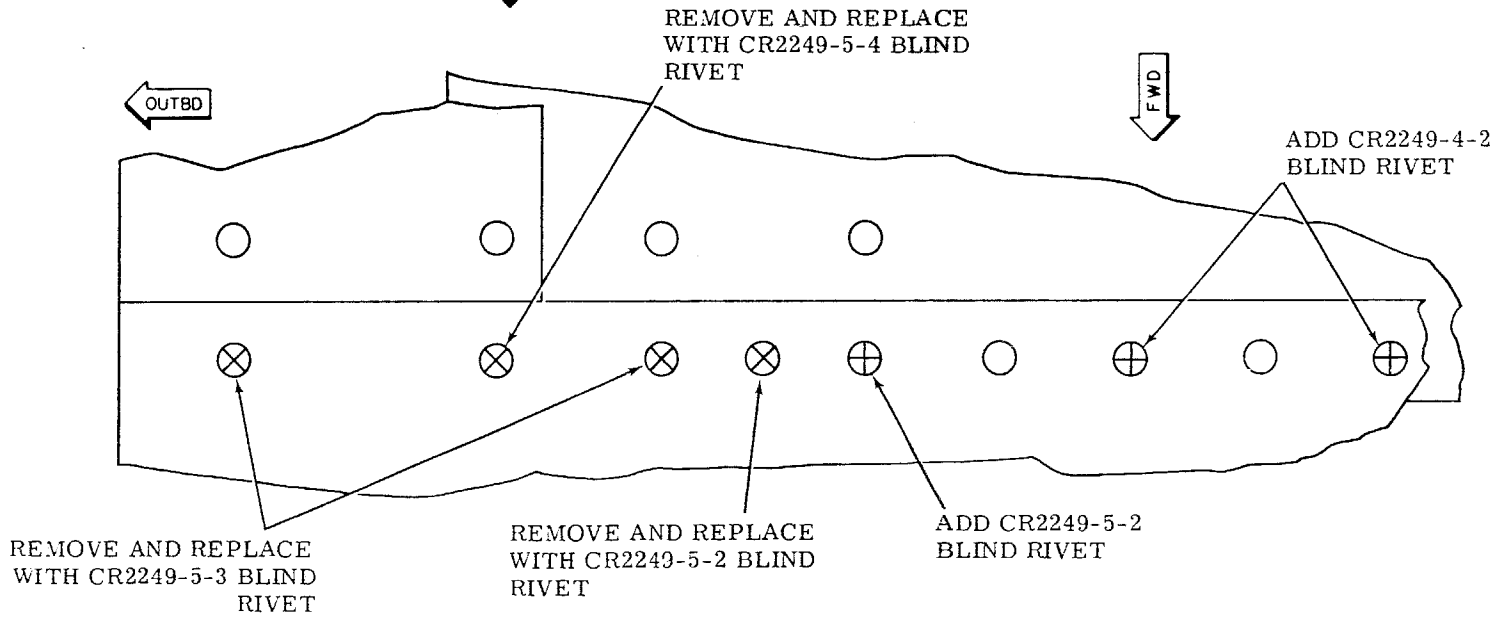
Figure 1.

PURPOSE: To prevent fuselage skins from cracking.

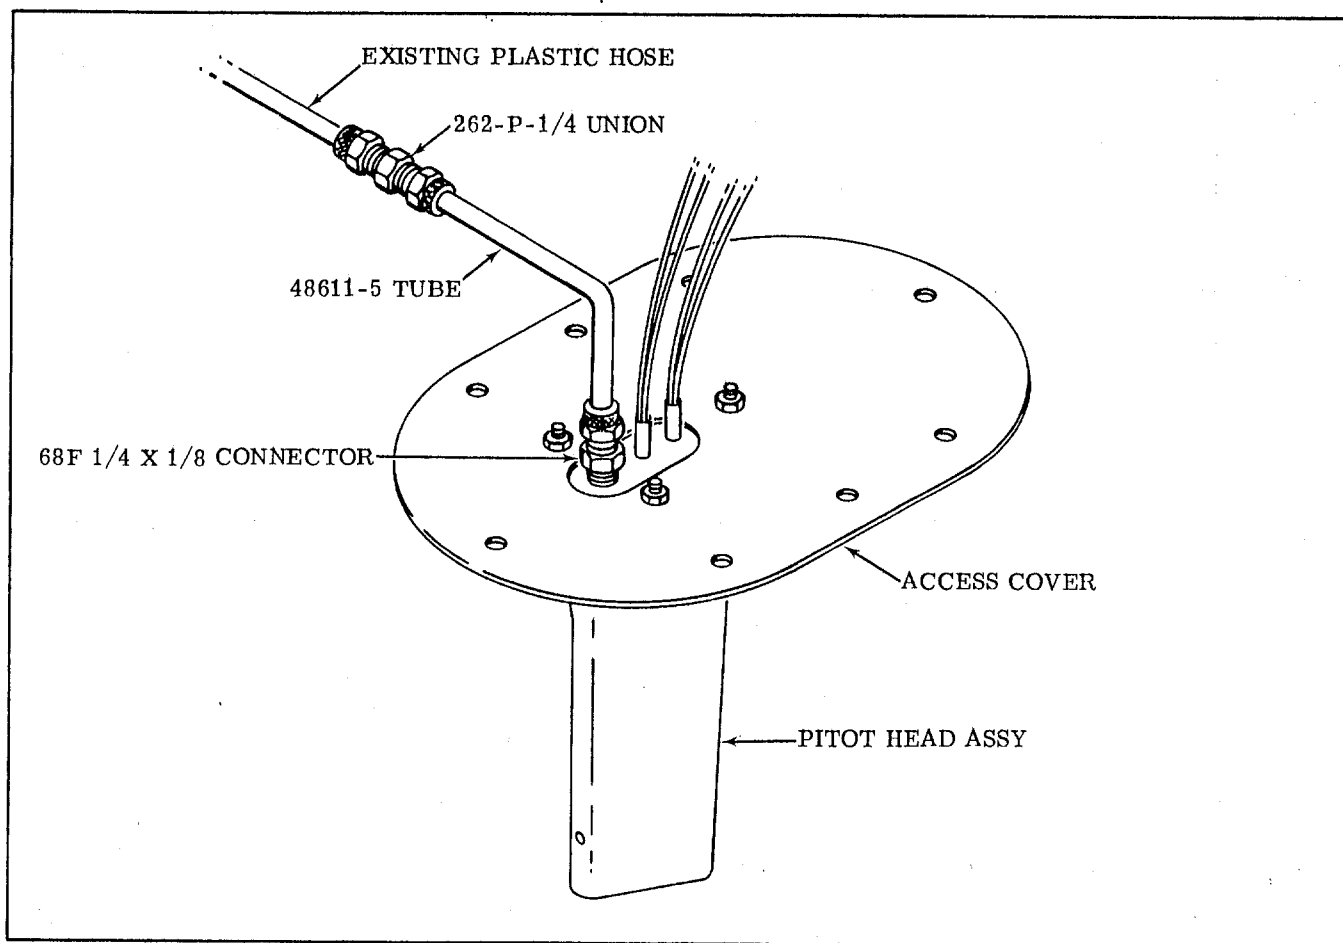
Figure 1.

REASON FOR PUBLICATION: TO REPLACE AIRSPEED PLASTIC HOSE WITH ALUMINUM TUBING ON PITOT HEAD ASSEMBLY TO PREVENT OVERHEATING.

1. Remove screws attaching pitot head assembly access cover to wing and pull down on pitot head assembly.
2. Disconnect plastic hose from pitot head assembly.
3. Remove and discard existing connector from pitot head assembly.
4. Cut off seven (7) inches from end of existing plastic hose.
5. Install 48611-5 tube on pitot head assembly using 68F 1/4 X 1/8 connector (see Figure 1.).
6. Connect 48611-5 tube to existing plastic hose using 262-P-1/4 union (see Figure 1.).
7. Reinstall pitot head assembly and access cover on wing.
8. Perform leakage test as outlined in the Model 112 Airplane Maintenance Manual, Section VIII.

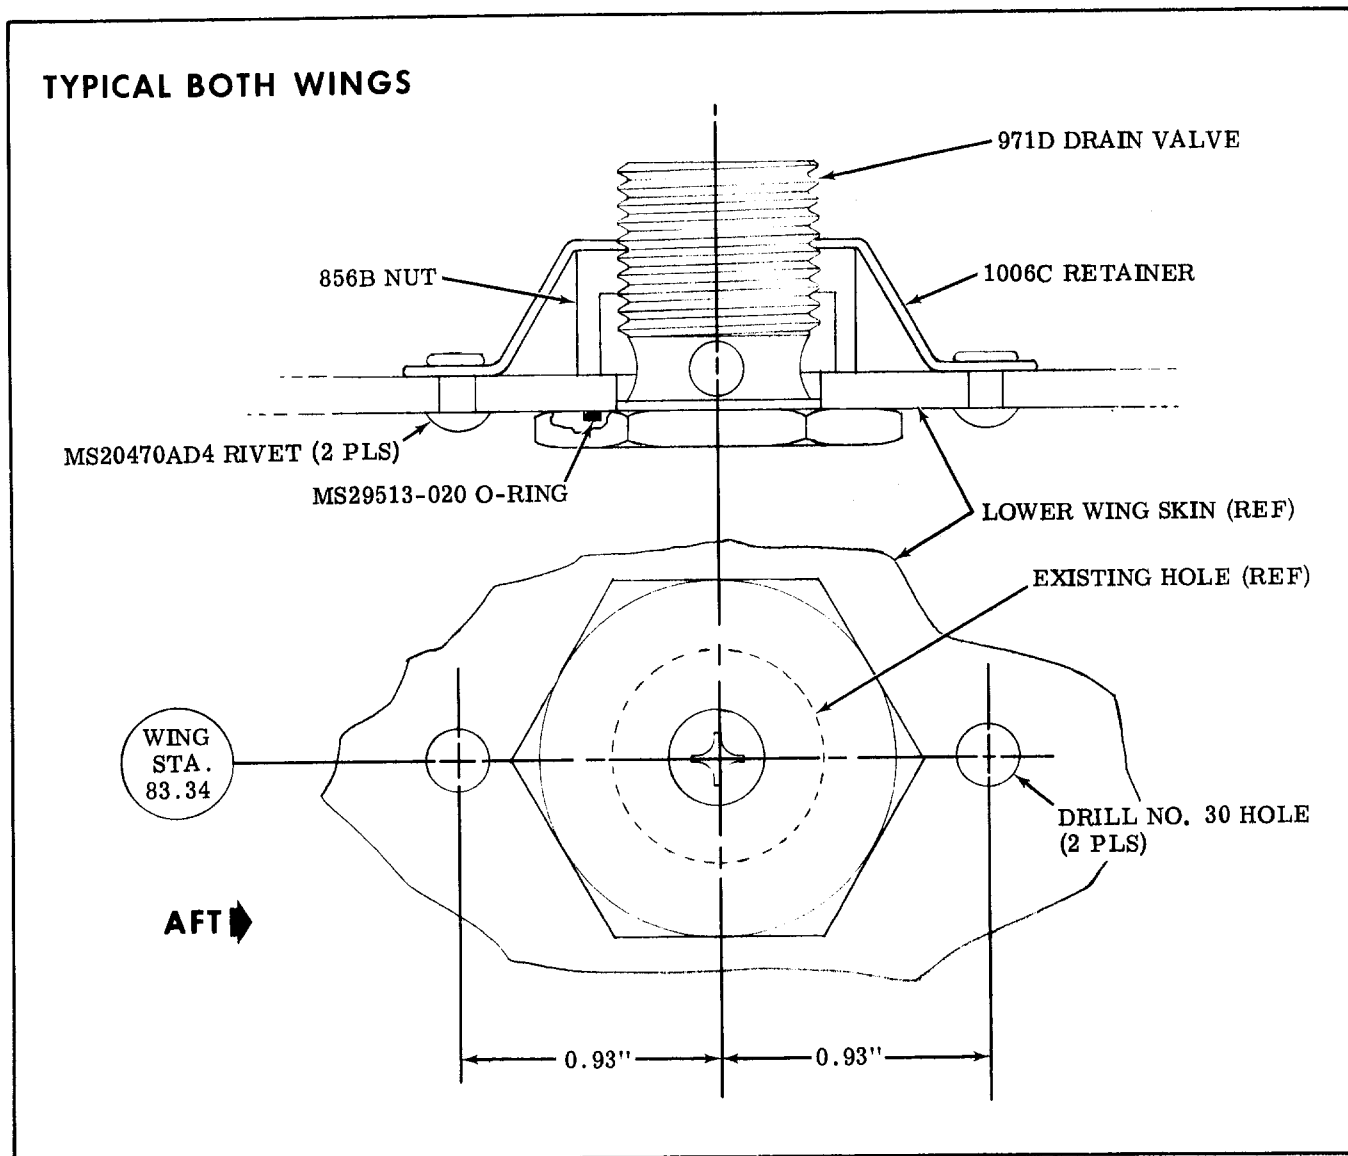
Figure 1.

REASON FOR PUBLICATION: PROVIDE A FULLY SEALED DRAIN VALVE TO LESSEN THE POSSIBILITY OF FUEL LEAKAGE.

7. Brush rivets with 1422, Class A sealant to form a fillet after installation.
8. Install 971D drain valve, MS29513-020 O-ring and 856B nut. Torque nut 480 to 690 inch-pounds (see Figure 1.).
9. Reinstall and reseal lower wing access cover(s) using PRC-1321 Class B sealant, as outlined in the Model 112 Airplane Maintenance Manual, Section V.
10. Inspect and pressure check the tanks after sealing compound has cured (approximately 8 to 10 hours) and check for possible leaks.

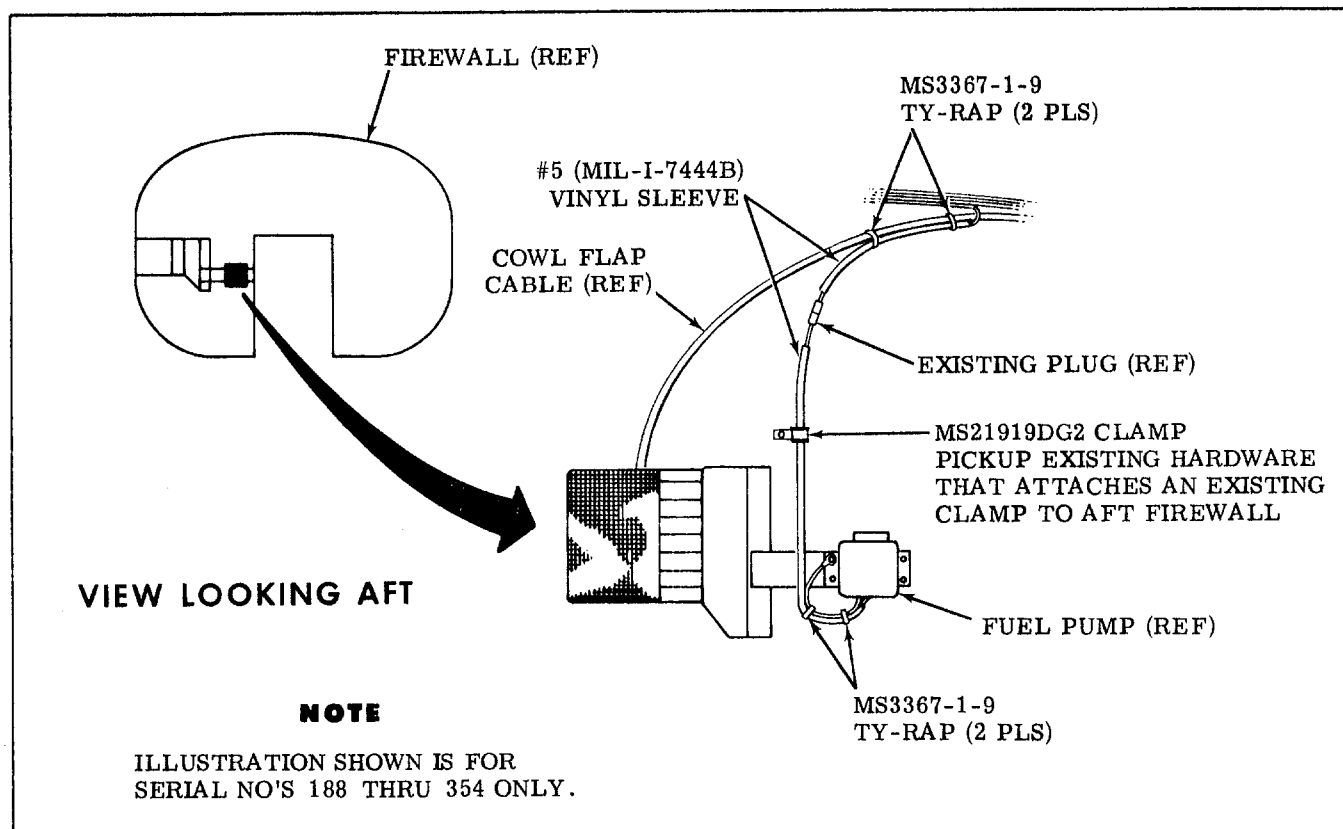
Figure 1.

REASON FOR PUBLICATION: SECURE FUEL PUMP ELECTRICAL LEAD TO PRECLUDE DAMAGE TO LEAD DUE TO EXCESSIVE MOVEMENT.

5. On airplane serial numbers 188 thru 354, clamp fuel pump wire to firewall with MS21919DG2 clamp using existing hardware and secure wiring using MS3367-1-9 ty-raps as required (see Figure 1.).
6. Reinstall upper engine cowl.

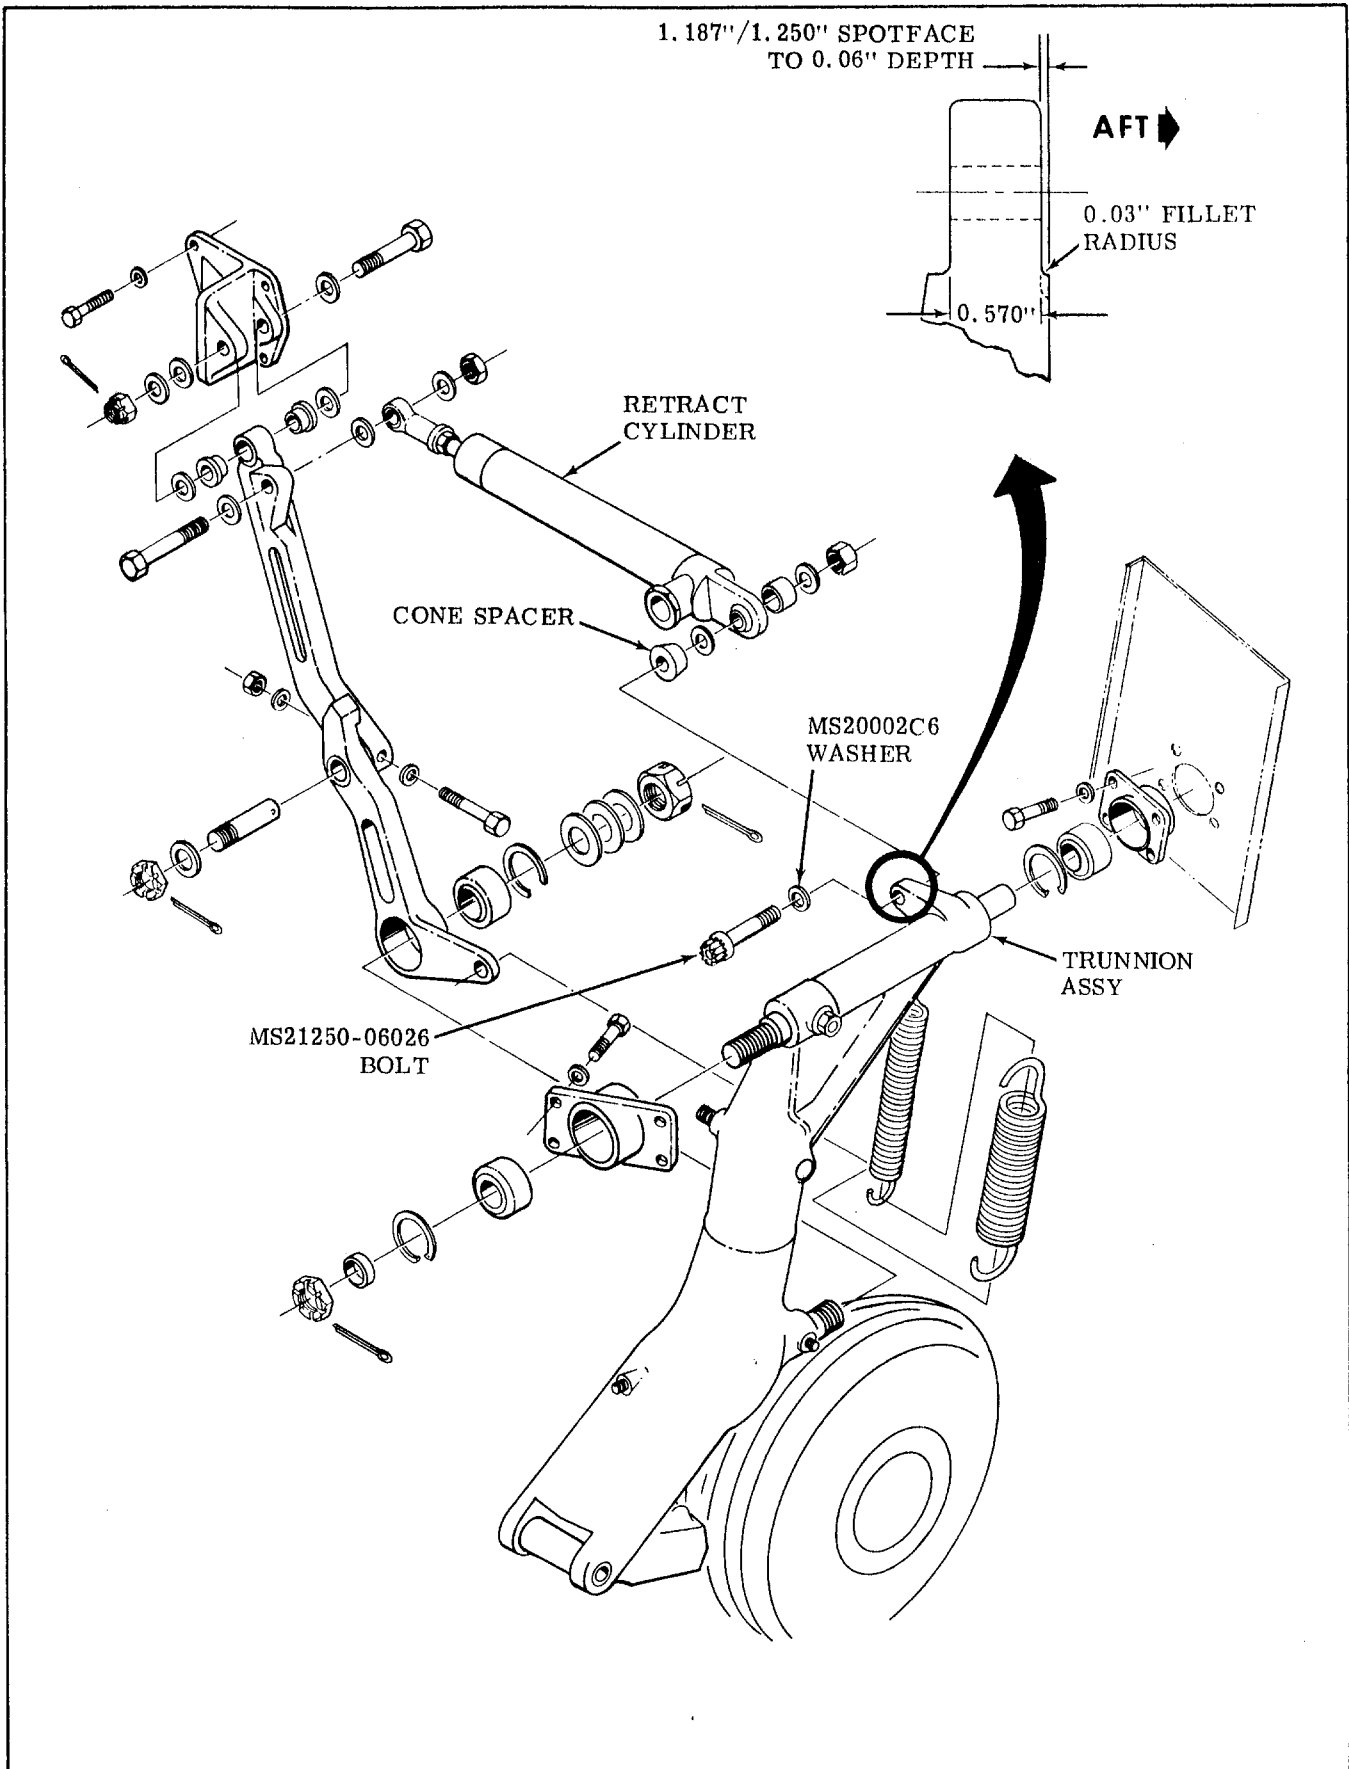
Figure 1.

REASON FOR PUBLICATION: PROVIDE FLAT SURFACE TO ALLOW CONE SPACER TO SEAT PROPERLY ON TRUNNION LUG AND/OR REPLACE RETRACT CYLINDER ATTACH BOLT.

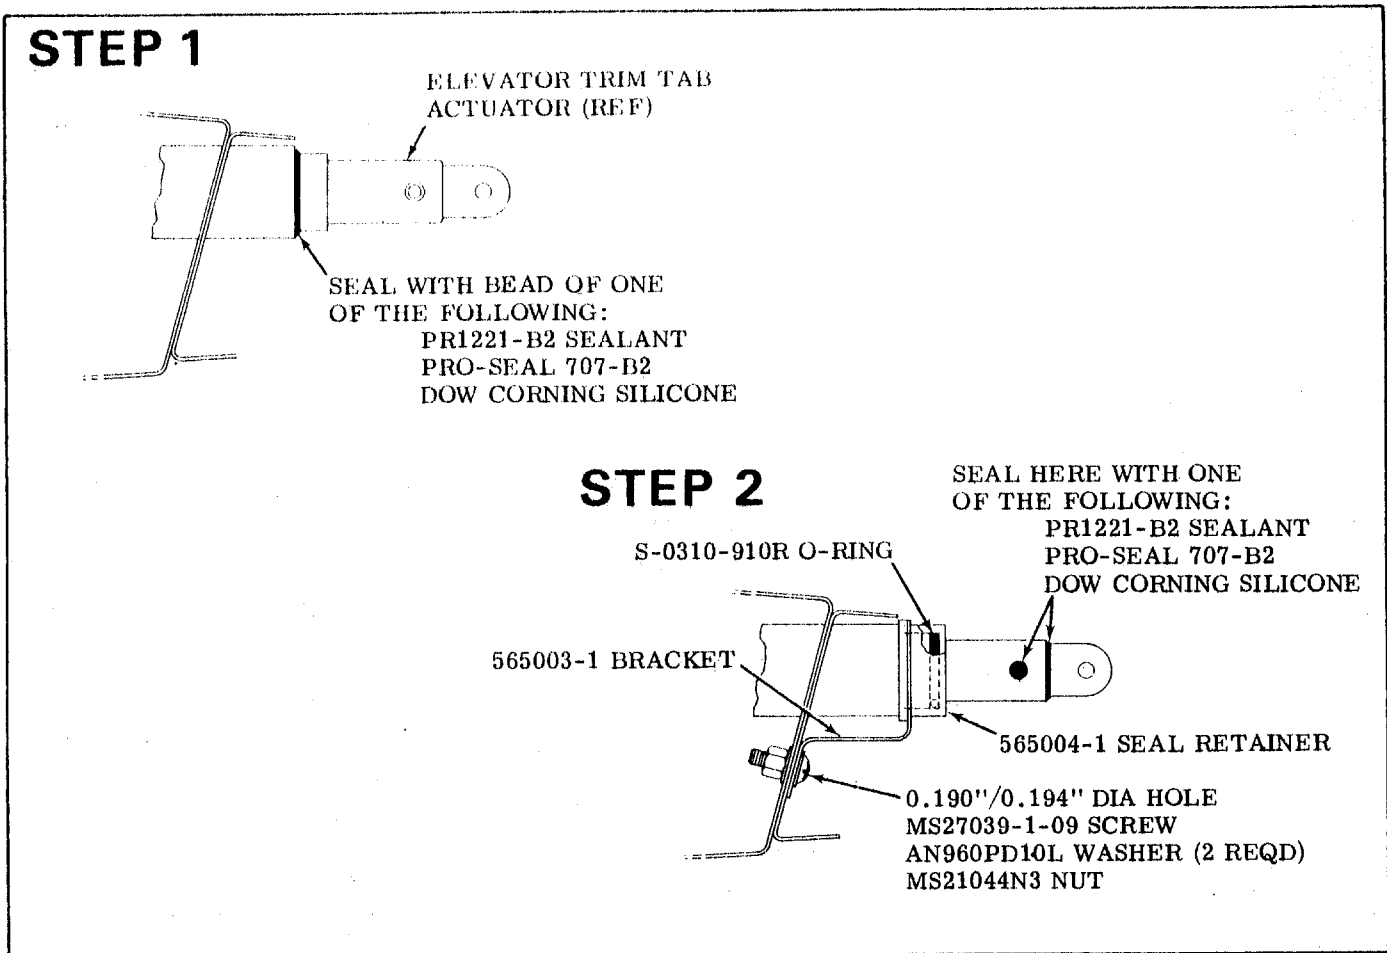
Figure 1.

REASON FOR PUBLICATION: PREVENT MOISTURE FROM ENTERING ELEVATOR TRIM TAB ACTUATOR.

3. To assure that all moisture is removed from elevator trim tab actuator, apply heat to actuator with a heat gun.

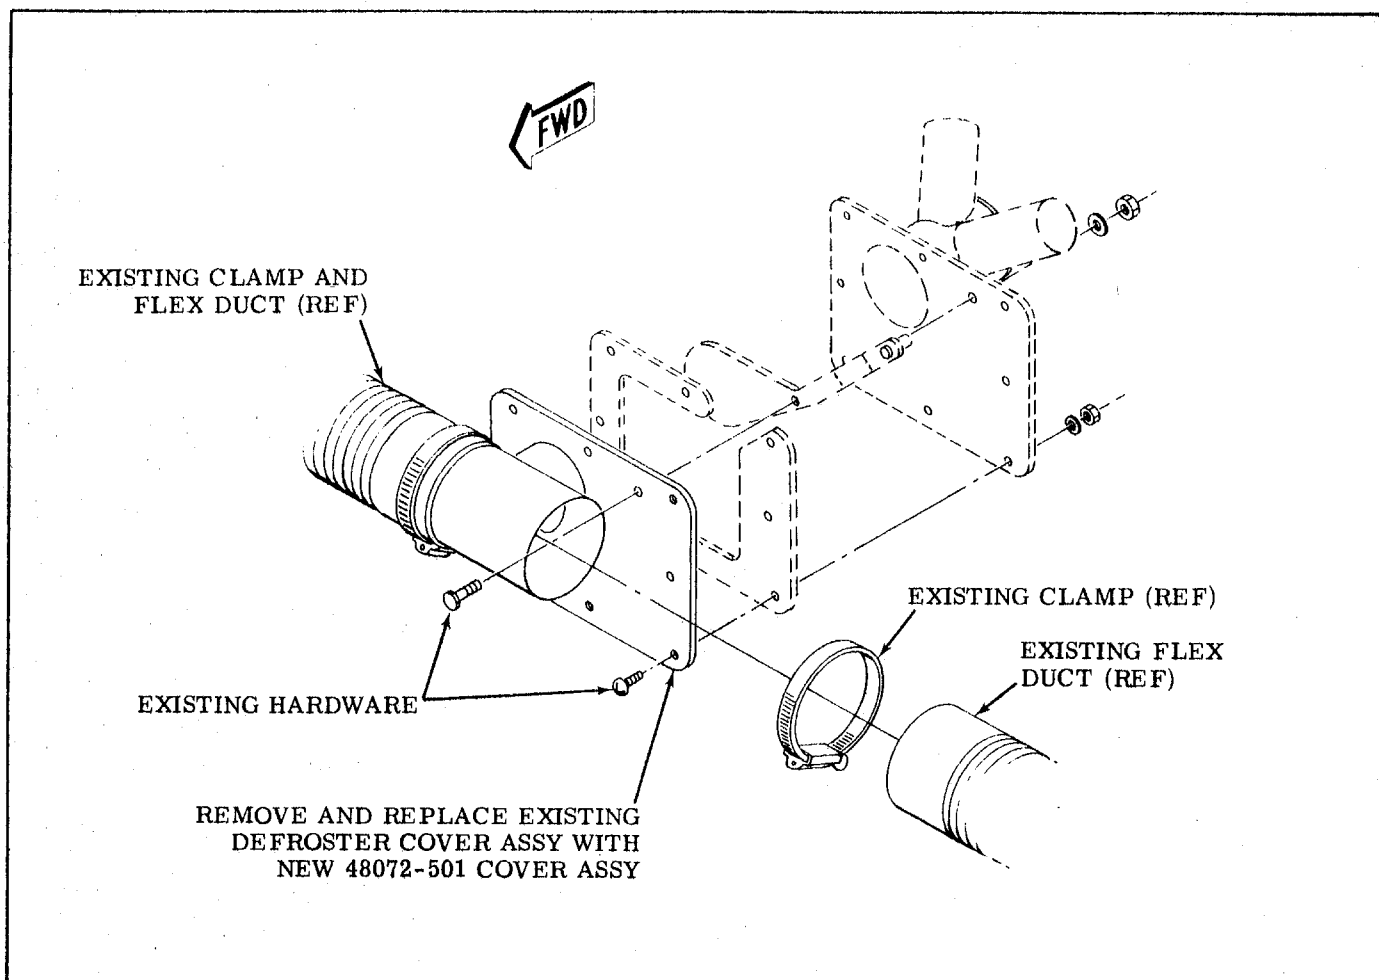
Figure 1.

REASON FOR PUBLICATION: DEFROSTER VALVE COVER ASSEMBLY MAY HAVE A DEFECTIVE WELD. THIS SERVICE LETTER IS BEING ISSUED TO CORRECT THIS SITUATION.

1. Remove upper engine cowling.
2. Disconnect flex ducts from defroster valve cover.
3. Remove and discard existing defroster valve cover assembly (see Figure 1.).
4. Install 48072-501 defroster valve cover assembly using existing hardware and seal around outer perimeter of cover assembly with Coast Pro-Seal 700, MIL-S-38249, Type I (see Figure 1.).
5. Reconnect existing flex ducts to new defroster valve cover assembly using existing clamps.
6. Reinstall upper engine cowling.

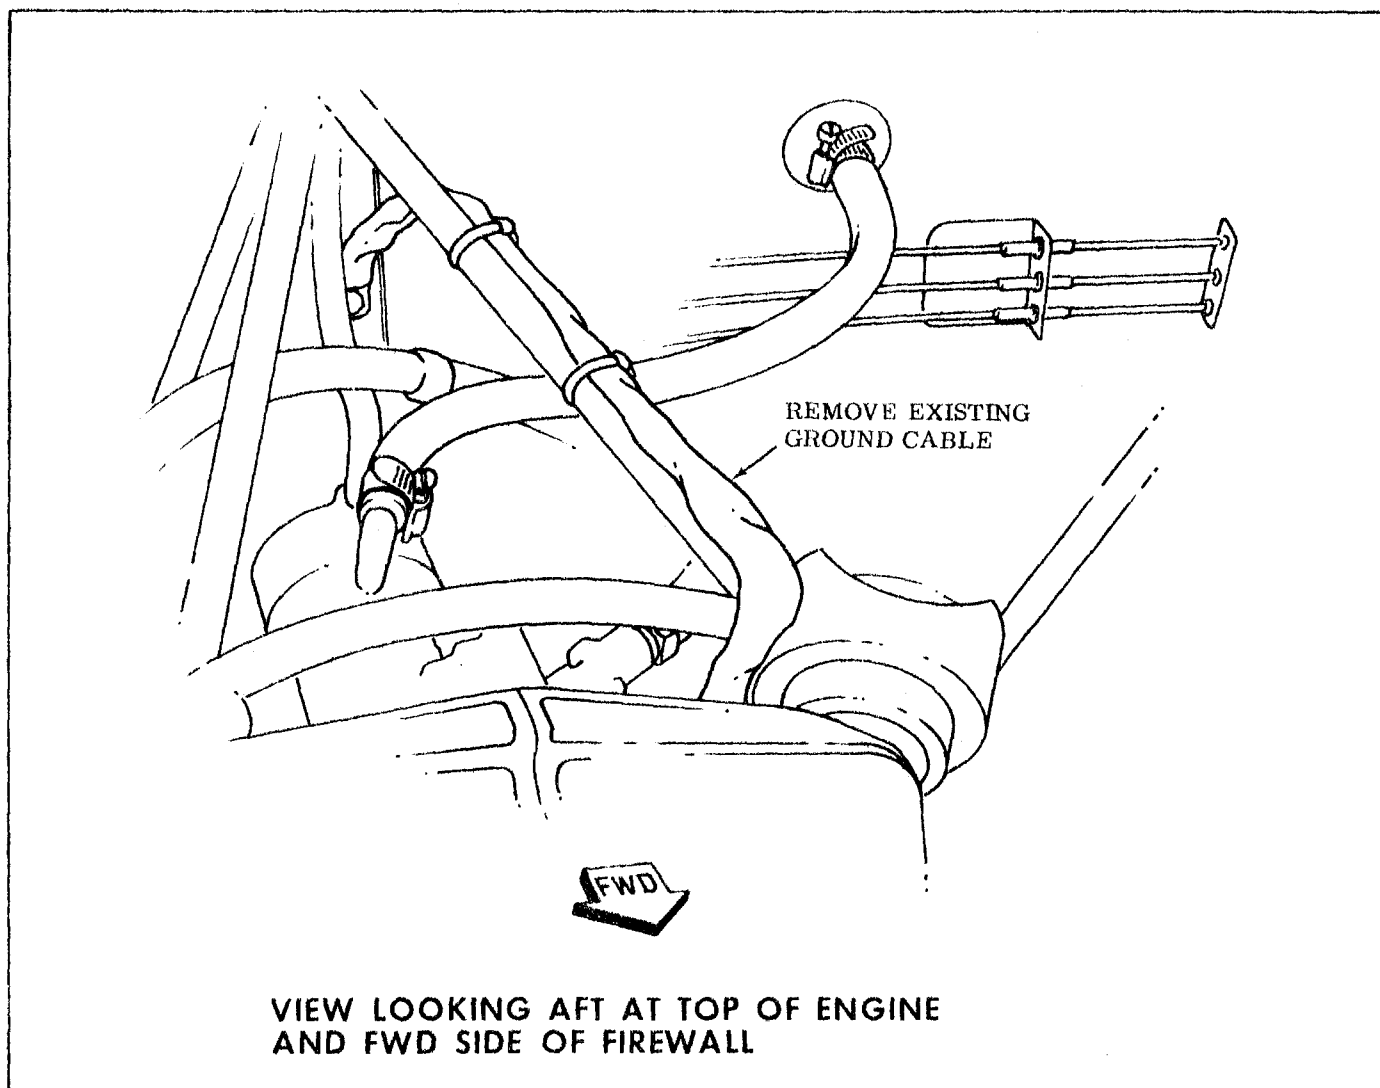
Figure 1.

REASON FOR PUBLICATION: TO PREVENT MAGNETIC COMPASS INTERFERENCE DUE TO IMPROPER/INSUFFICIENT BONDING OF ENGINE TO AIRFRAME GROUND. THIS HAS BEEN NOTED ON CERTAIN AIRCRAFT BY BEING UNABLE TO ACHIEVE PROPER COMPASS HEADINGS.

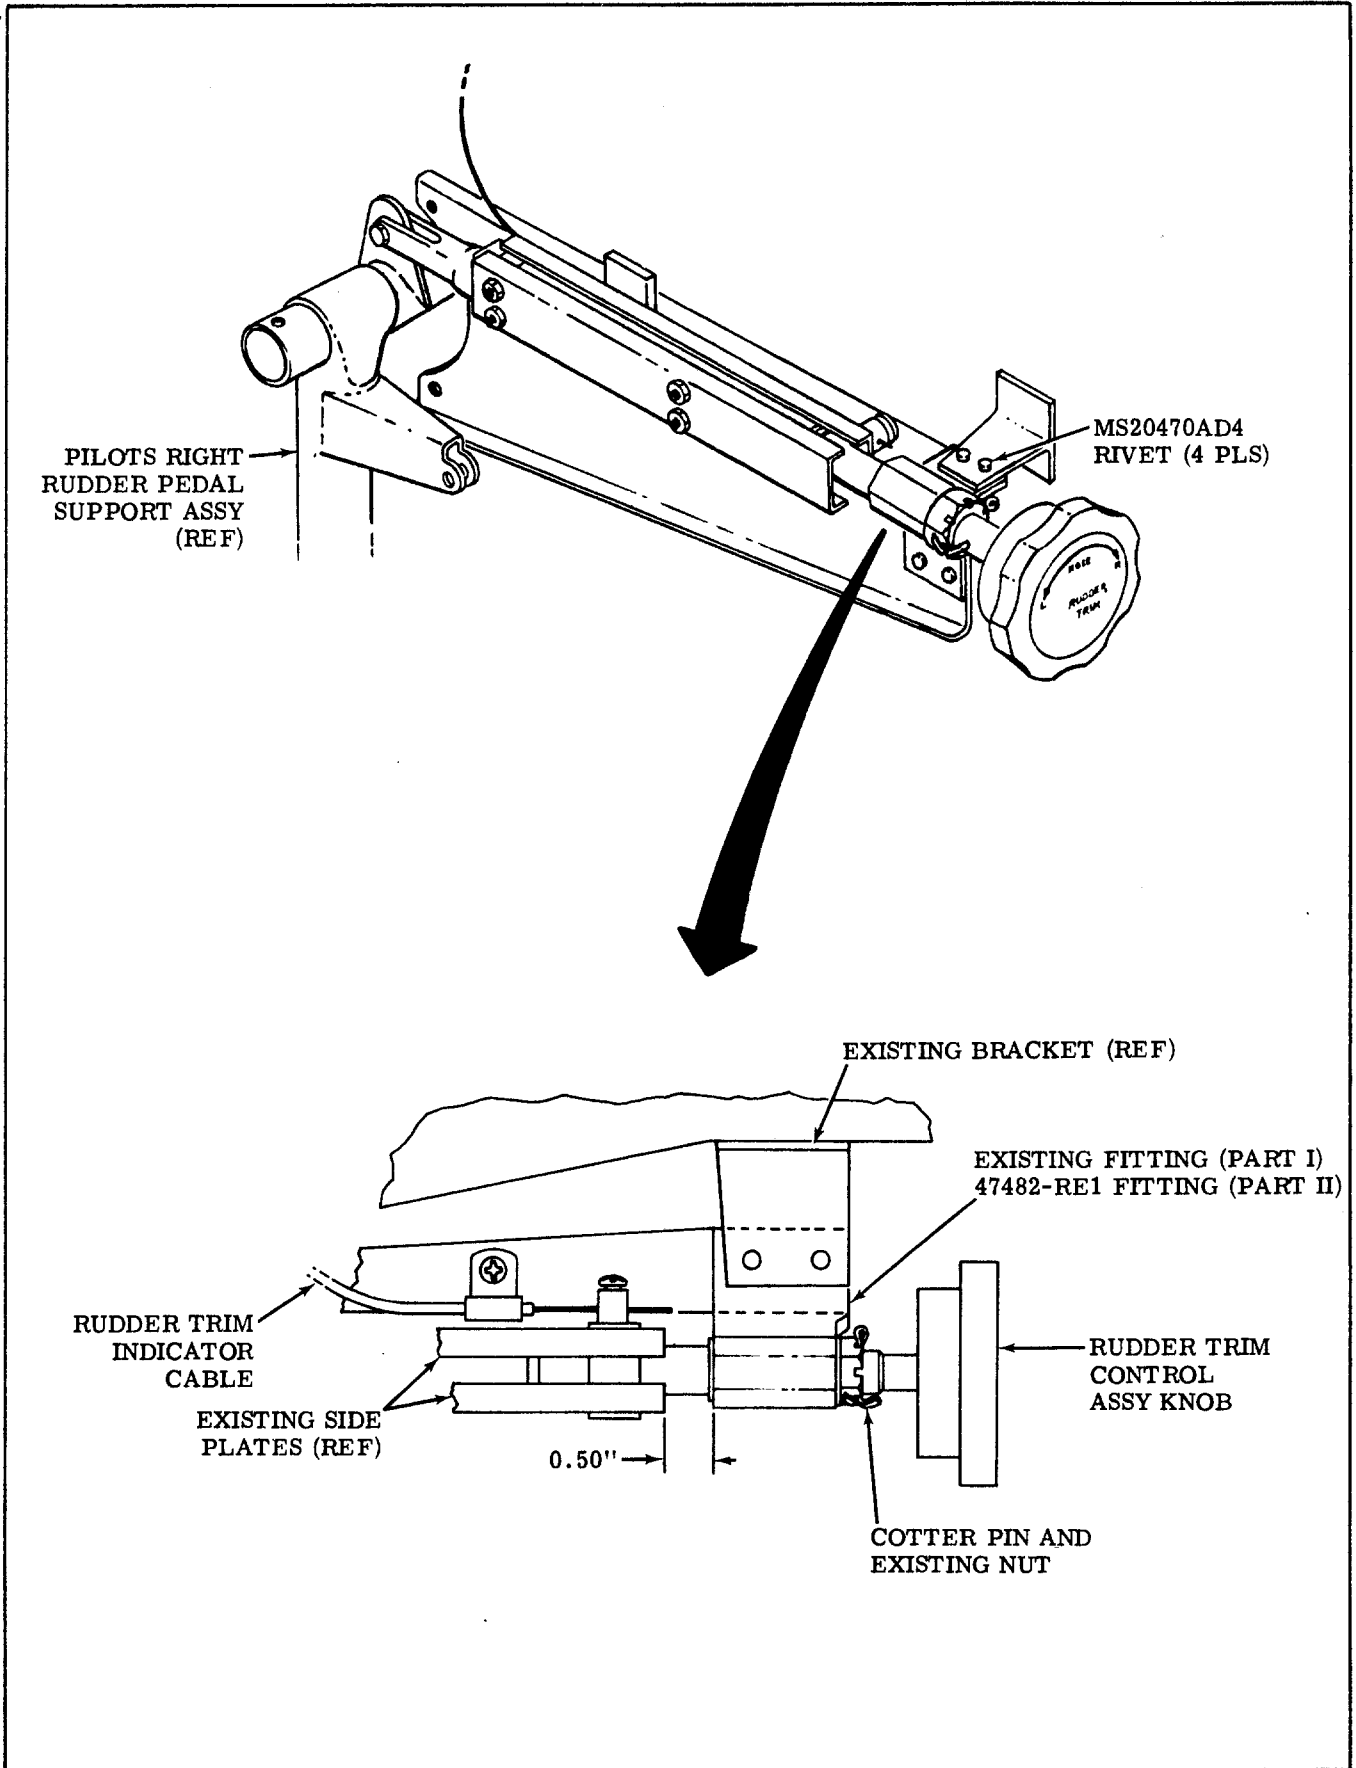
Figure 1.

REASON FOR PUBLICATION: TO IMPROVE RUDDER TRIM AND PREVENT THE POSSIBLE BOTTOMING OF RUDDER TRIM SPRING AT EXTREME TRIM CONDITION.

3. Check for 0.50 (\pm 0.03) inch dimension between rudder trim control assembly fitting and side plate (see Figure 1.).
4. If dimension between rudder trim control assembly fitting and side plate exceeds 0.53-inch, remove straight edge from pilot's rudder pedals and proceed to Part II.
5. If dimension between rudder trim control assembly fitting and side plate is 0.50 (\pm 0.03) inch, remove straight edge from pilot's rudder pedals.
6. Remove rudder trim control assembly knob and nut, loosened in step 1., from shaft.
7. Disconnect forward shaft of rudder trim control assembly from top of pilot's right rudder pedal support assembly.
8. Disconnect rudder trim indicator cable from rudder trim control assembly and remove rudder trim control assembly from airplane.
9. Disassemble rudder trim control assembly and discard existing springs.
