GULFSTREAM
COMMANDER
114/A

**Rockwell Commander
AC114-A
SN-14408
Owner: Ronald D. Bishop
Based: SNA**

SECTION II
EMPENNAGE

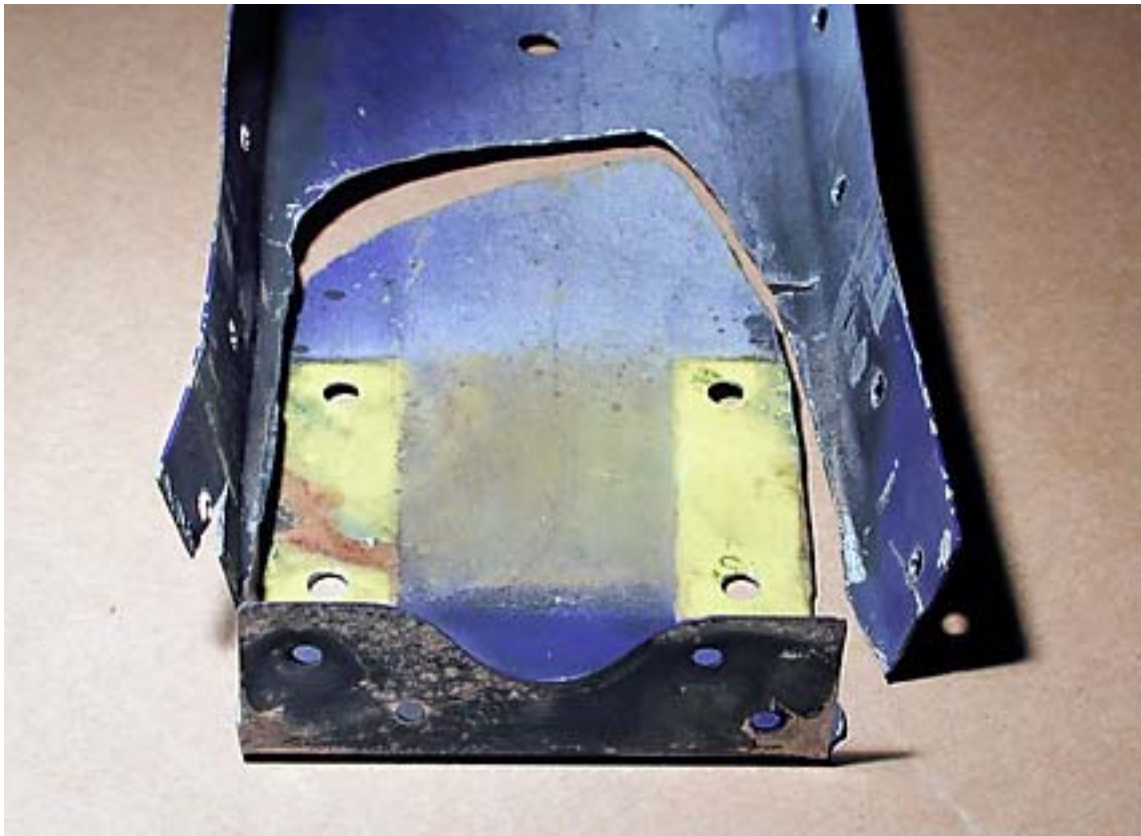
Once the rudder was removed it was very obvious that we had a major failure.

The upper rudder fitting broke completely away from the rudder spar. The fitting stayed connected to the vertical stabilizer and the rudder was leaning aft.

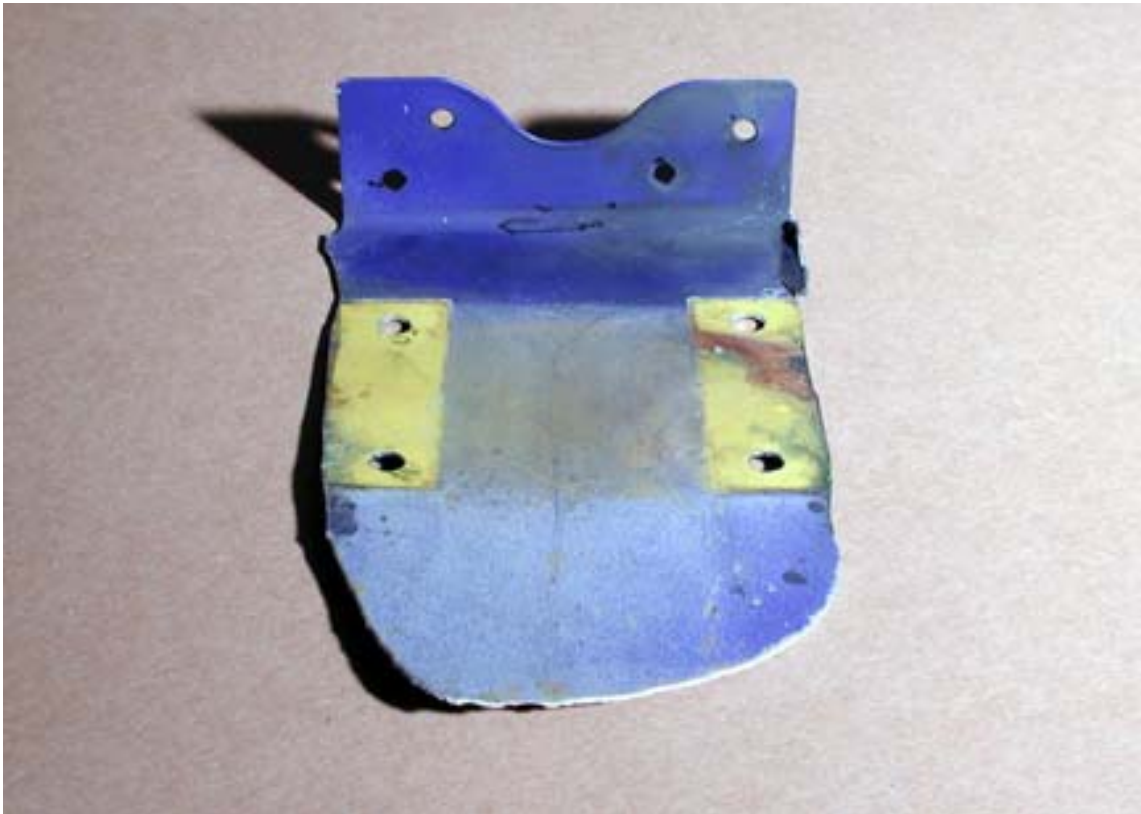
Here is the broken out piece of the rudder spar after we removed the connecting fitting assembly.

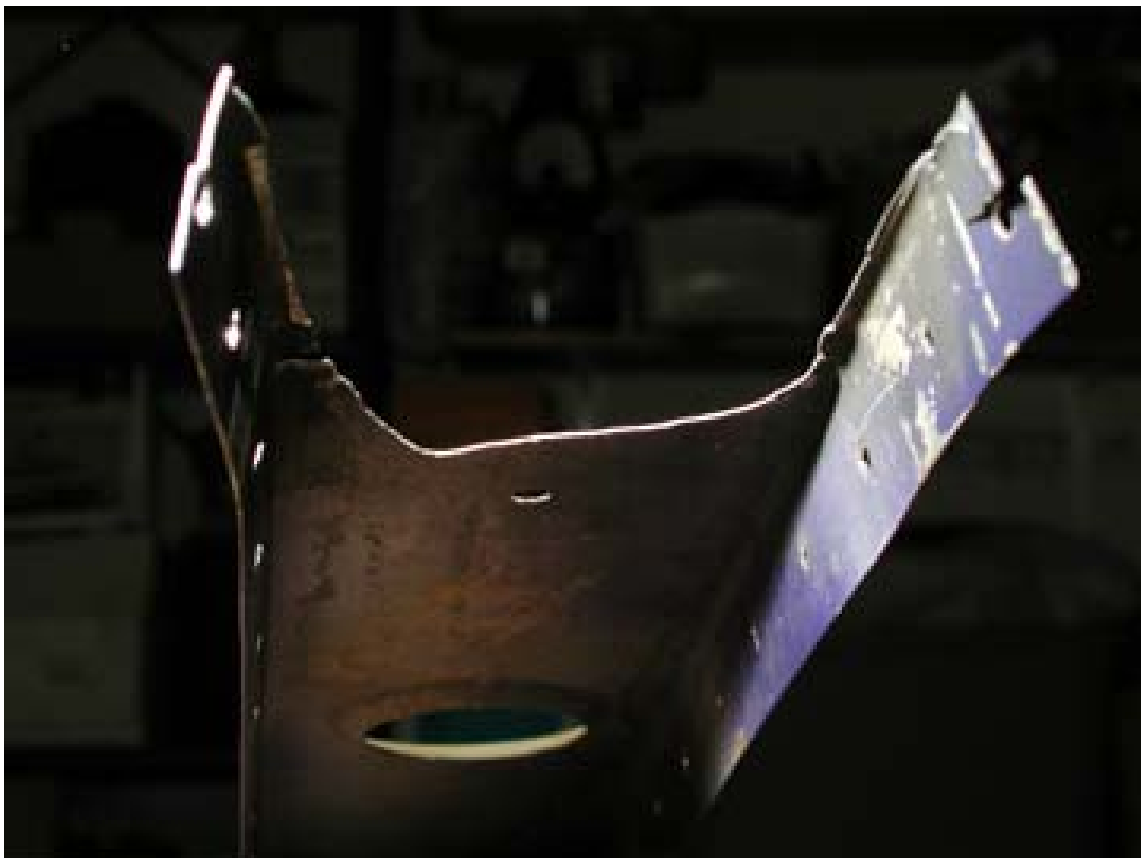
This is another view of where the broken out piece belongs on the spar.

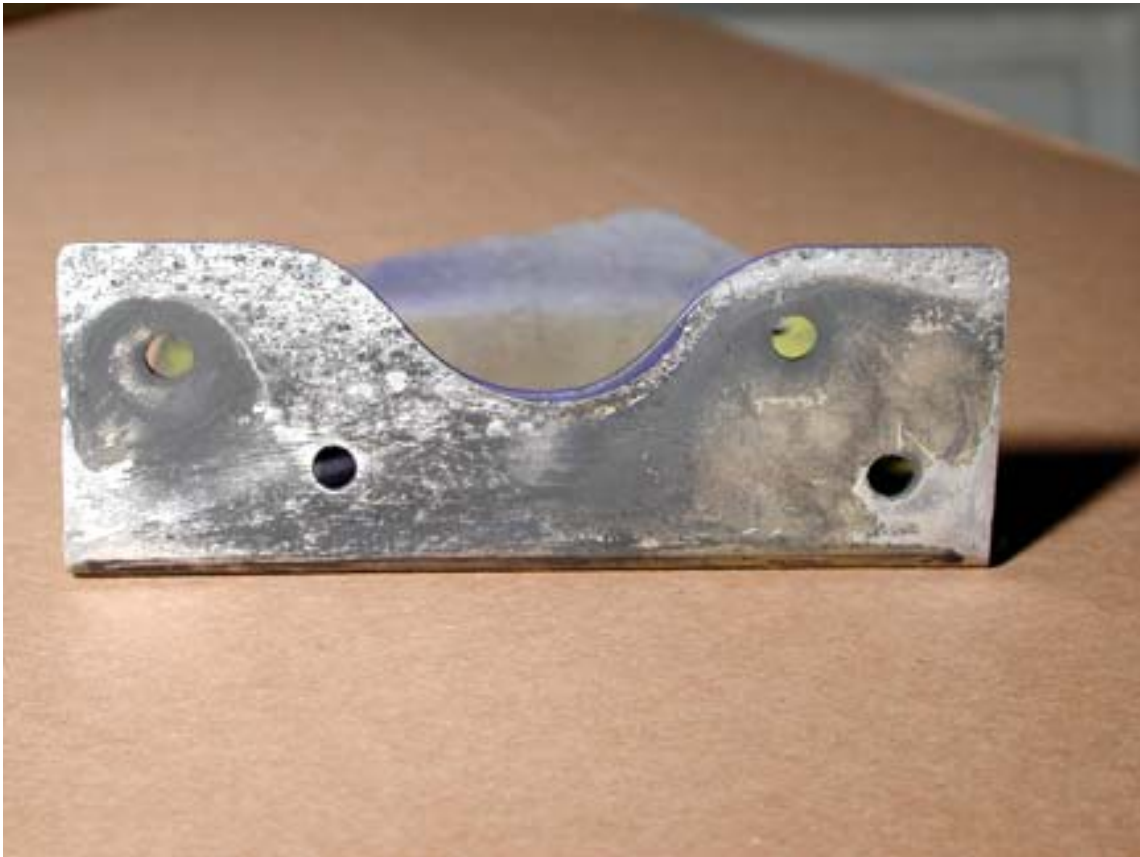
Here is the cause of the failure.

The rivets on the upper part horizontal plane of the rudder tip were never installed from the factory since new. For 24 years the rudder spar has been moving.

The inspectors and FAA approved repair facility pointed out the amount of black and shinny areas on the part clearly indicates the amount of movement that had been going on before the failure.

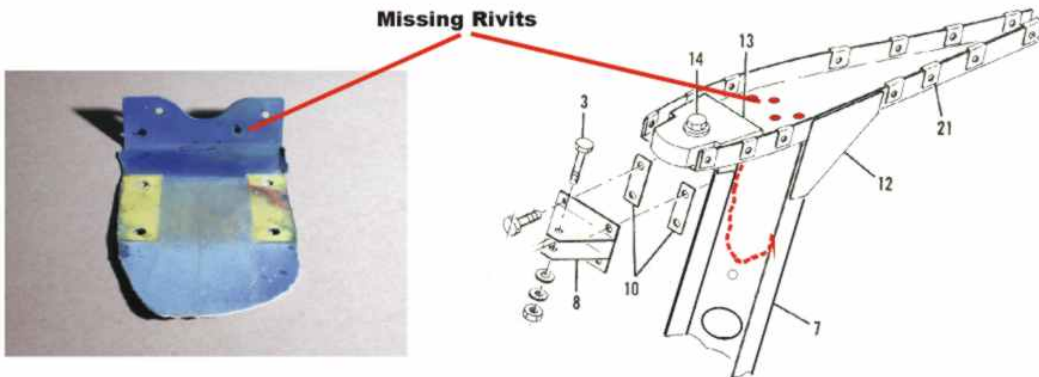
If you take a look at the broken out piece of the rudder spar you will note that there are four holes drilled for rivets on the horizontal plane of the spar.
