SERVICE LETTER NO. SL-112-46
Revision No. 1
27 October 1981

ELEVATOR AND RUDDER HINGE FITTING INSPECTION AND/OR REPLACEMENT

SERVICE LETTER NO. SL-112-46
14 November 1979

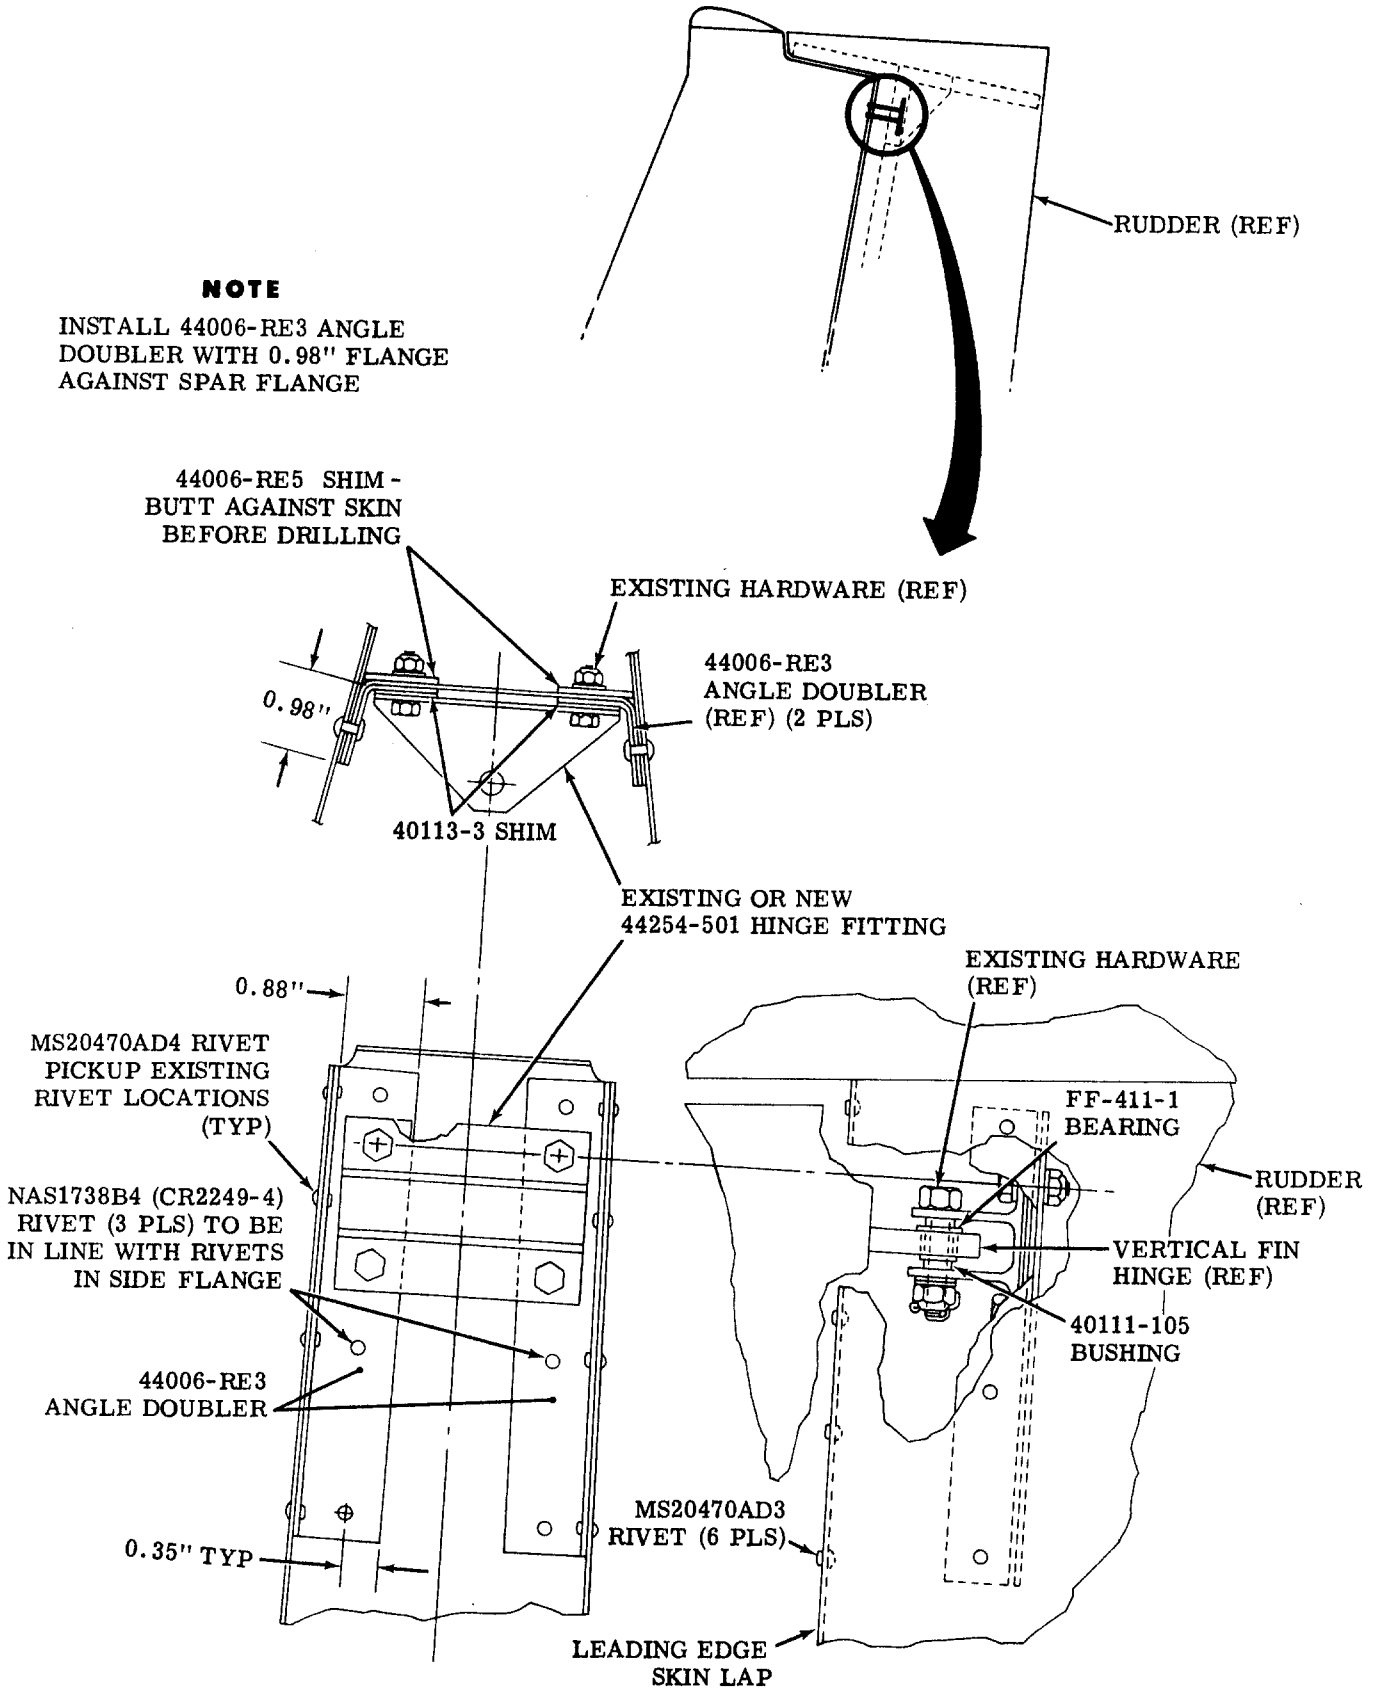
Figure 1.

REASON FOR PUBLICATION: POSSIBLE ELONGATION OF HOLES IN HINGE FITTINGS AND CRACKS IN RUDDER SPAR.

6. Dye penetrant inspect the bend radius of rudder spar, in area of upper hinge fitting, for cracks.
7. If no cracks are found in bend radius of rudder, in area of upper hinge fitting, proceed to step 9.

8. If cracks are found in bend radius of rudder spar, in area of upper hinge fitting, proceed as follows:
 - a. Remove upper four (4) rivets, attaching skin to spar, from left and right side of rudder assembly (total of eight (8) rivets).

- b. Remove upper six (6) rivets from rudder assembly leading edge skin lap.
 - c. Stop drill all cracks with a No. 40 (0.098) diameter drill.
 - d. Locate, drill and install 44006-RE3 angle doubler (2 places) on rudder assembly (see Figure 1.).

- e. If existing hinge fitting is to be used, trim 0.06-inch to 0.07-inch from each end of existing hinge fitting.
 - f. Install existing or new 44254-501 hinge fitting, 44006-RE5 shim (2 places) and 40113-3 shim (2 places) using existing hardware (see Figure 1.).

10. Reinstall tip on rudder assembly.
11. Remove and discard existing oilite bearing from upper vertical fin hinge.
12. Install FF-411-1 bearing in upper vertical fin hinge and ream hole in new bearing to 0.317/0.318-inch (see Figure 1.).

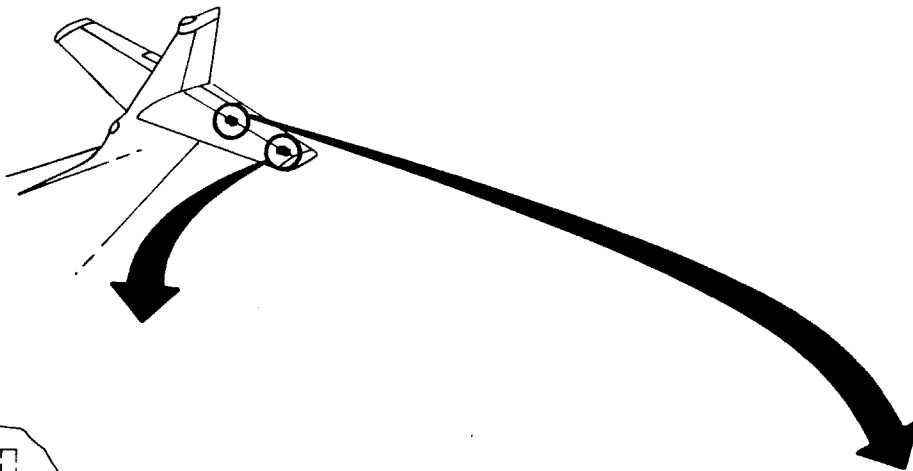
Figure 2.

16. If no play is evident in outboard hinge fitting, per step 14., proceed to step 18.
17. If play is evident in outboard hinge fitting, per step 14., proceed as follows:

- d. Install new 44285-1 hinge fitting on elevator using existing hardware (see Figure 2.).
 - e. Attach skin to elevator structure using MS20426AD4 rivets and NAS1738B4 blind rivets.
 - f. Repaint elevator surfaces as necessary.
 - g. Reinstall tip on elevator.
18. Remove and discard existing oilite bearings from horizontal stabilizer center and outboard hinges.
 19. Install F316G bearing (4 places) on horizontal stabilizer center and outboard hinges and ream hole in bearings to 0.317/0.318-inch (see Figure 2.).
 20. Reinstall rudder assembly on airplane as outlined in the Airplane Maintenance Manual, Section VII, using existing hardware and 40111-105 bushing (see Figure 1.).

21. Reinstall left and right elevator assemblies on airplane as outlined in the Airplane Maintenance Manual, Section VII, using existing hardware, 40111-107 bushing (center hinge) and 40111-105 bushing (outboard hinge) (see Figure 2.).
