The following is a numerical list of all active Service Letters.

Model 114 Service Letter Index (Cont)

SERVICE LETTER NO. SL-114-1A

CABIN NOISE REDUCTION

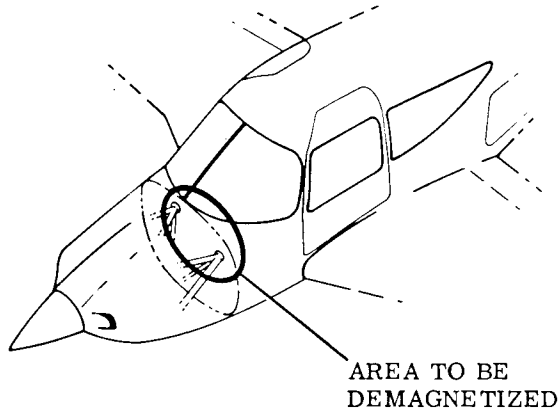
REASON FOR PUBLICATION: TO PREVENT MAGNETIC COMPASS INTERFERENCE DUE TO IMPROPER/INSUFFICIENT BONDING OF ENGINE TO AIRFRAME GROUND. THIS HAS BEEN NOTED ON CERTAIN AIRCRAFT BY BEING UNABLE TO ACHIEVE PROPER COMPASS HEADINGS.

- a. Remove magnetic compass from airplane.
- b. Remove upper engine cowling.
- c. Place degaussing ring over area shown below. Turn degaussing ring ON, move over area in slow circular motions approximately four (4) times and then move degaussing ring away from airplane structure.

Do not turn degaussing ring OFF until well away from airplane structure.
