General Aviation Division
Rockwell International

SERVICE INFORMATION NO. SI-102

SUBJECT: FAA AIRWORTHINESS DIRECTIVE 74-24-13.

SUBJECT: FLOW DIVIDERS FOR BENDIX FUEL INJECTION SYSTEMS, INSPECTION AND MODIFICATION OF

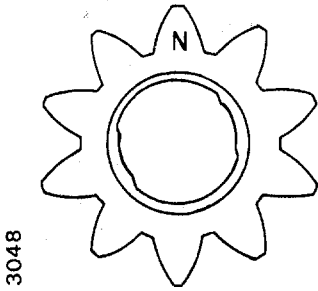
Figure 1. Nitrided Driving Impeller

The new nitrided driving impeller can be identified by the character "N" located on the centerline of a geartooth. (See Figure 1.) The new, carburized driven impeller will have the character "C" located on a geartooth centerline. (See Figure 2.)
