SERVICE LETTER NO. SL-1

EFFECTIVITY: Rockwell Commander 112 S/N 3 through 79

SUBJECT: Rudder Assembly

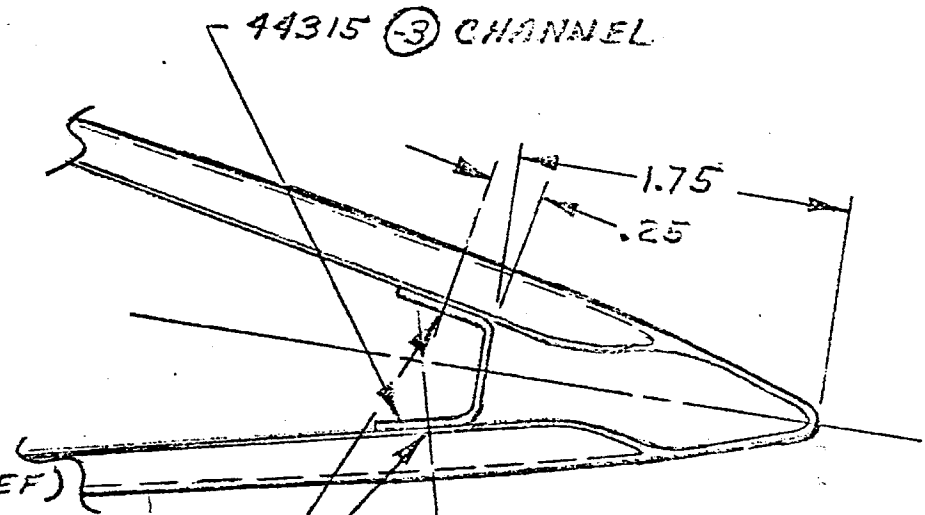
SECT A-A

PURPOSE: Service investigation has revealed that the skin on the aft portion of the rudder assembly may need to be stiffened in order to prevent cracks from forming on the skin.

2. Remove rudder.
3. Drill top and bottom rivet holes on both sides of rudder.
4. Mark rivet center line on channel then mark locating line for one of the rivets.
5. Insert channel through lightening hole on the leading edge of rudder and position channel so that center line for one end rivet is visible through rivet hole. Drill and cleco.

CR 2249-4-1 CHERRY RIVET
10 REQ

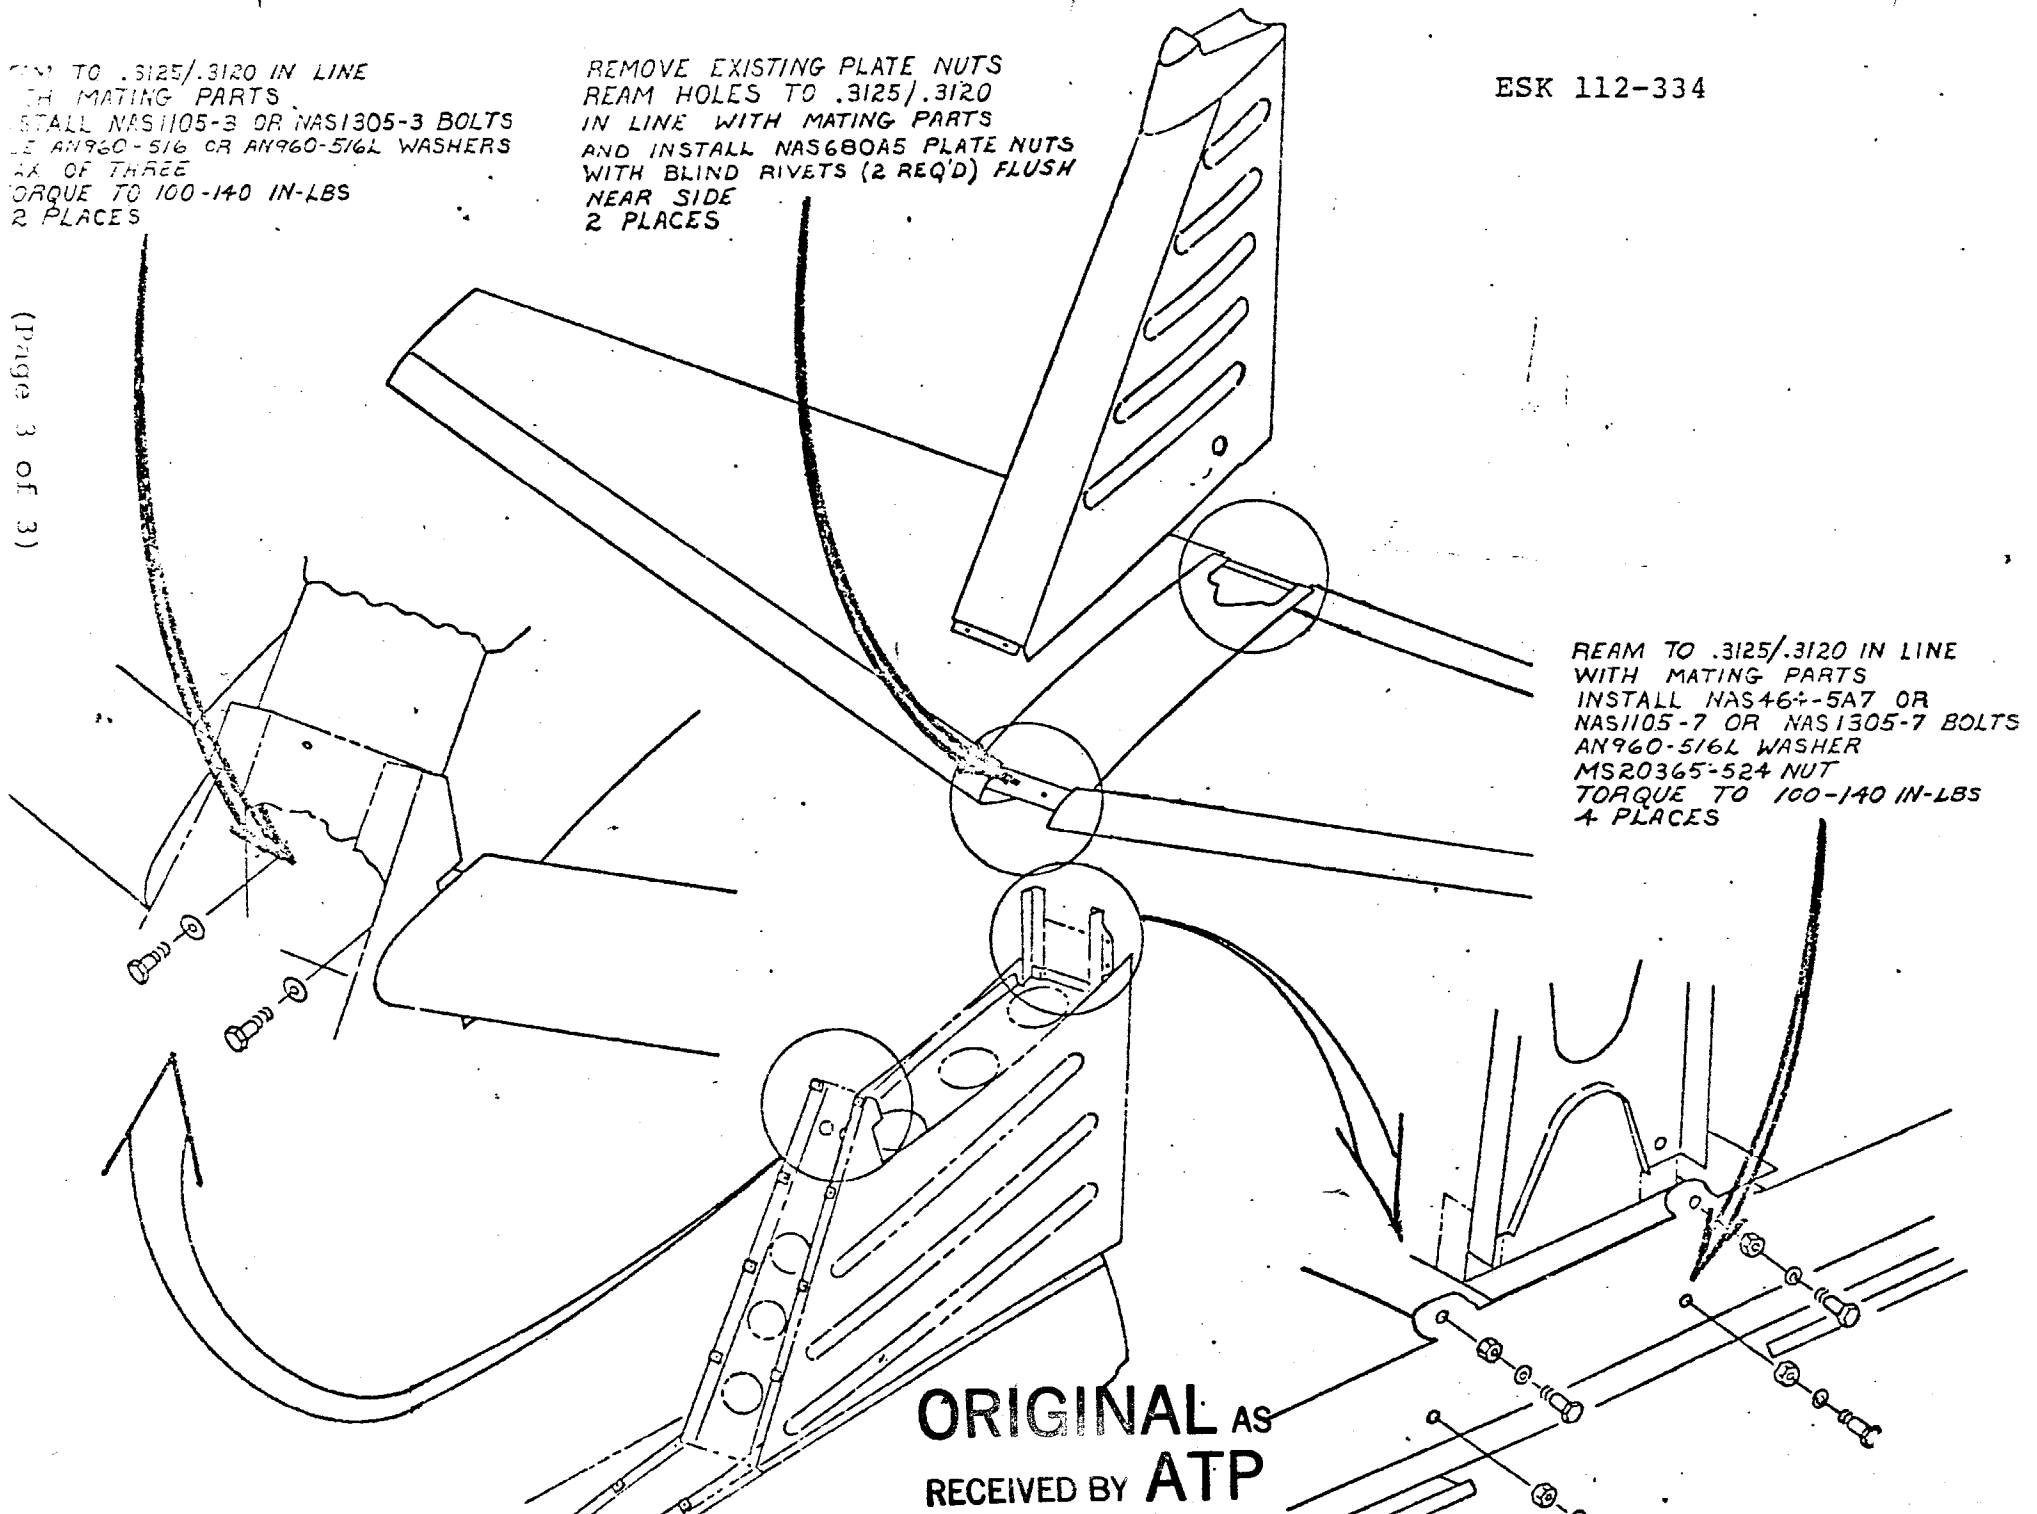
3. If excessively long bolts are noted in Step 1 and/or Step 2; or if any looseness is noted in the horizontal stabilizer spar attachment points, proceed with Steps 4 through 9.

5. Remove the 2 forward and 8 aft horizontal stabilizer attach bolts. Visually inspect the holes in the horizontal stabilizer and the lower vertical fin assembly for signs of bolthole elongation, if none appears re-install the horizontal stabilizer (per Step 6). If elongation has occurred in any of the boltholes, repair per ESK 112-334 and proceed to Step 6.
6. RE-ASSEMBLY: The (8) rear attach bolts should be installed first, with a minimum of (2) washers per bolt (AN960-416 or AN960-516 if 5/16 bolts have been used).

REAM TO .3125/.3120 IN LINE
WITH MATING PARTS
INSTALL NAS464-5A7 OR
NAS1105-7 OR NAS1305-7 BOLTS
AN960-516L WASHER
MS20365-524 NUT
TORQUE TO 100-140 IN-LBS
4 PLACES

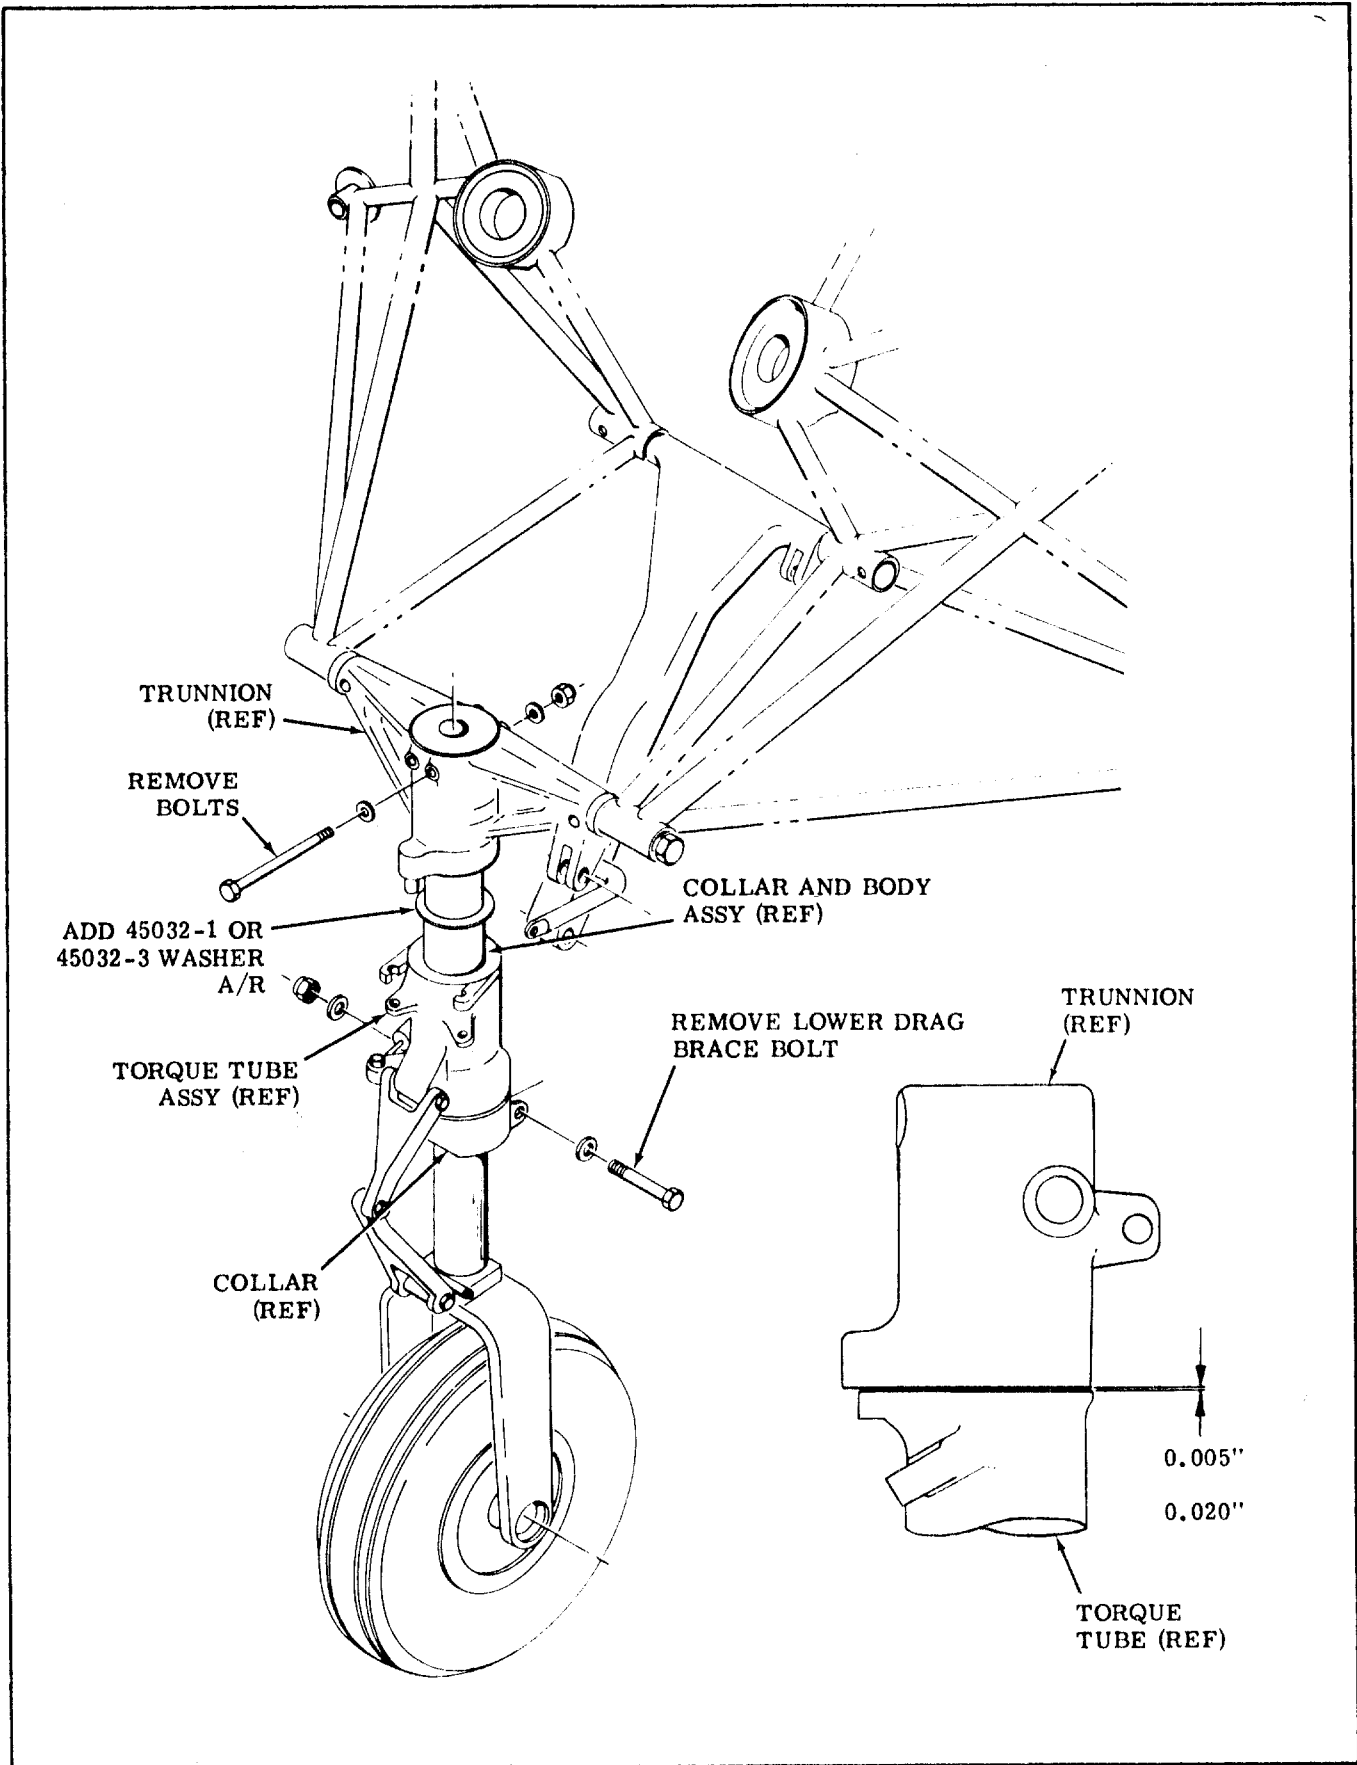
Figure 1.

1. Jack airplane as outlined in Model 112 Airplane Maintenance Manual, Section IV.
2. With torque tube firmly against lower collar, check gap dimension between nose landing gear trunnion and torque tube. Gap should not be more than 0.020-inch or less than 0.005-inch (see Figure 1.).
3. If gap between nose gear trunnion and torque tube is less than 0.020-inch, proceed to step 14.

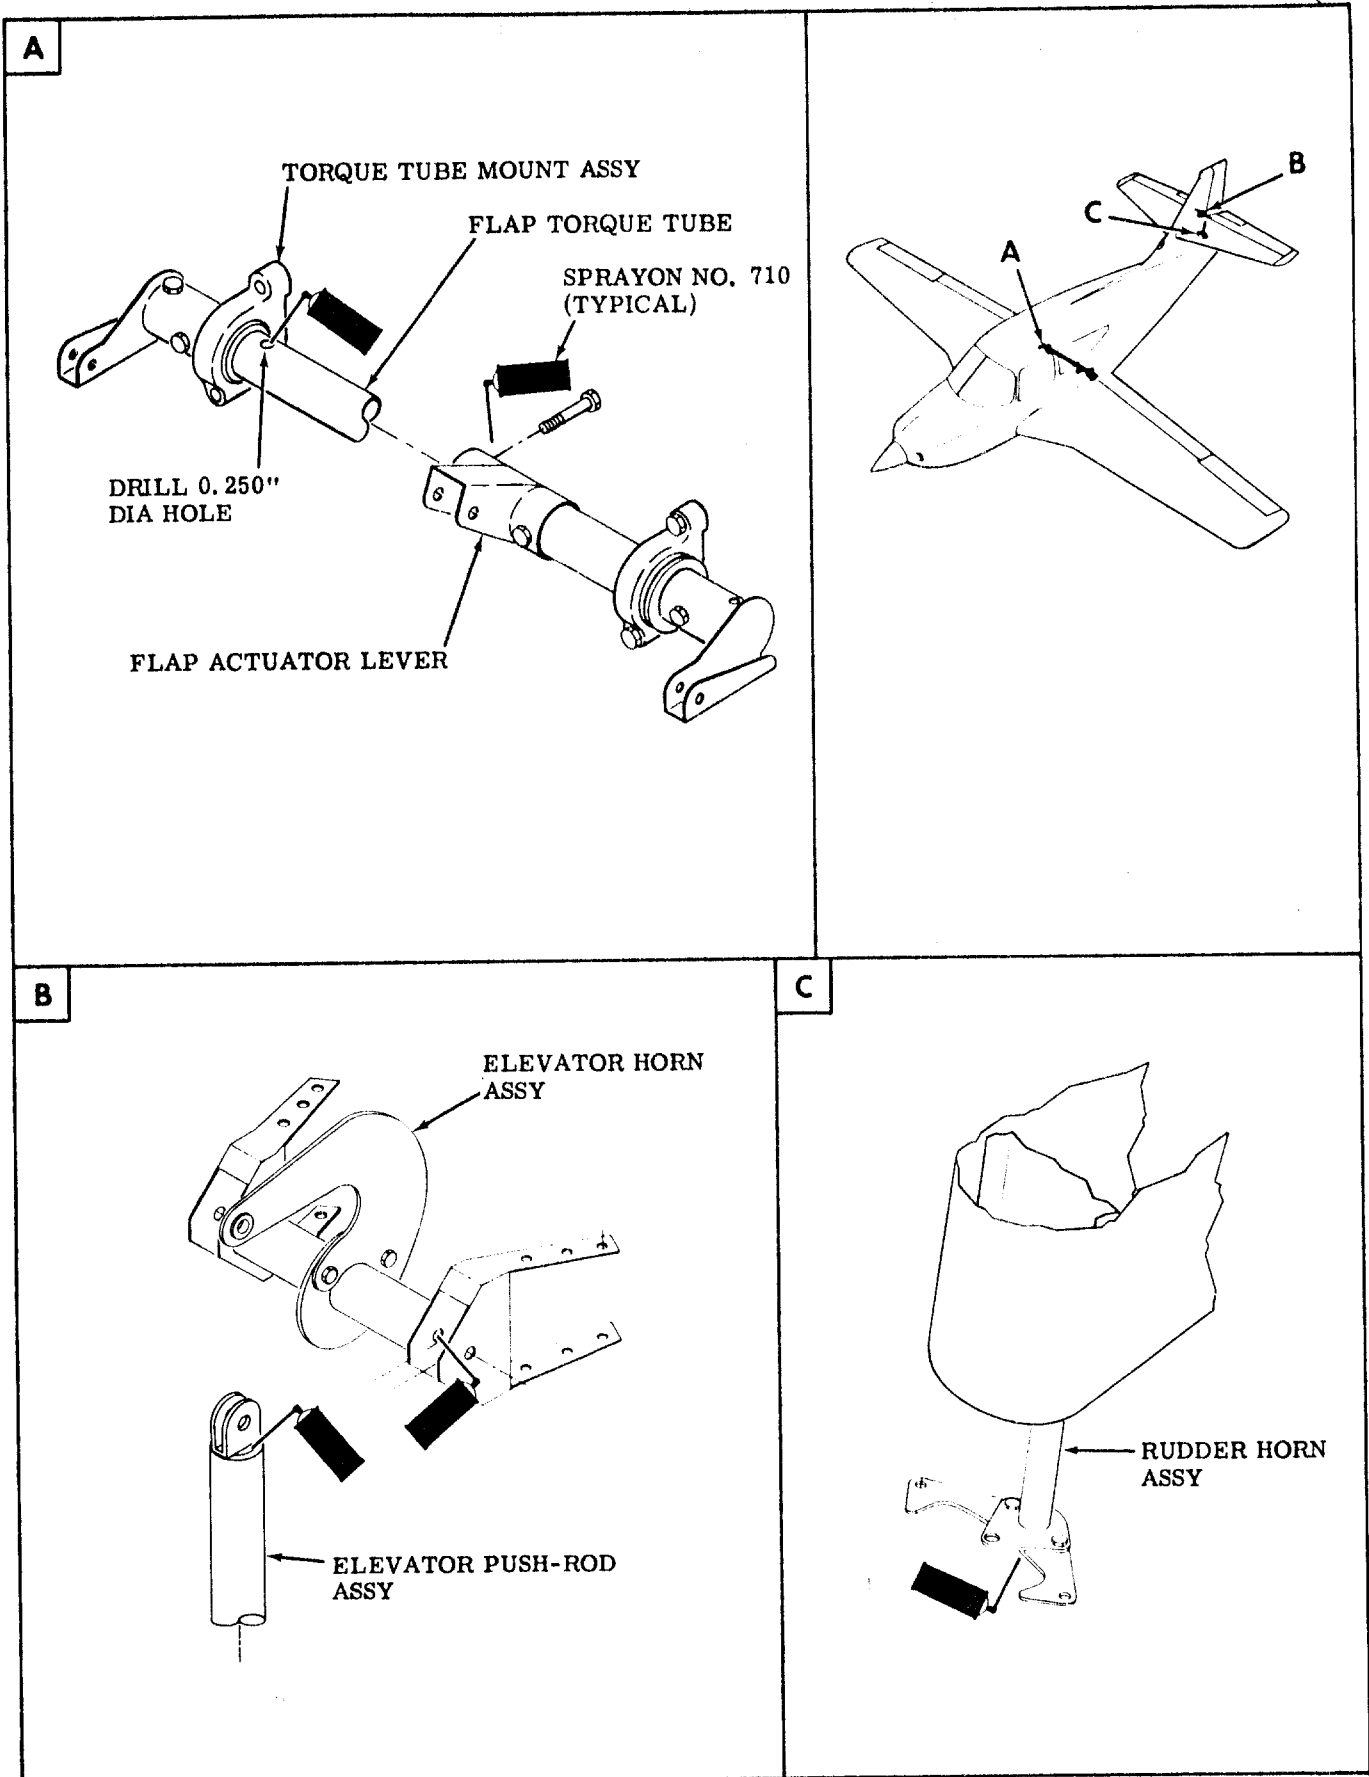
Figure 1.

REASON FOR PUBLICATION: PROVIDE INTERNAL CORROSION PROTECTION FOR FLAP TORQUE TUBE, ELEVATOR HORN ASSEMBLY, ELEVATOR PUSH-ROD ASSEMBLY AND RUDDER HORN ASSEMBLY.

1. Remove screws attaching fiberglass stinger to aft fuselage, disconnect tail navigation light wiring and remove stinger from airplane.
2. Remove aft baggage curtain from baggage compartment.
3. Relieve tension on rudder cables and disconnect cables from rudder.
4. Remove bolts from rudder hinges and remove rudder from airplane.
5. Disconnect elevator actuator rod.
6. Remove six (6) screws and two (2) bolts at the inboard end of elevator.
7. Remove elevator hinge bolts and remove elevators from airplane.
8. Remove bolt attaching elevator push-rod assembly to elevator horn assembly.
9. Remove bolts attaching elevator horn assembly to horizontal stabilizer and remove elevator horn assembly from airplane.
10. Spray interior of elevator push-rod assembly, elevator horn assembly and rudder horn assembly with Sprayon No. 710 (see Figure 1.).

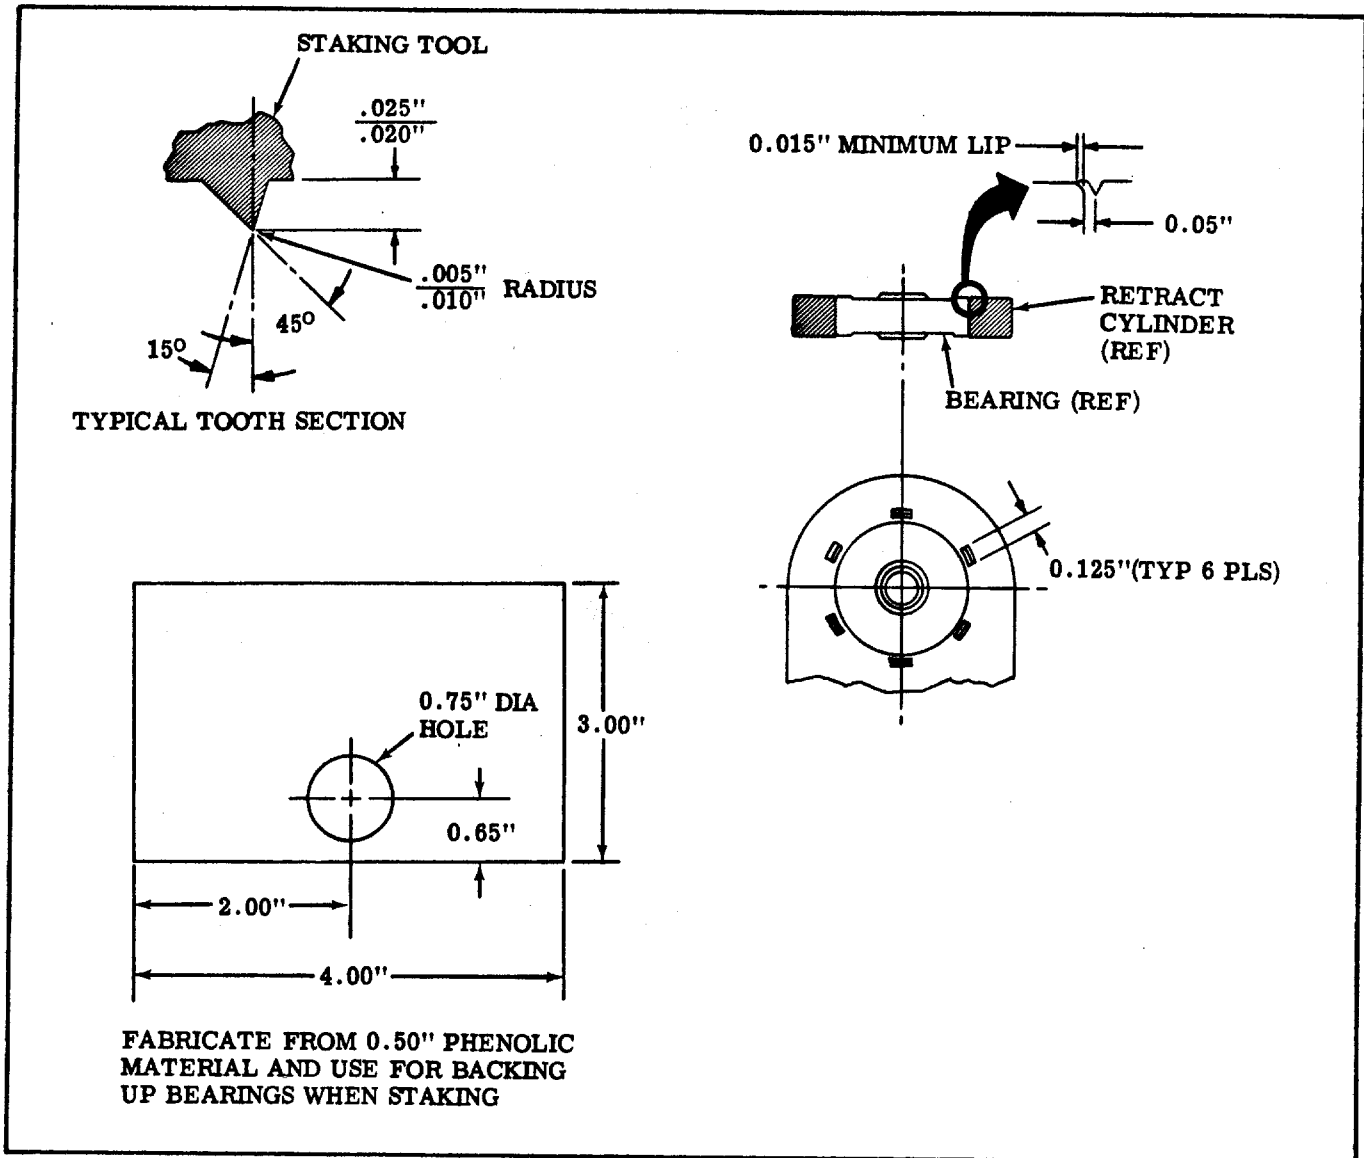
- b. Inspect cylinder end plug bearings to assure that the bearings are properly staked as shown in Figure 3.

Fabricate a block from 1/2-inch phenolic material for backing up bearing when staking (see Figure 3.).

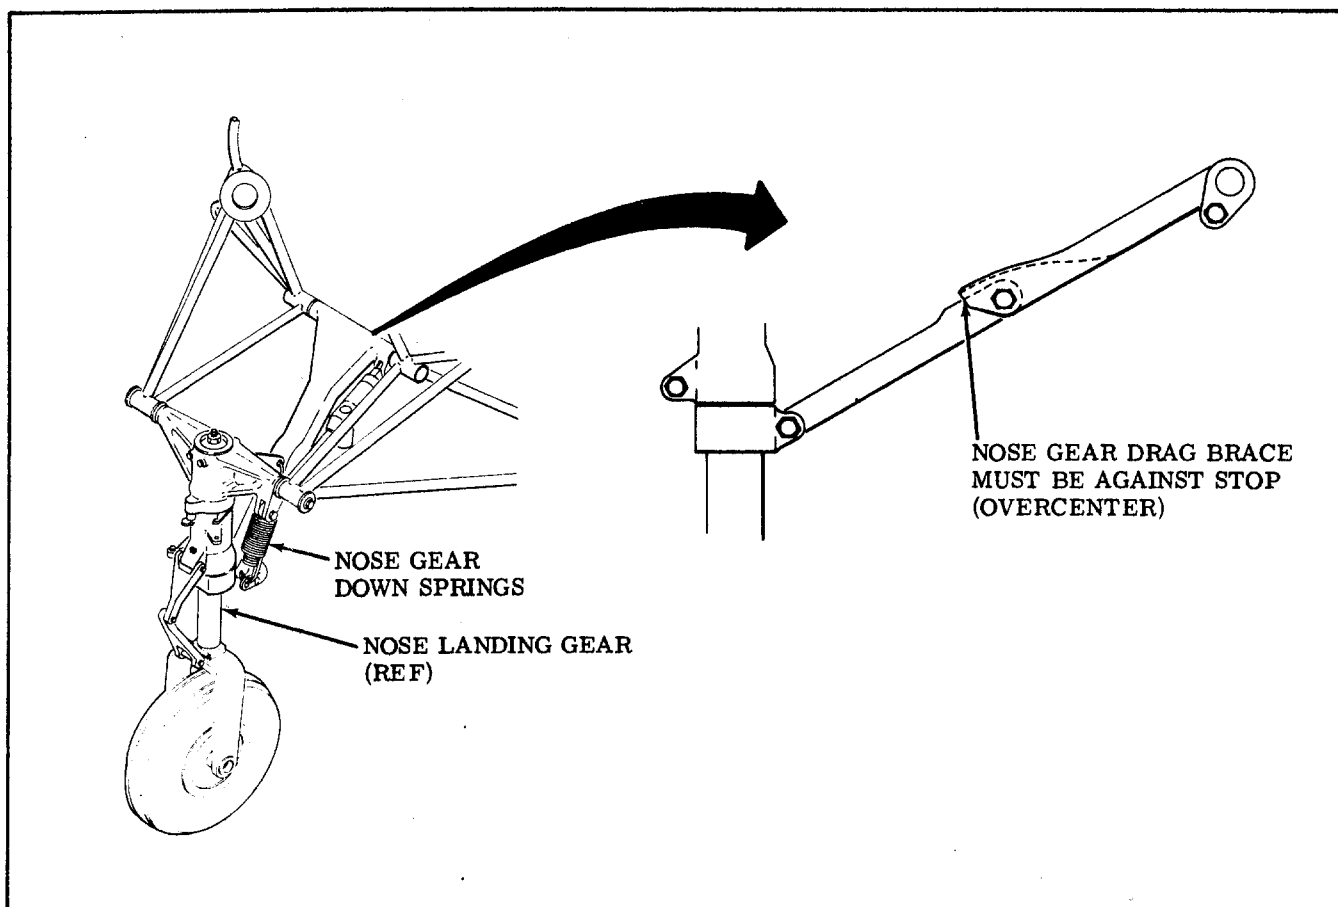
Figure 1.

- a. With the cylinder lock engaged on the nose gear actuating cylinder and the drag brace in a relaxed position, the drag brace must be resting on the overcenter stop at the knuckle area.
- b. Push up on the drag brace pivot point and check for a clearance of 0.040 to 0.125-inch.

- c. If clearance is not correct, readjust nose gear actuating cylinder as outlined in the Airplane Maintenance Manual, Section VI.

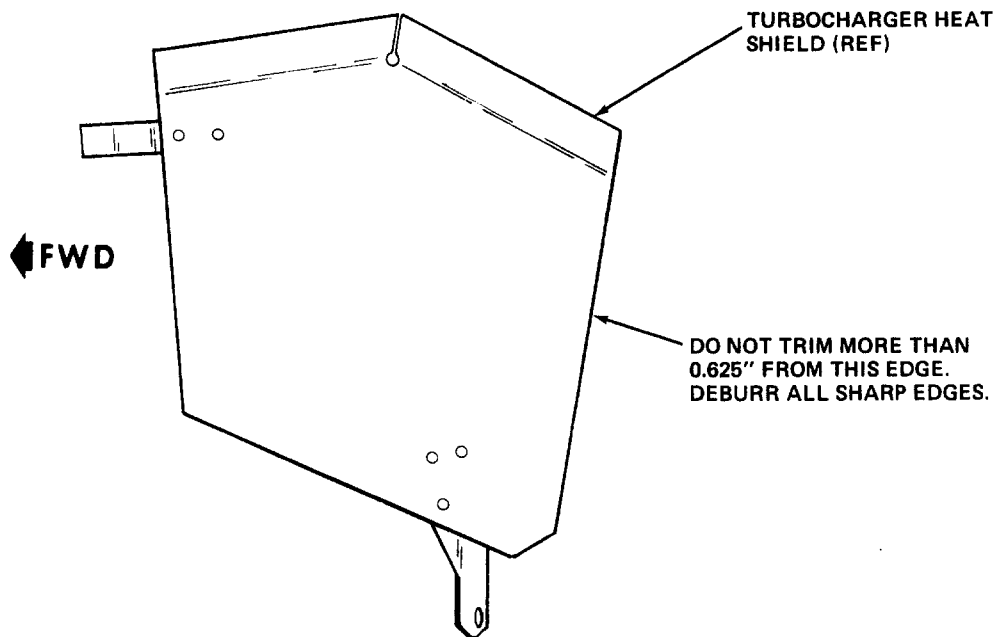
Figure 1.

REASON FOR PUBLICATION: POSSIBLE ENGINE MOUNT STRUCTURAL DAMAGE DUE TO RUBBING OF TURBOCHARGER HEAT SHIELD.

1. Remove upper cowling from engine.
2. Inspect engine mount, adjacent to turbocharger heat shield, for possible damage to engine mount (refer to Figure 1).
3. If no damage is evident and clearance between turbocharger heat shield and engine mount is 0.50-inch or more, proceed to step 7.
4. If contact between turbocharger heat shield and engine mount is evident but no major damage has occurred (see step 6), remove heat shield and trim to provide a clearance of 0.50-inch between heat shield and engine mount (refer to Figure 1).
5. Reinstall heat shield, assuring that 0.50-inch clearance is maintained.
6. If extensive damage to engine mount is evident (any penetration of the tube), contact Gulfstream American Corporation Customer Service Department for further instructions.
7. Reinstall upper cowling on engine.
8. Fill out and mail Compliance Card.

NOTE
TRIM HEAT SHIELD ONLY
IN AREA OF ENGINE MOUNT
IF NECESSARY.

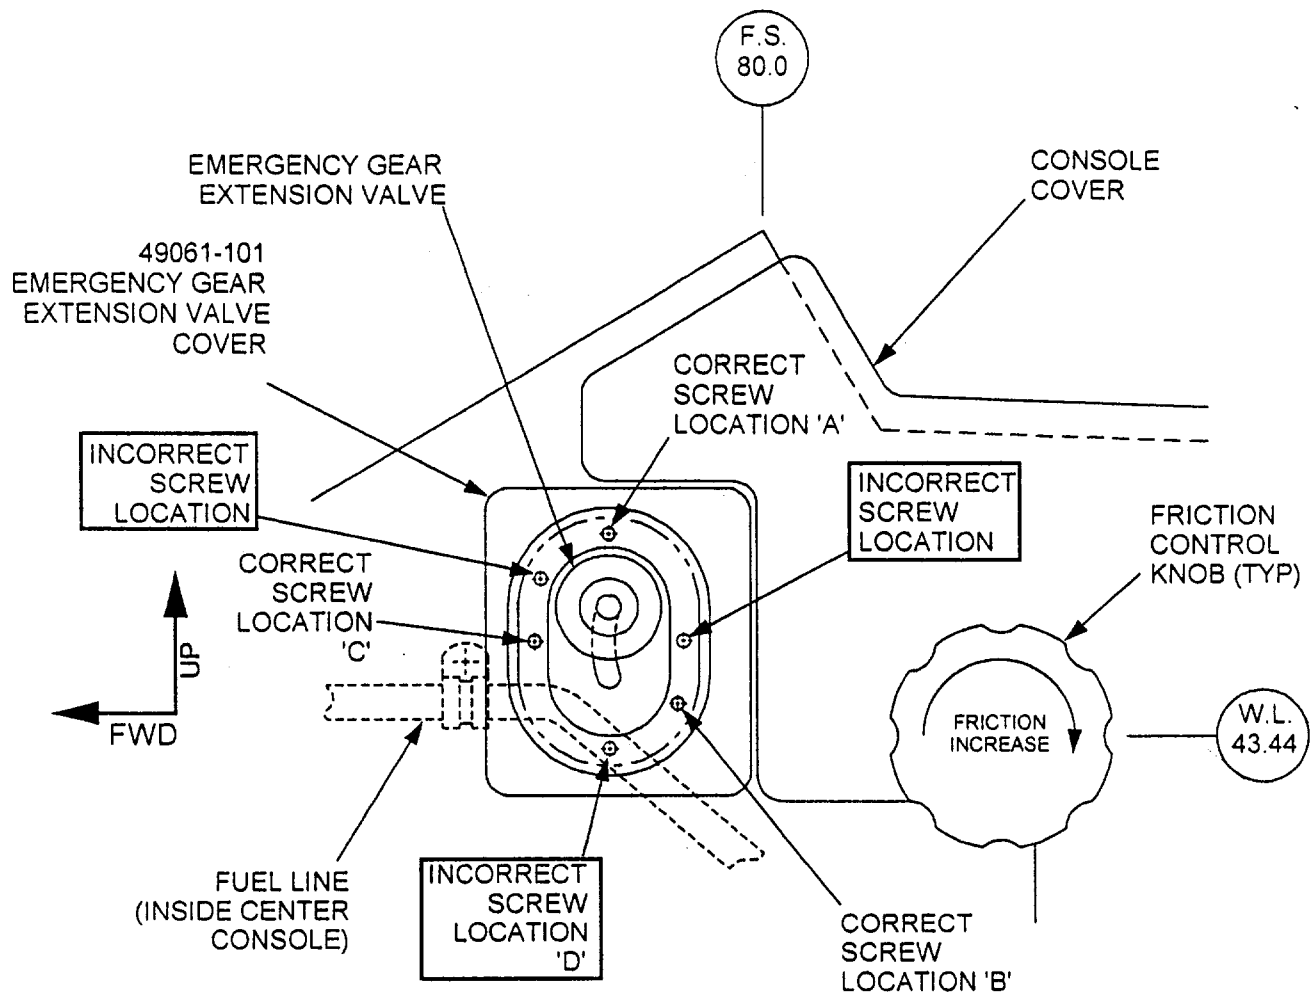
Figure 1.

7. Move the throttle lever forward until it clears the throttle warning microswitch. Raise the quadrant cover plate and the forward console cover to permit inspection of the fuel line for nicks or scratches in the area where the bottom screw of the improperly attached Emergency Gear Extension Valve Cover attached to the center console.

- a. If no damage to the fuel line is found, reattach the center console parts (Part II, steps 1 thru 6 in reverse order), proceed to Part IV.
 - b. If a nick or scratch is found in the area being inspected, or any other damage to the fuel is found, proceed to Part III.

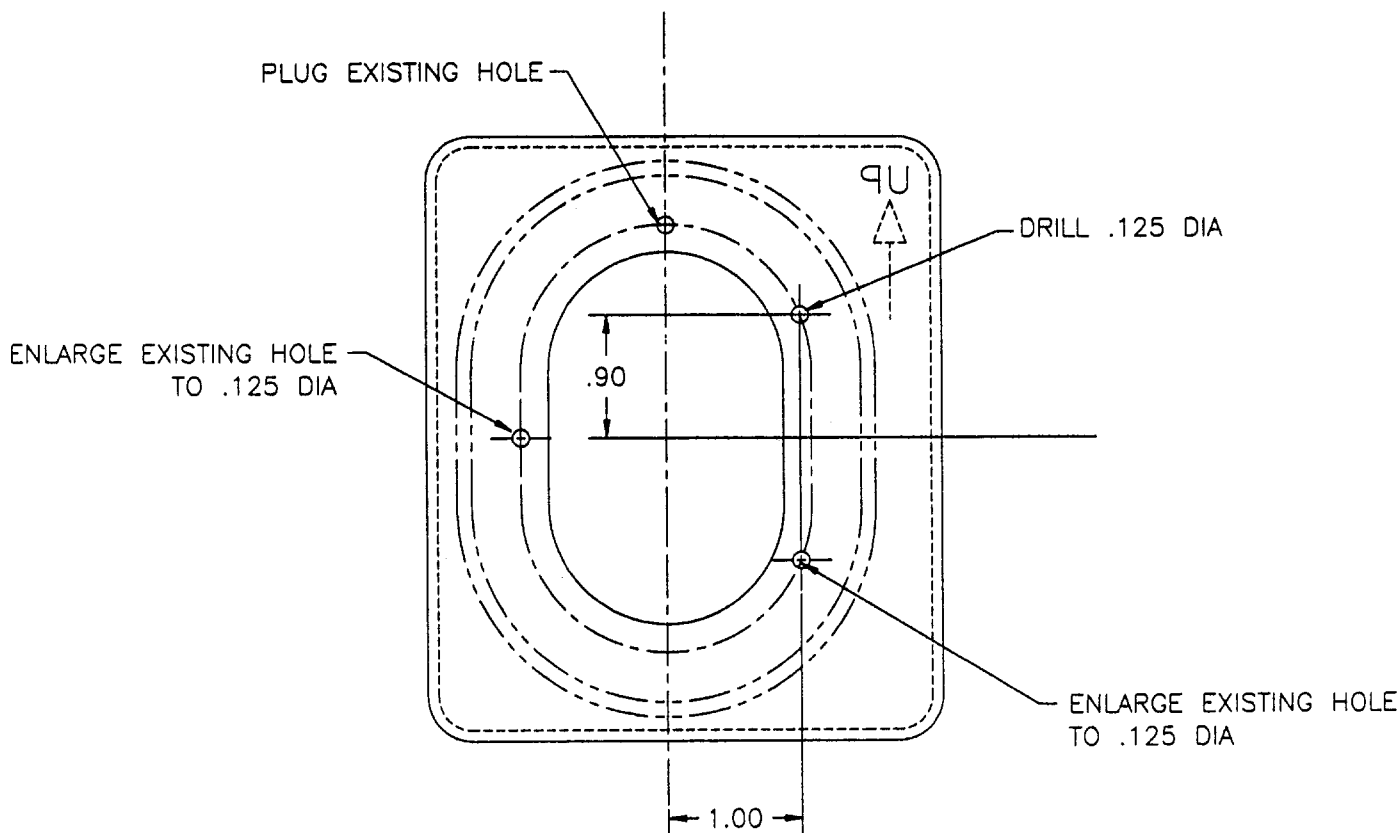
Figure 3. Cover Plate Modifications

REASON FOR PUBLICATION: To reduce the possibility of improper installation of the Emergency Gear
Extension Valve Cover Plate by field maintenance personnel.

3. Drill an additional .125 diameter hole in the location shown in Figure 3.
4. Paint the cover plate to match the interior of the aircraft.
5. When the paint is dry, draw an arrow and write the word 'UP' on the back side of the plate in a contrasting color as shown in Figure 4.
