SERVICE LETTER NO. SL-112-46
Revision No. 1
27 October 1981

ELEVATOR AND RUDDER HINGE FITTING INSPECTION AND/OR REPLACEMENT

SERVICE LETTER NO. SL-112-46
14 November 1979

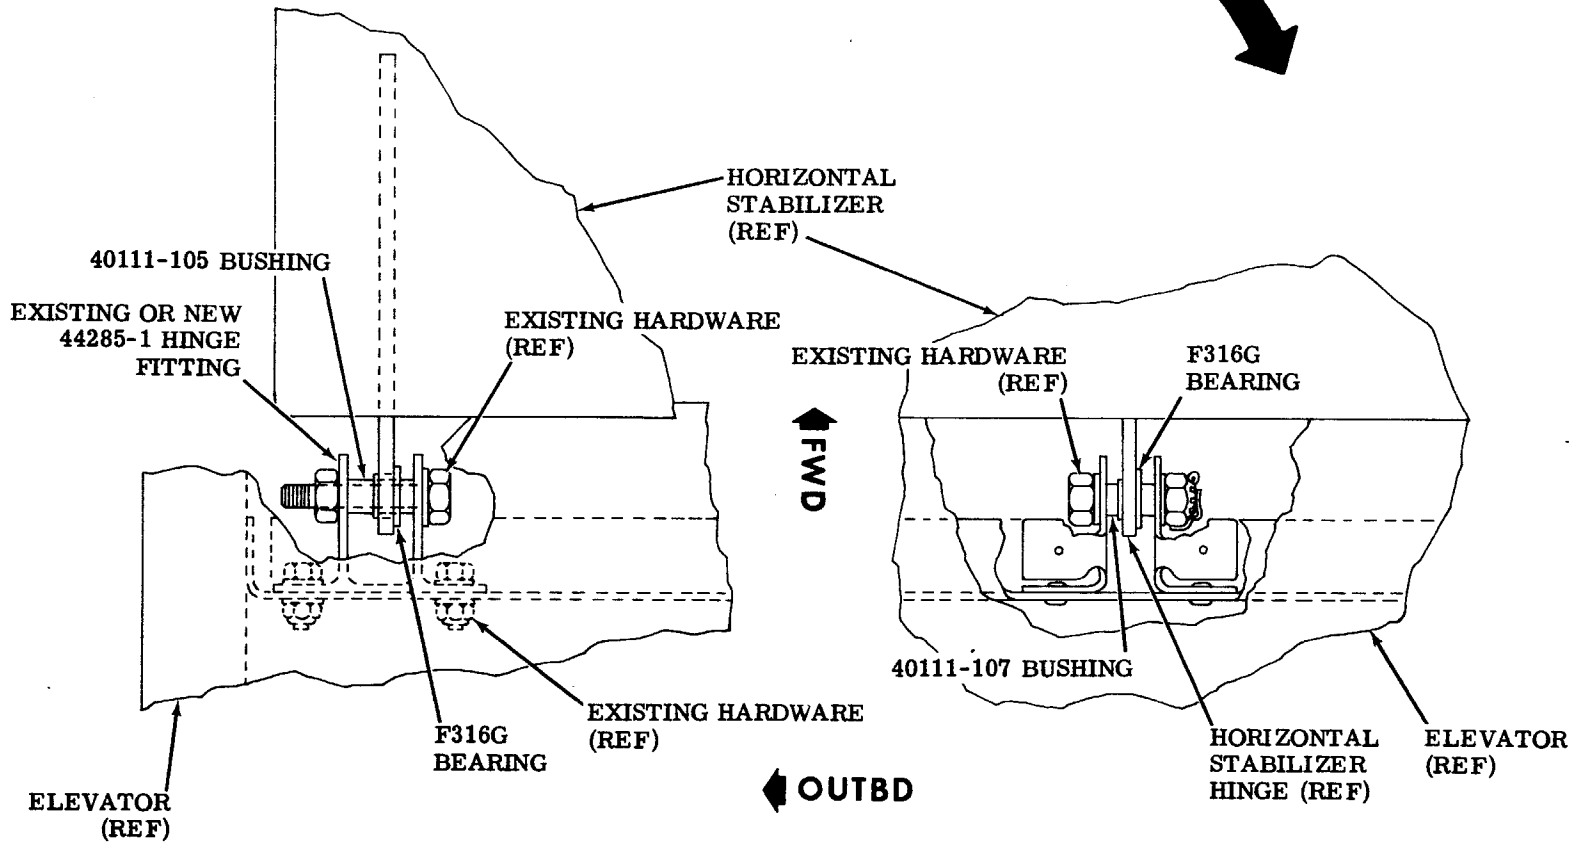
Figure 2.

REASON FOR PUBLICATION: POSSIBLE ELONGATION OF HOLES IN HINGE FITTINGS AND CRACKS IN RUDDER SPAR.

Replace center hinges if holes are elongated.

- d. Install new 44285-1 hinge fitting on elevator using existing hardware (see Figure 2.).
 - e. Attach skin to elevator structure using MS20426AD4 rivets and NAS1738B4 blind rivets.
 - f. Repaint elevator surfaces as necessary.
 - g. Reinstall tip on elevator.
18. Remove and discard existing oilite bearings from horizontal stabilizer center and outboard hinges.
 19. Install F316G bearing (4 places) on horizontal stabilizer center and outboard hinges and ream hole in bearings to 0.317/0.318-inch (see Figure 2.).
 20. Reinstall rudder assembly on airplane as outlined in the Airplane Maintenance Manual, Section VII, using existing hardware and 40111-105 bushing (see Figure 1.).

21. Reinstall left and right elevator assemblies on airplane as outlined in the Airplane Maintenance Manual, Section VII, using existing hardware, 40111-107 bushing (center hinge) and 40111-105 bushing (outboard hinge) (see Figure 2.).
